IN THE MATTER OF an Application by Nova Scotia Power Inc. for
Approval of the **2013 Annual Capital Expenditure (ACE) Plan**

2013 ACE Plan

2013 Annual Capital Expenditure Plan

Weymouth Surge Tank Inspection

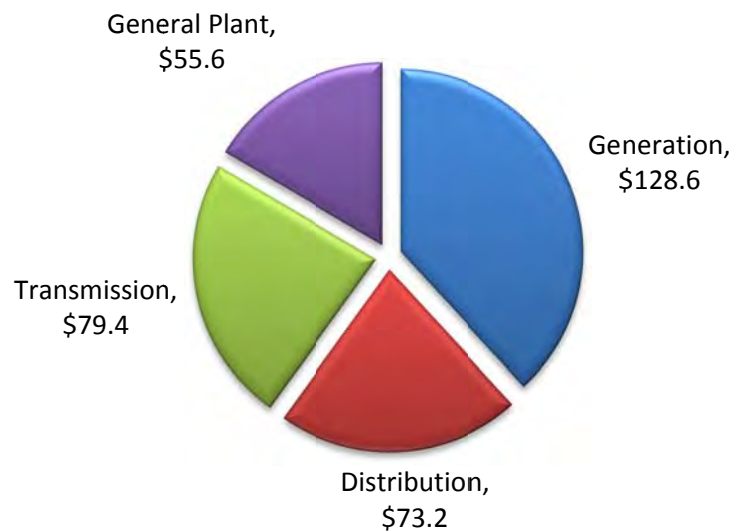
2013 Capital Spending by Function

(Millions of Dollars)

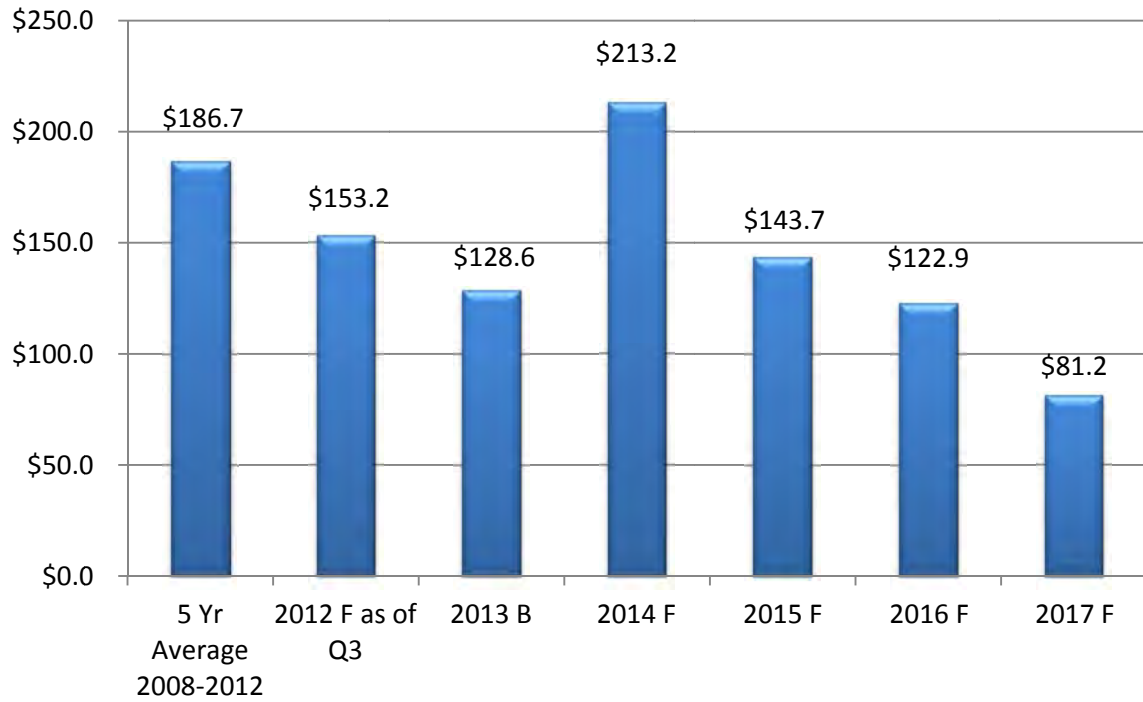
3 Generation

(Millions of Dollars)

F = Forecast, B=Budget in above figure

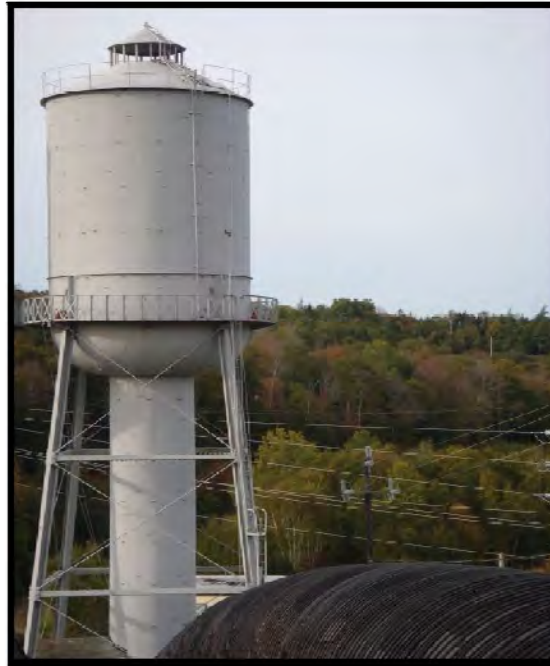
File Name: 50030

General photo.

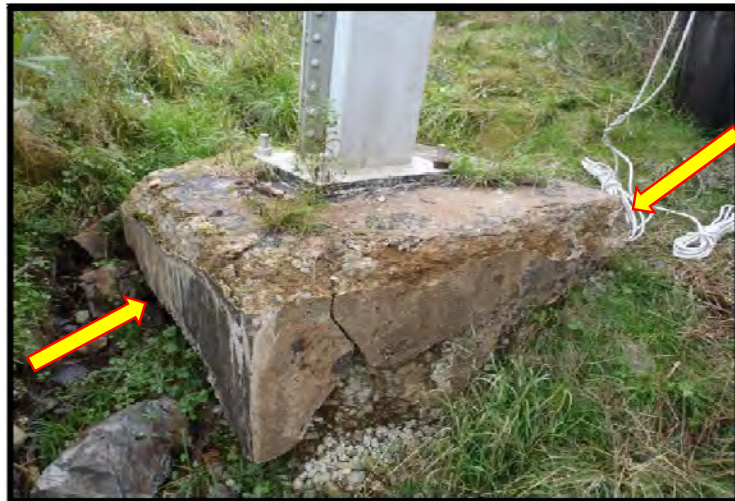
File Name: 50014

Very poor condition.

See next page for close-up photos of areas indicated.

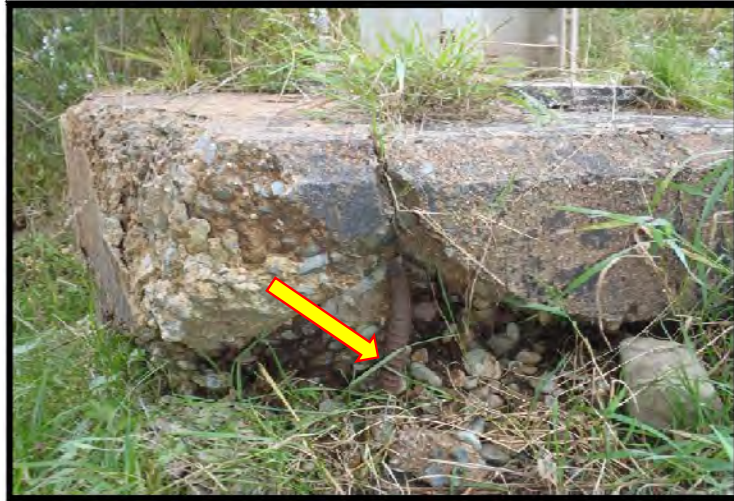
File Name: 50017

Severe deterioration of footing, note exposed rebar.

See below for additional photos.

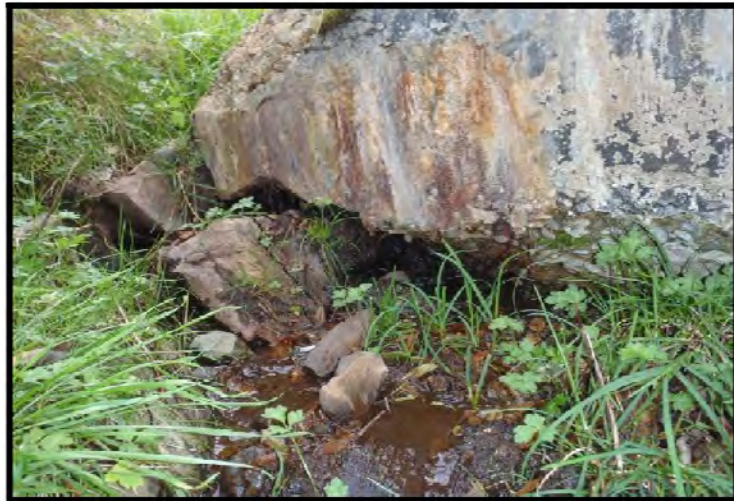
File Name: 50015

West post foundation.

Close-up of deterioration noted in photo 2.

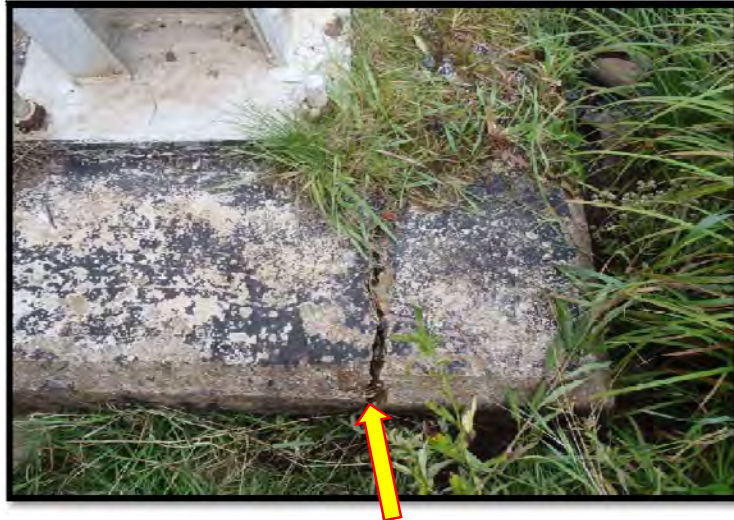
File Name: 50018

West post foundation.

Large 3/4" crack and 1/2" dislocation running to anchor bolts. Note vegetation growing in cracks.

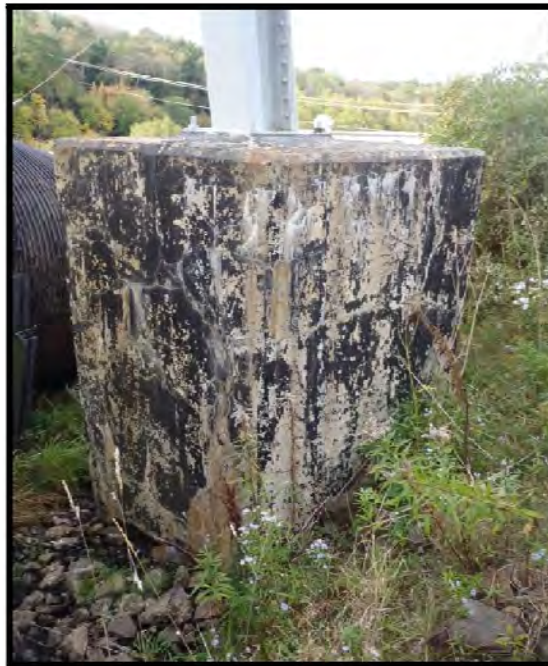
File Name: 5005

General condition photo.

Surface map cracking consistent over footing surface. Some cracks visible up to 1/2" wide.

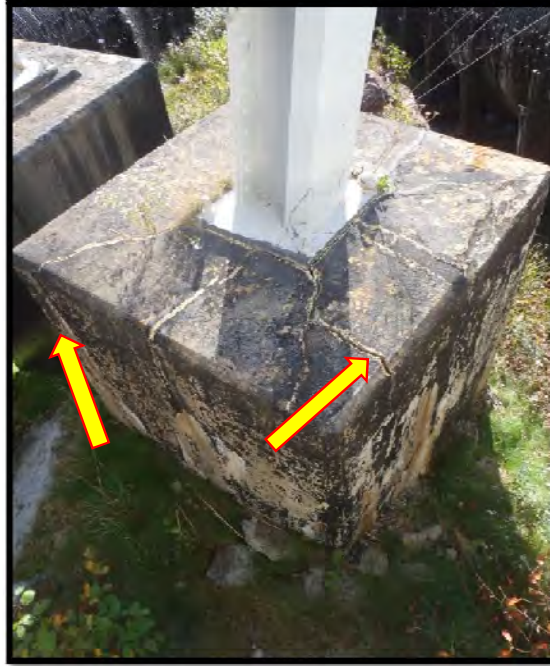
File Name: 50027

Note large cracks in footing.

See below and next page for close-up photos of areas indicated.

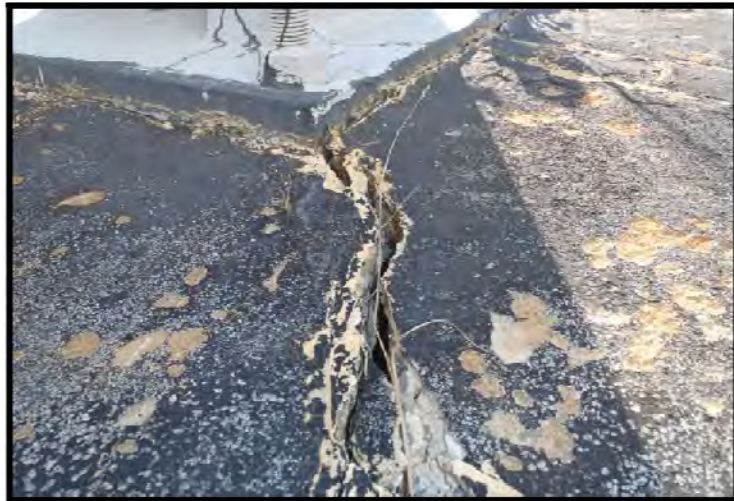
File Name: 50039

East post foundation.

Large cracks in footing 5/8".

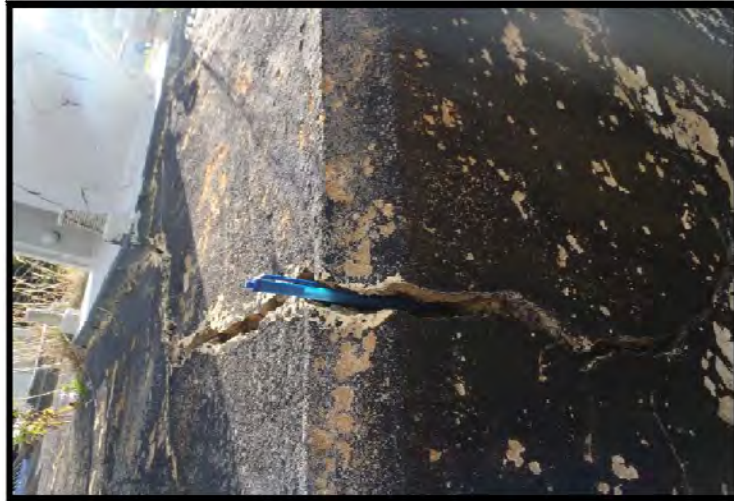
File Name: 50038

East post foundation.

Large cracks in footing 5/8" wide, 1/4" dislocated.

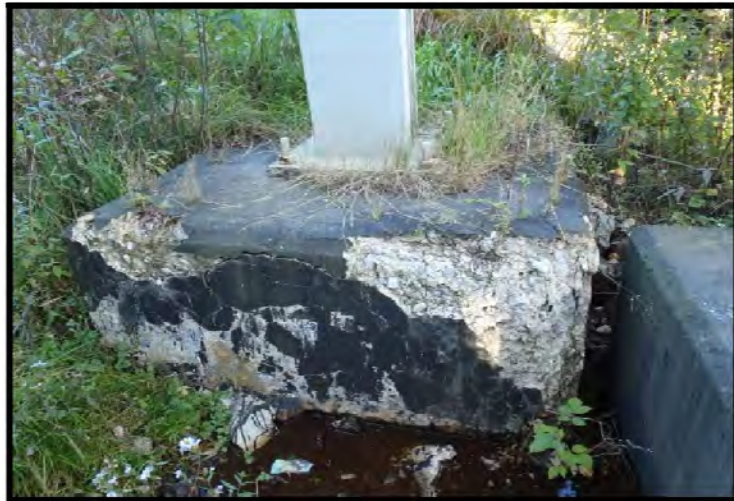
File Name: 50043

North post foundation.

Heavy spalling and deterioration.

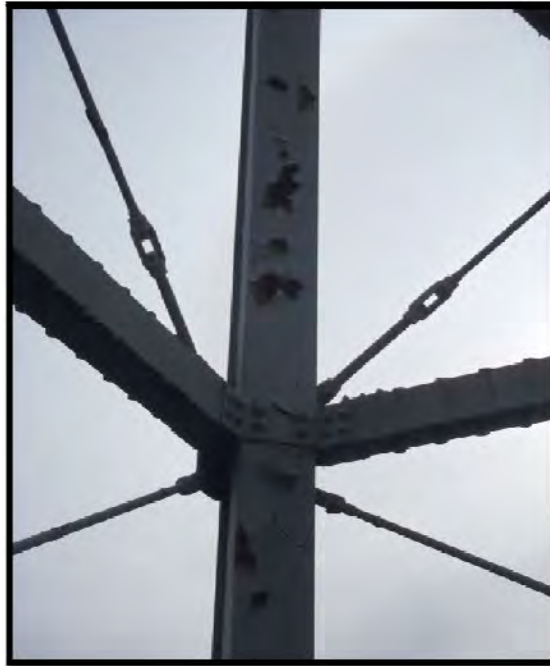
File Name: 50050

View of coating failure on posts. Not typical of all locations. See below for close-up.

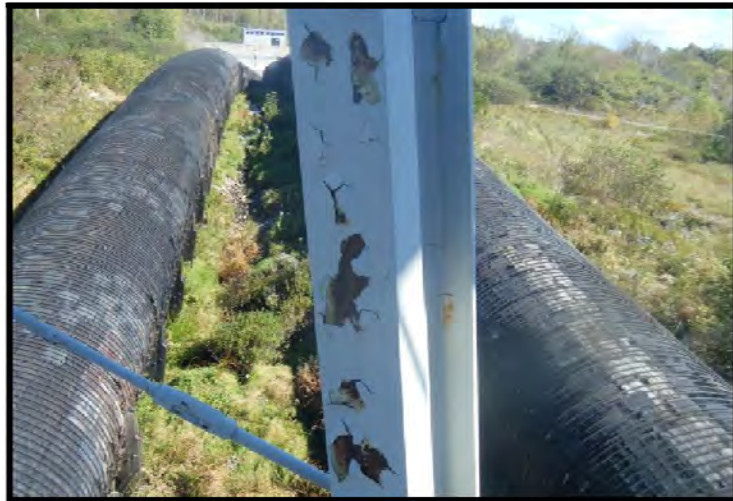
File Name: 10010

View of coating failure on posts.

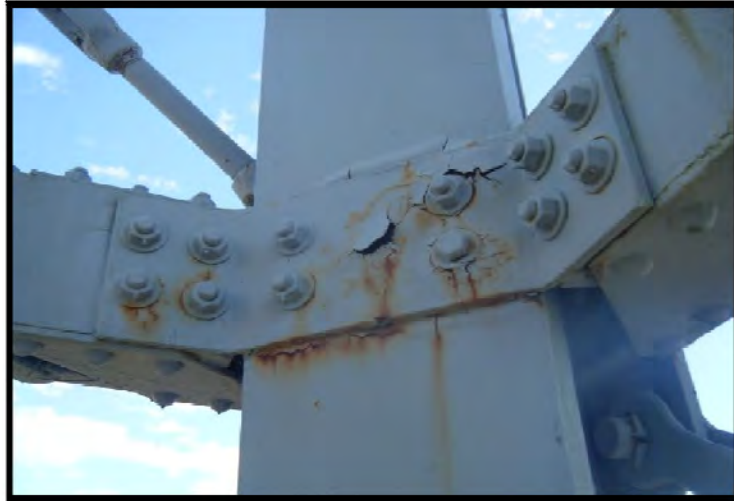
File Name: 1009

View of coating failure on posts.

View of typical condition of connection.

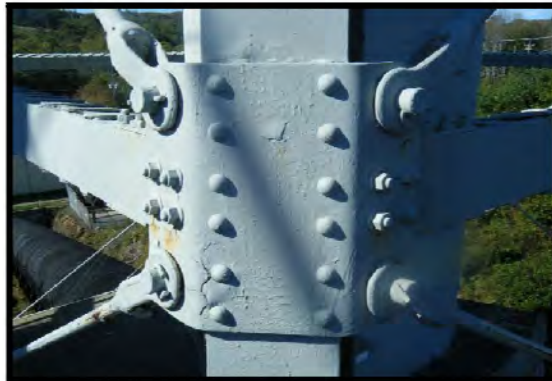
File Name: 10011

View of typical condition of post / rod connection

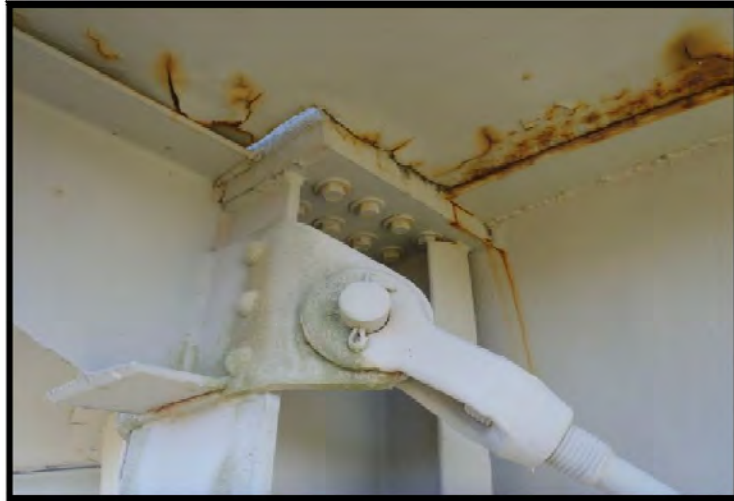
File Name: 4007

Typical condition of post shell connection

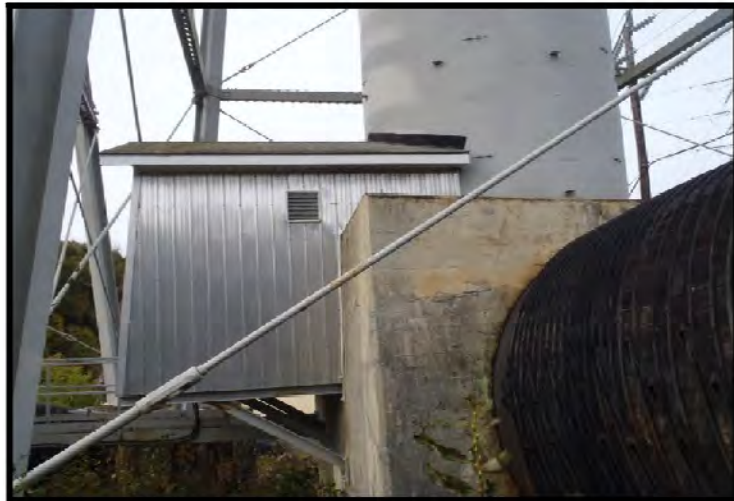
File Name: 50034

General photo of exterior Tee foundation.

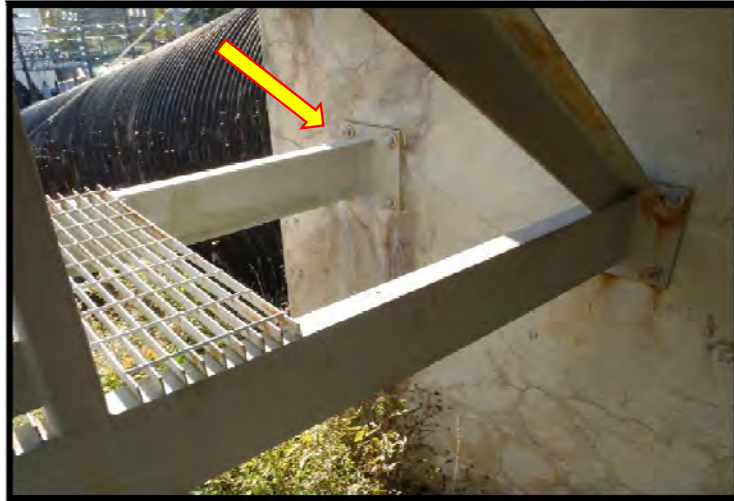
File Name: 50061

Connection loose. See below for close-up.

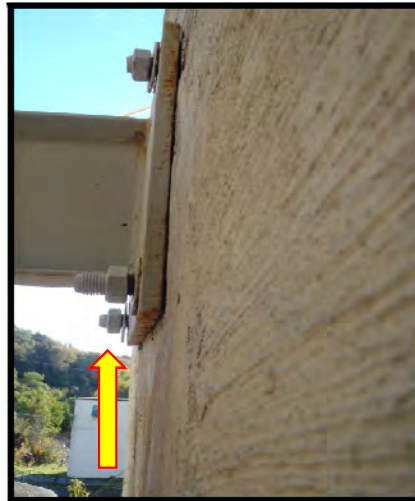
File Name: 50062

Bolted connection loose.

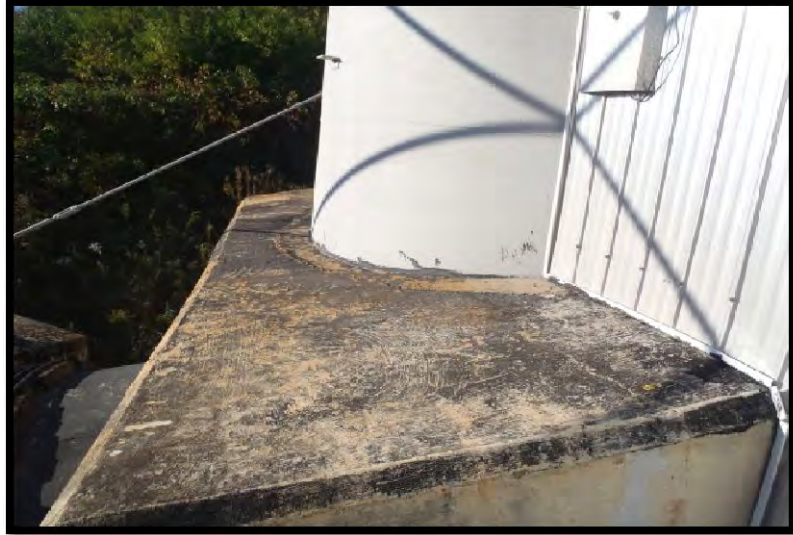
File Name: 50064

General photo showing bubbler house tee foundation and external riser.

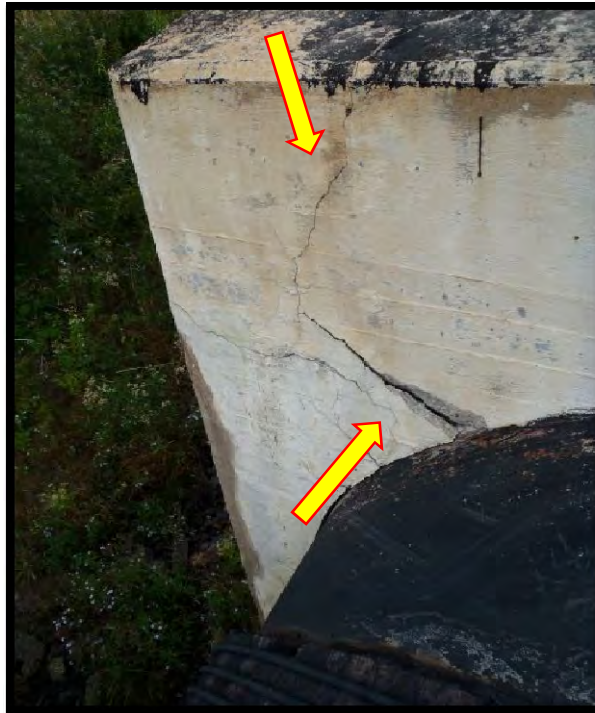
File Name: 50039

Large cracks and dislocation. Close-up of indicated area on next page.

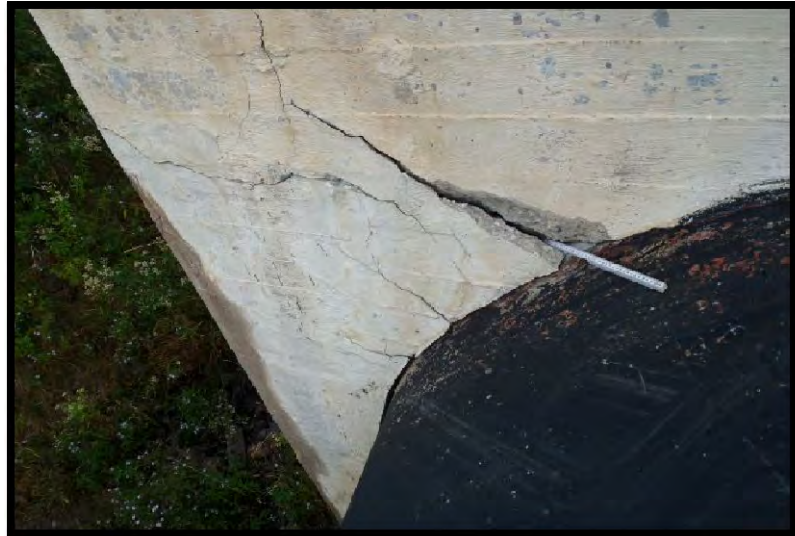
File Name: 50040

1" - Crack

3/8" - Horizontal dislocation

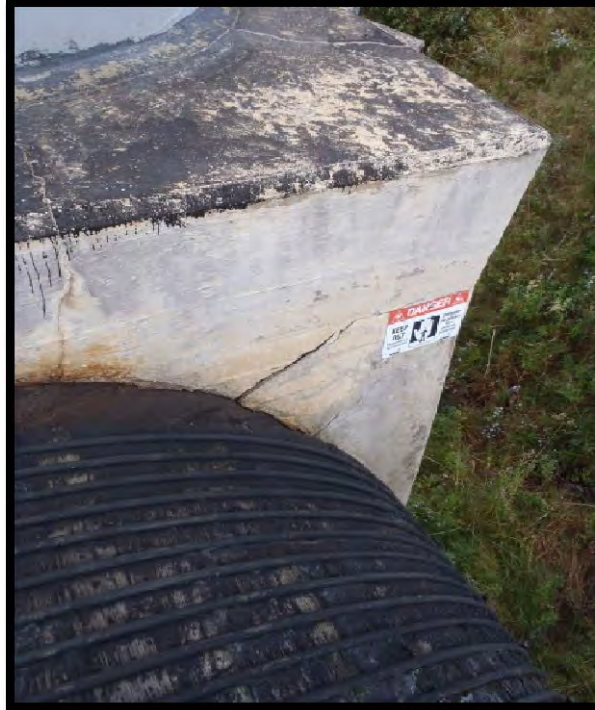
File Name: 50044

Large cracks and dislocation. Close-up of indicated area on next page.

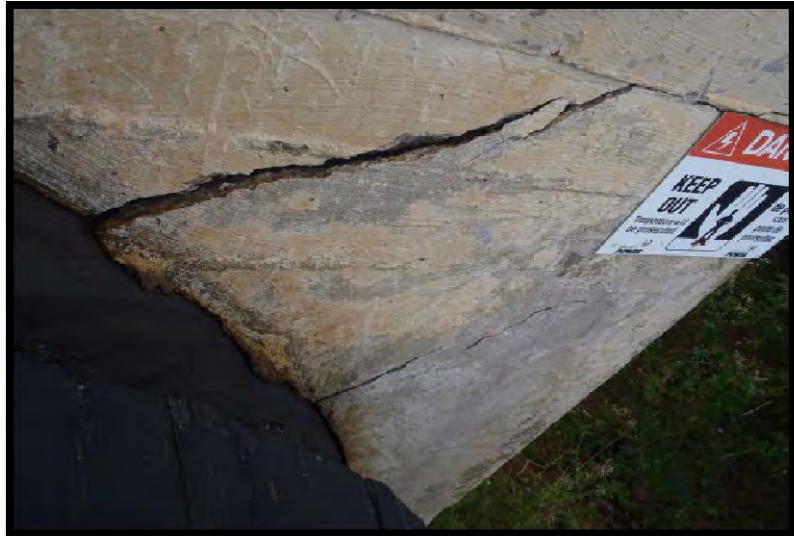
File Name: 40046

3/4" - Crack

1/4" - Horizontal dislocation

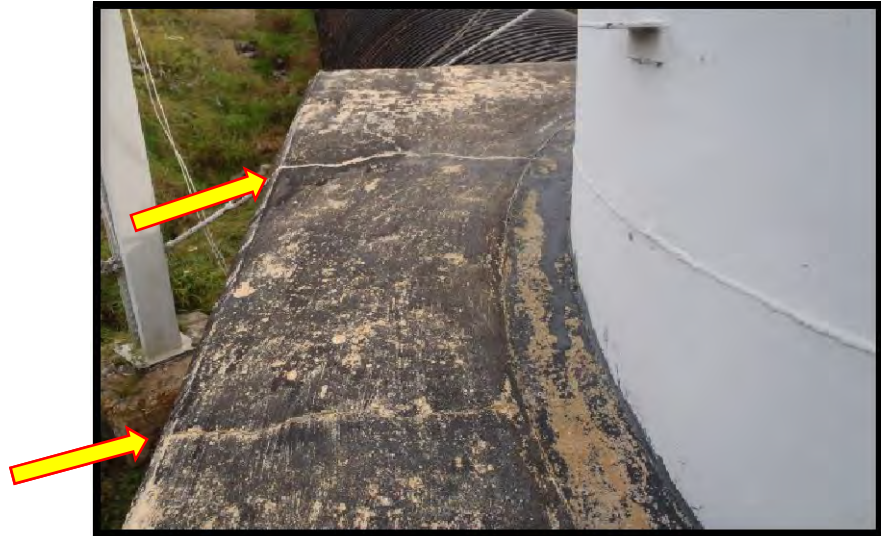
Tee foundation

General condition photo. Some cracks (1/4") visible.

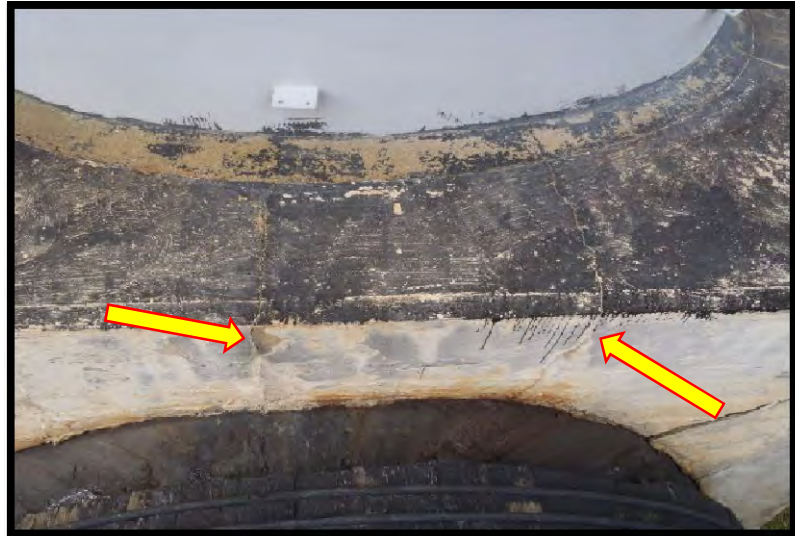
Tee foundation

Intersection between foundation, penstock, and external riser. Some cracks visible (1/8")

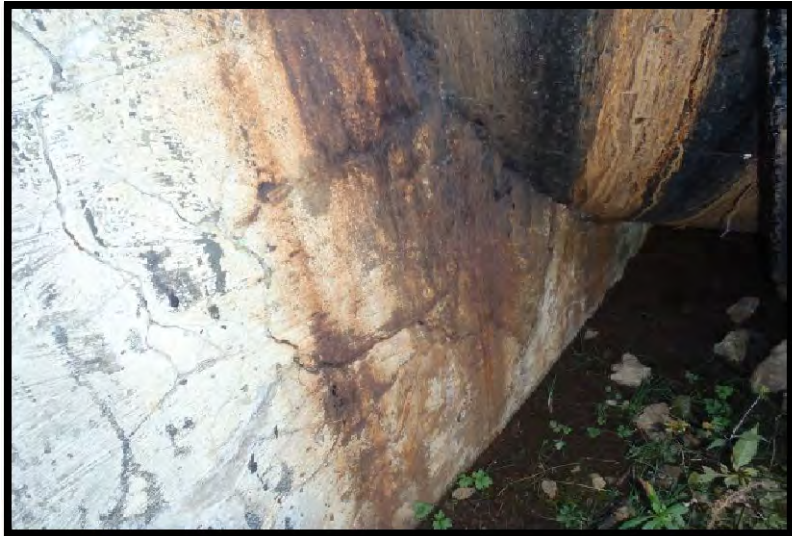
Tee foundation

Map cracking visible over entire area.

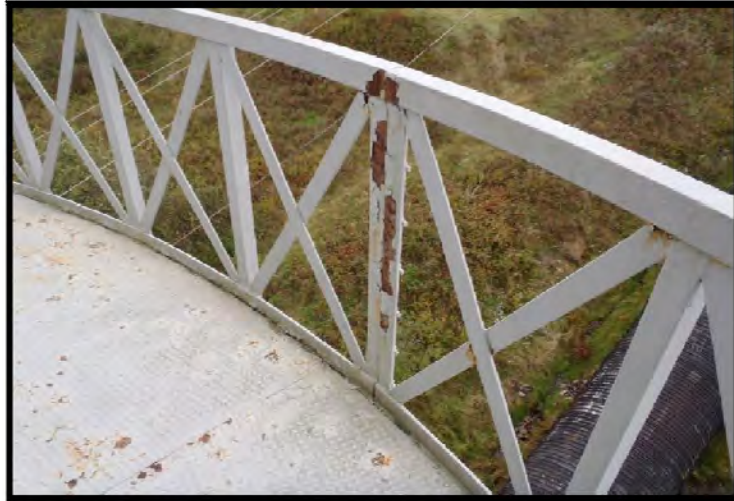
Localized coating failure on balcony.
Additional photos below.

The balcony and handrails are in good to fair condition. There were no cracks or deformed members found during the inspection. The coating failure is mainly on the deck, and the underside of the deck. This failure is likely due to the lack of adequate drainage causing ponding of water.

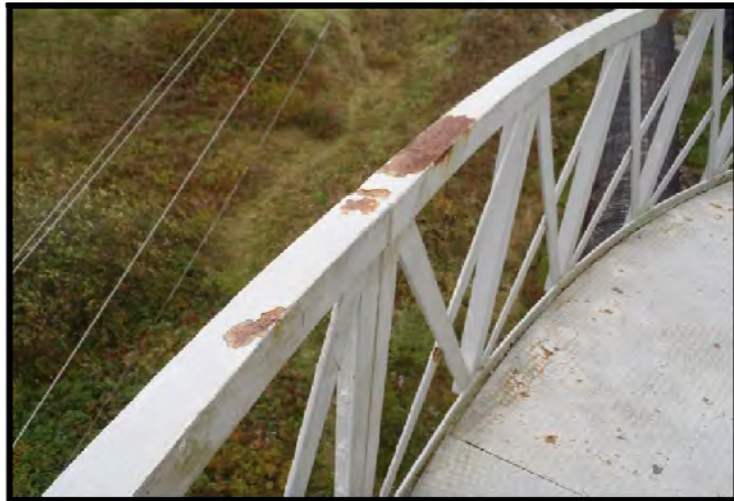
Localized coating failure on balcony. Typical.

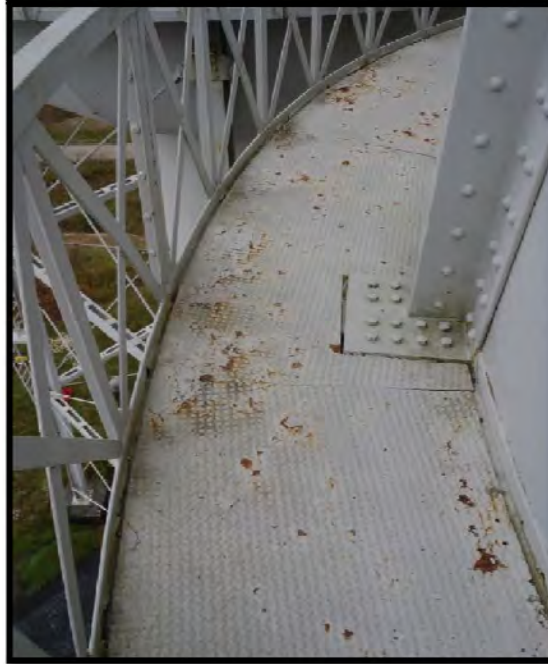
Failed coating on deck. Typical.

Also note the condition of the connection of the post to the tank shell.

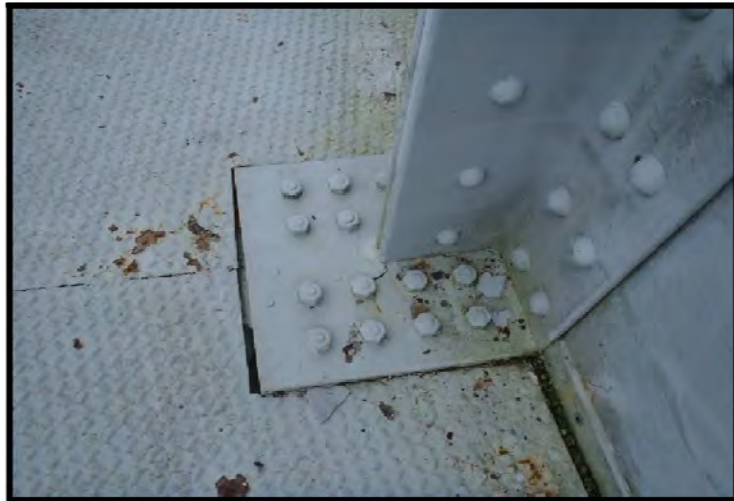
Typical condition of the connection of the post to the tank shell.

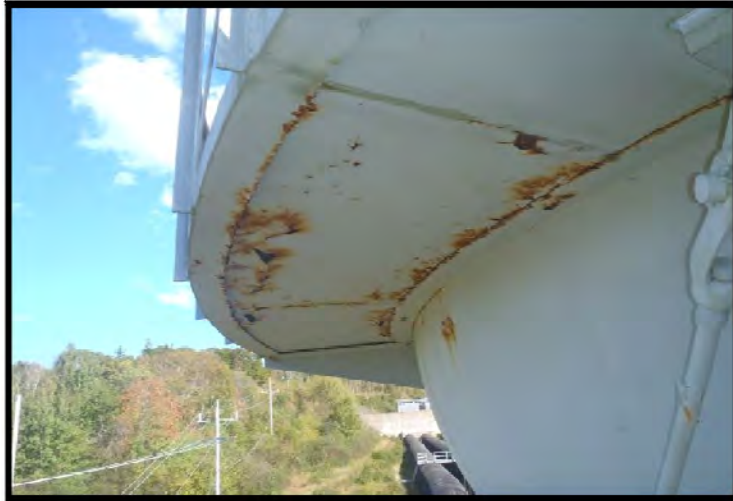
Typical condition of the balcony underside.

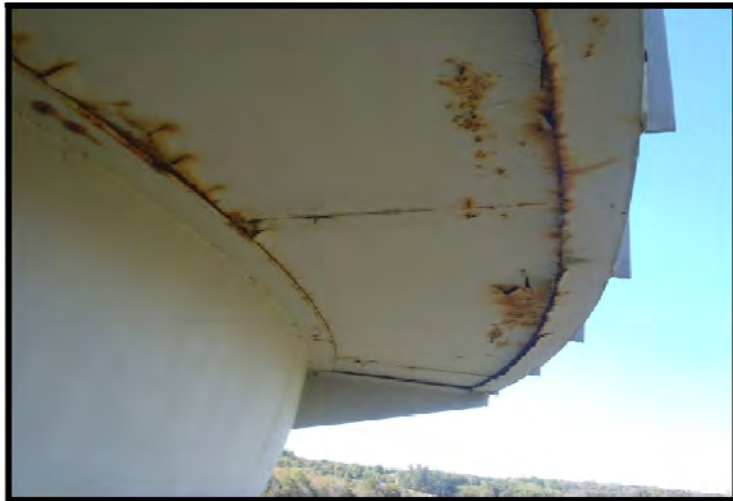
Typical condition of the balcony underside.

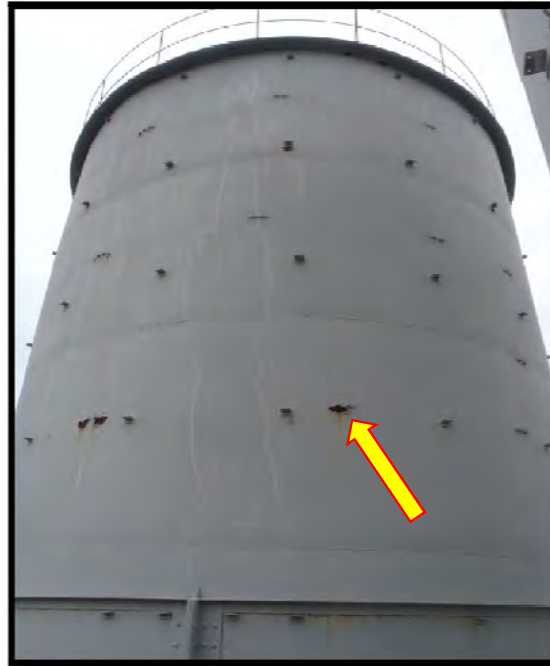
Typical condition photo.

Note localized coating failures around unused brackets.

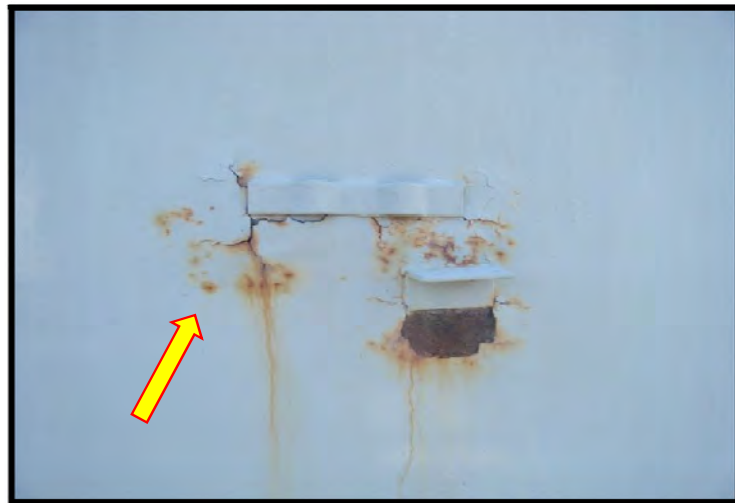
Localized coating failure, typical around nearly all of these unused brackets.

Coating failure has created a type of pocket, which is holding moisture and debris, accelerating localized corrosion.

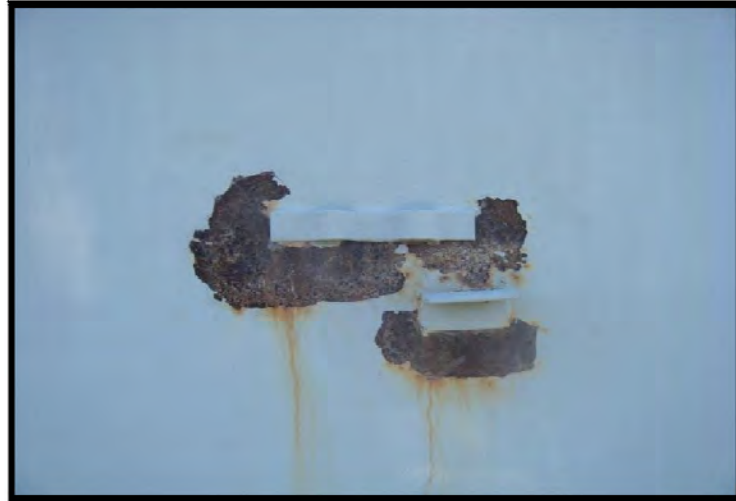
Typical condition of tank surface under coating failure.

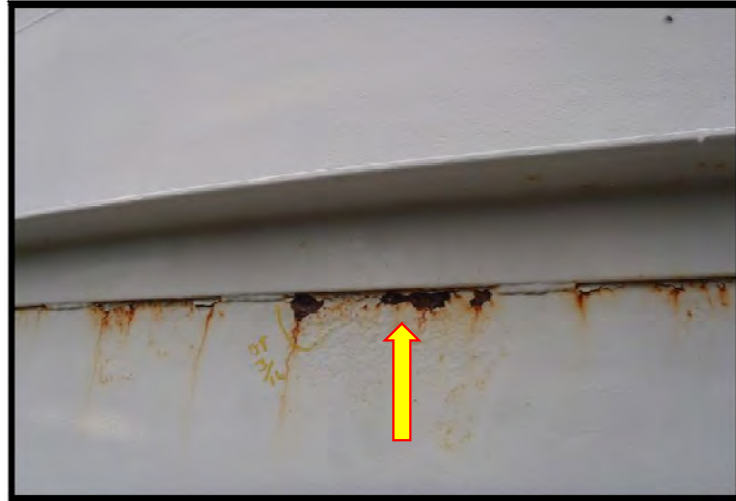
Areas of heavy localized corrosion.

Due to corrosion in the area it was not possible to use UT inspection to find the remaining wall thickness in the area of the pit.

Areas of pitting can be seen under solid areas of the coating, indicating that this type of corrosion has been active for over 20 years.

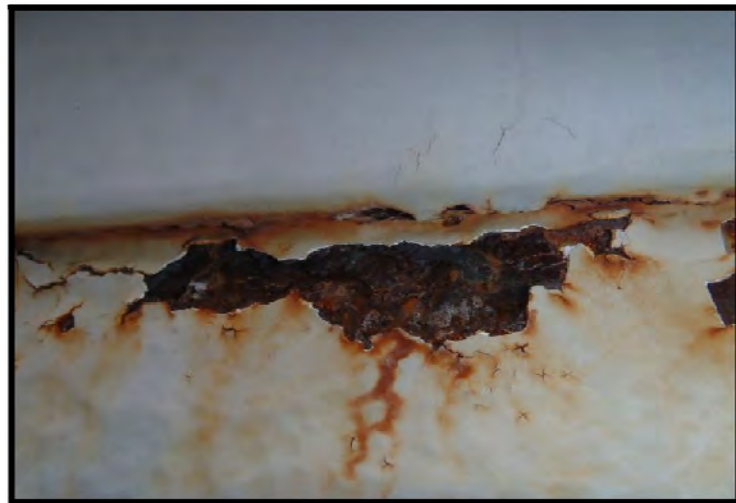
Close-up of area above.

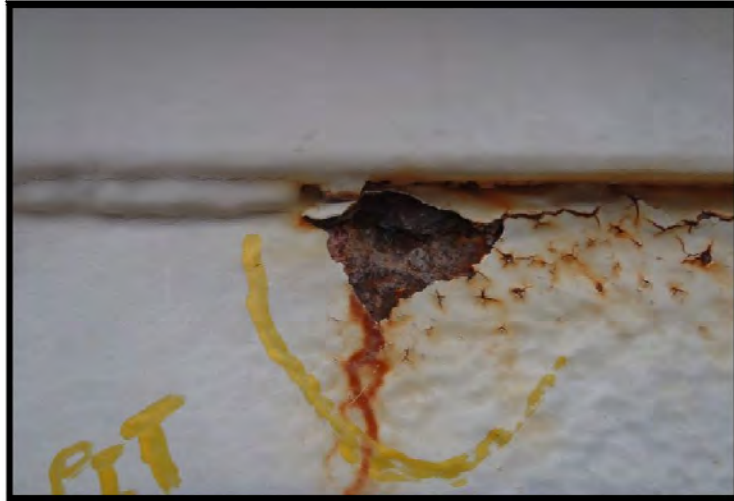
Close-up of area on previous page.

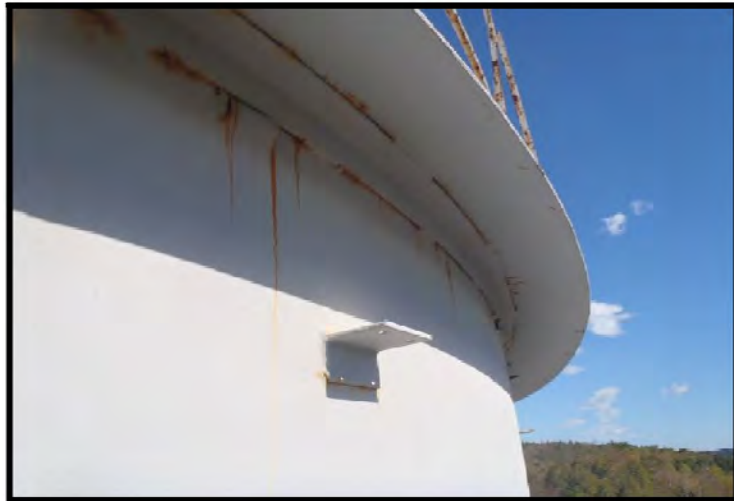
Failed coating located at intersection between tank roof and shell.

Note areas of localized coating failure and corrosion.

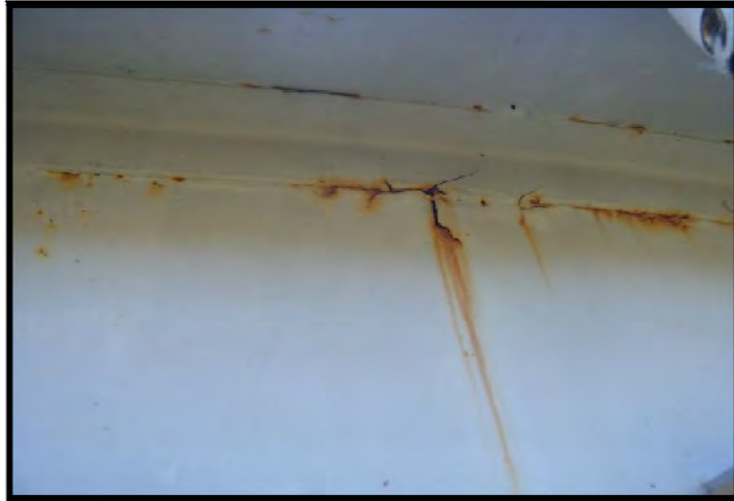
Corrosion and coating failure is typical of other areas on the surge tank.

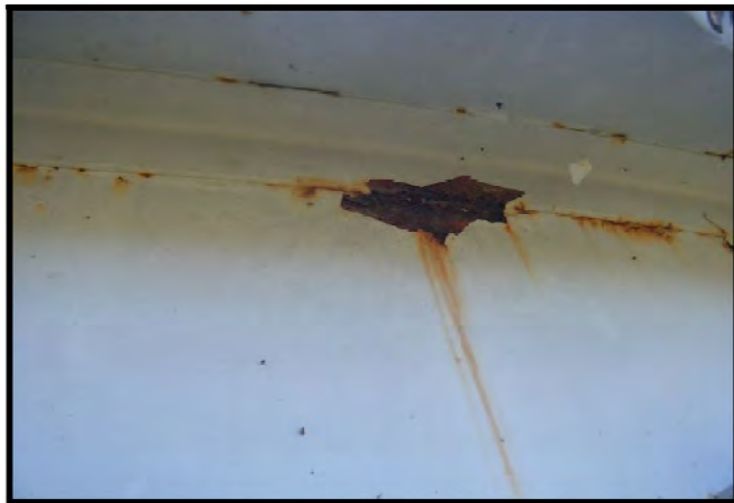
Area above with coating removed.

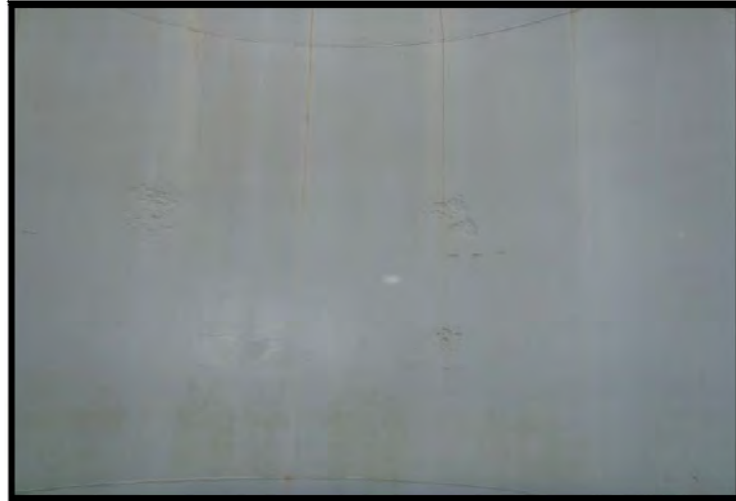
General photo showing coating intact.
Typical of interior coating condition.

The tank exterior is in good condition structurally. The tank interior is in very good condition. The coating is intact on all the plates and seams. There is some discoloration of the coating at, and below the water level. The transition area where the tank bowl meets the external riser is in good condition. There is no damage to the structure, or the coating.

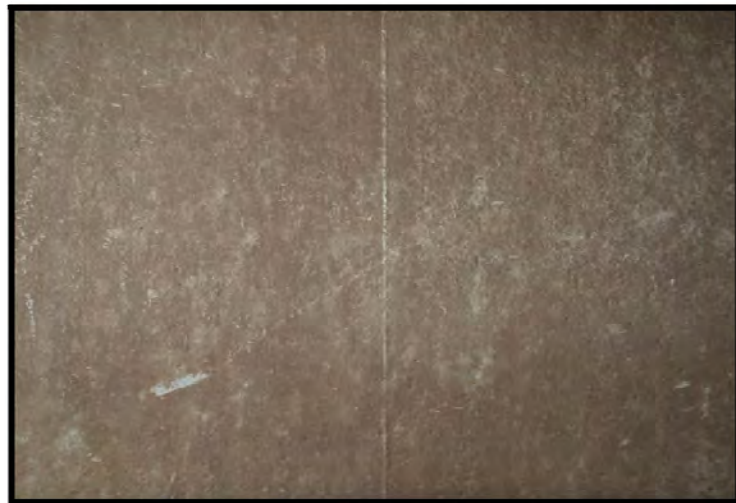
Tank interior below water line. Coating in
good condition.

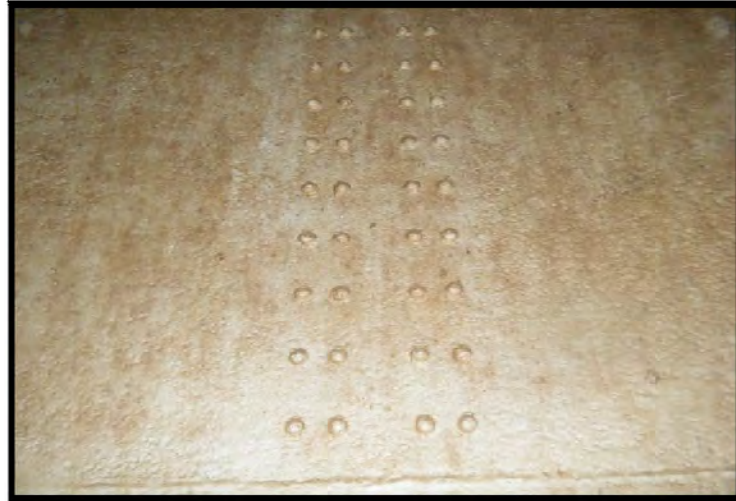
View of tank bowl. View of post attachment visible in photo. Area in good condition.

Coating in good condition.

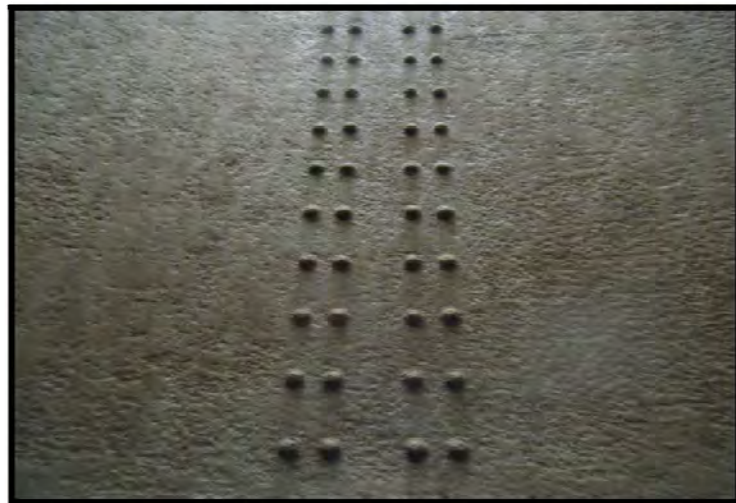
View of tank bowl. View of post attachment visible in photo. Area in good condition.

Coating in good condition.

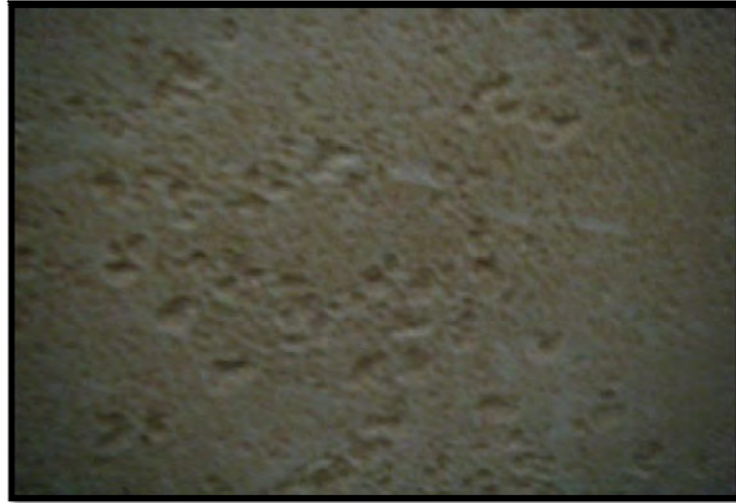
Surface pitting which covers the entire tank bowl. Approx 1/8" deep and 1/2" diameter. Tank bowl coating is 100% intact, no area of active corrosion were found.

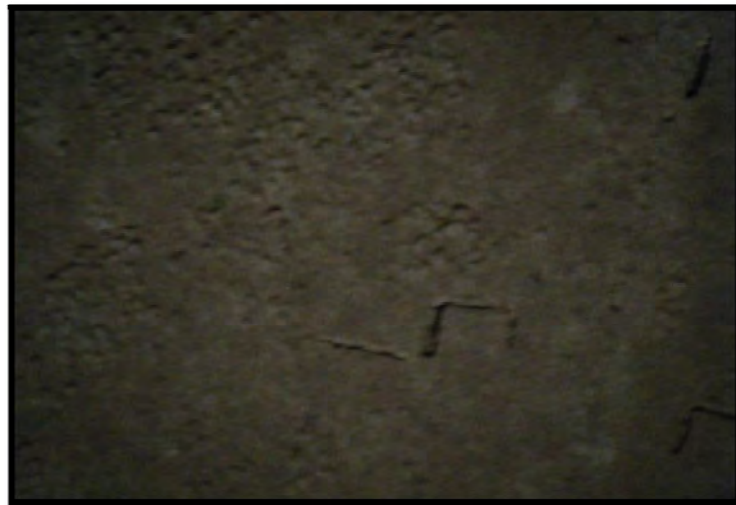
Additional photo of above description.

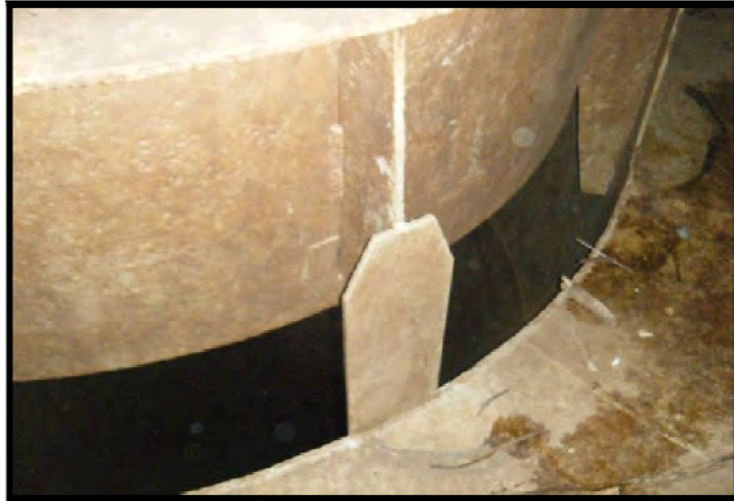
Connection between tank bowl and internal riser. Area in good condition, coating in good condition.

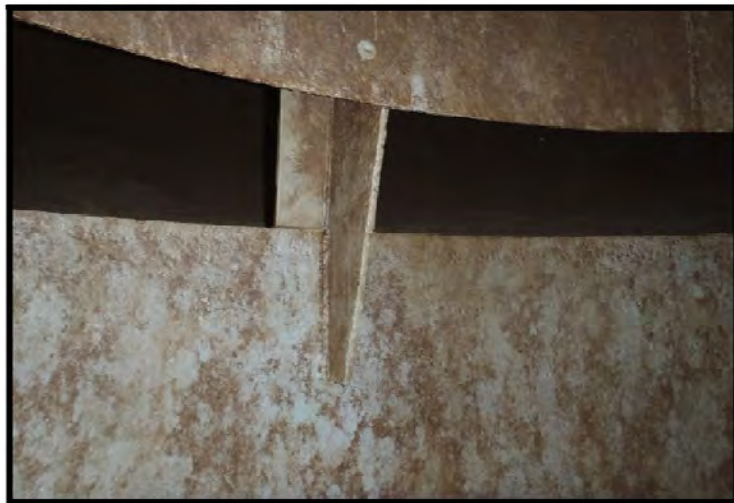
Intersection between tank bowl and external riser. Area in good condition, coating in good condition. View from inside

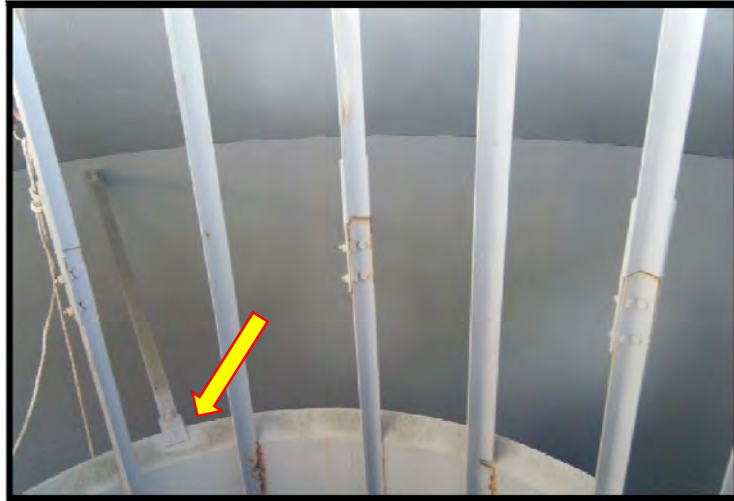
Connections to internal riser were in good condition. Typical condition photo.

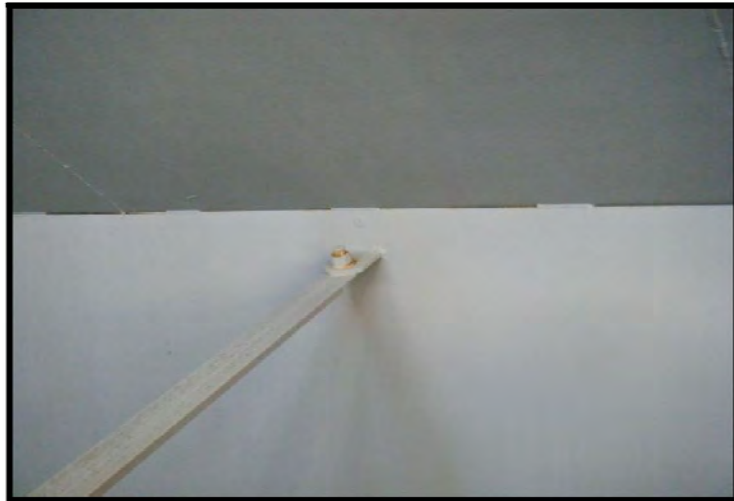
Spider rod connections to tank were in good condition. Typical condition photo.

The spider rods are in good condition. All components were securely attached, no cracks or deformed members were found.

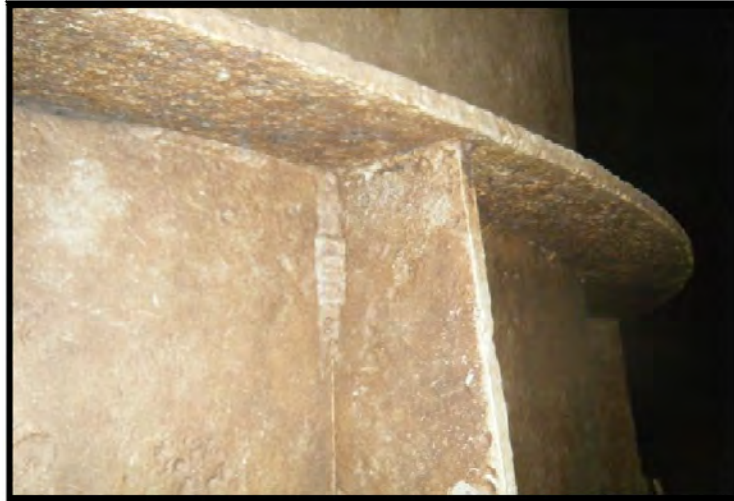
Internal riser in good condition. View of stiffening member below the water line.

The internal riser exterior is in good condition. The internal riser interior is in good condition. No structural defects were observed.

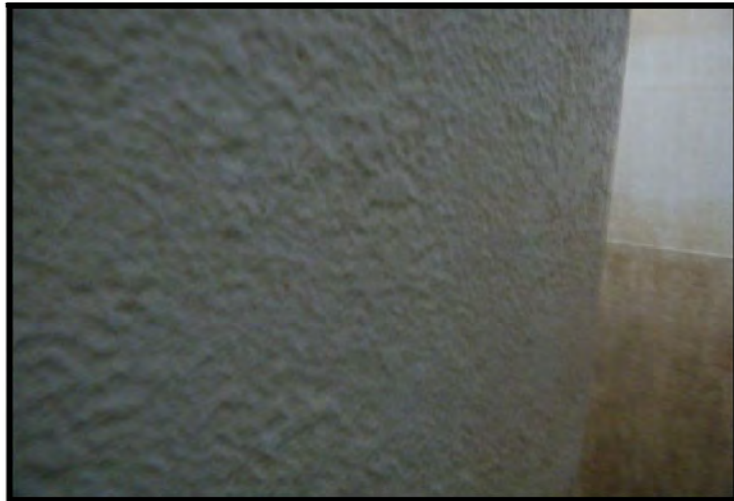
Typical condition photo. Coating in good condition.

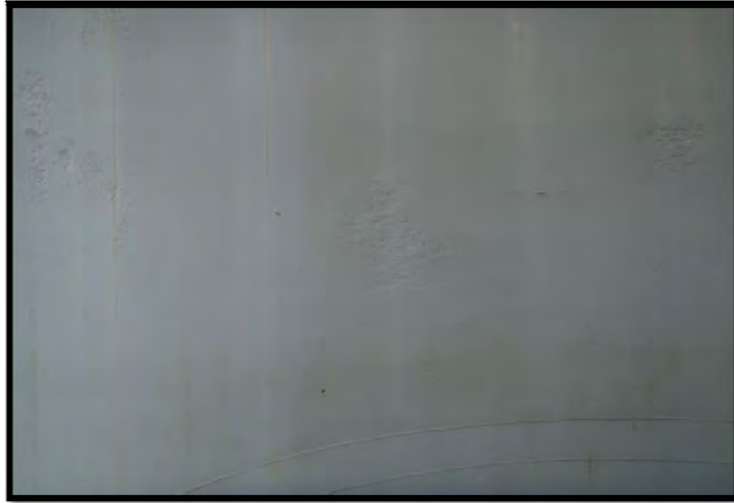
View above water line. Coating in good condition.

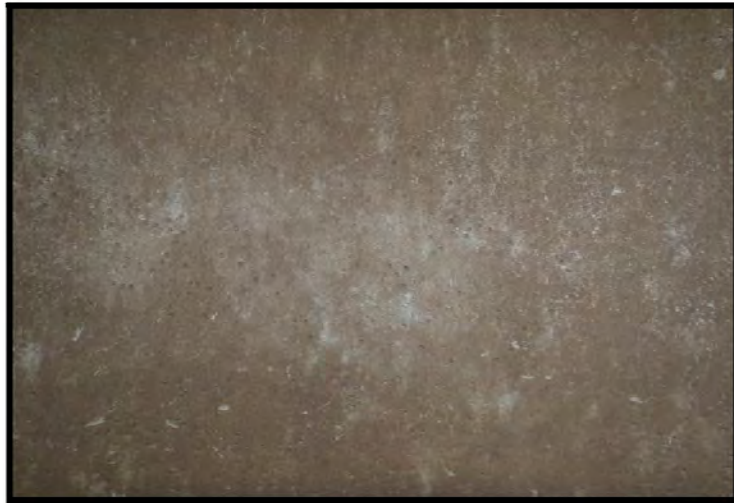
View below the water line. Coating in good condition.
