IN THE MATTER OF an Application by Nova Scotia Power Inc. for
Approval of the **2013 Annual Capital Expenditure (ACE) Plan**

2013 ACE Plan

2013 Annual Capital Expenditure Plan

Weymouth Surge Tank Inspection

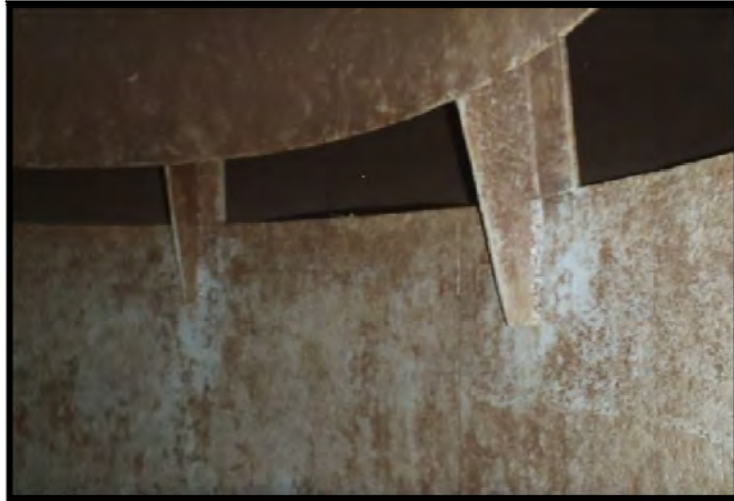
Area where internal riser meets the external riser was in good condition. Typical condition photo.

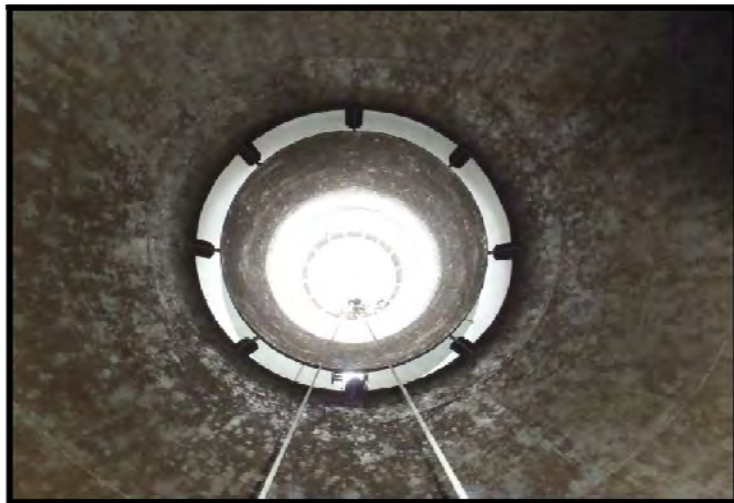
Additional view of area where internal riser meets the external riser.

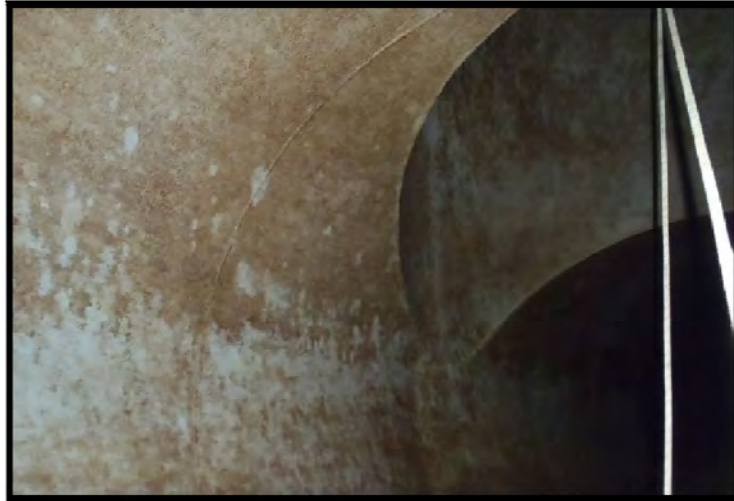
File Name: 50064

General photo of west side. Area was found to be in good condition. Coating in good condition.

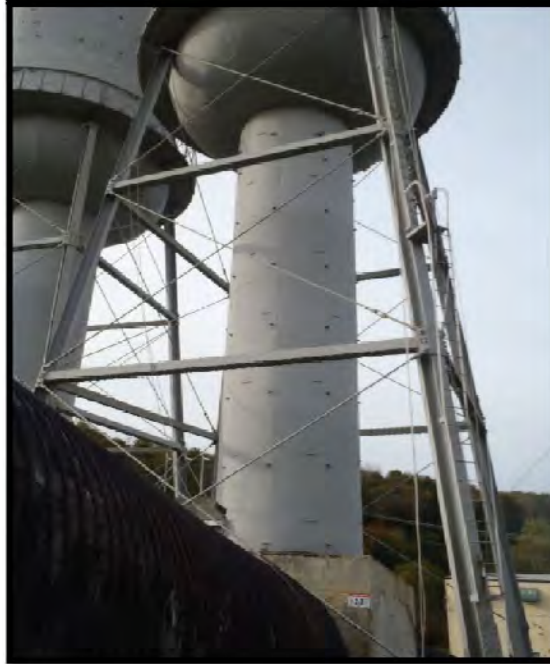
File Name: 50057

External riser was found to be in good condition. Typical condition photo.

The external riser exterior were found to be in good condition. There were no cracks or deformed members found. The coating system is in good condition and the coatings on the plates and seams is are intact.

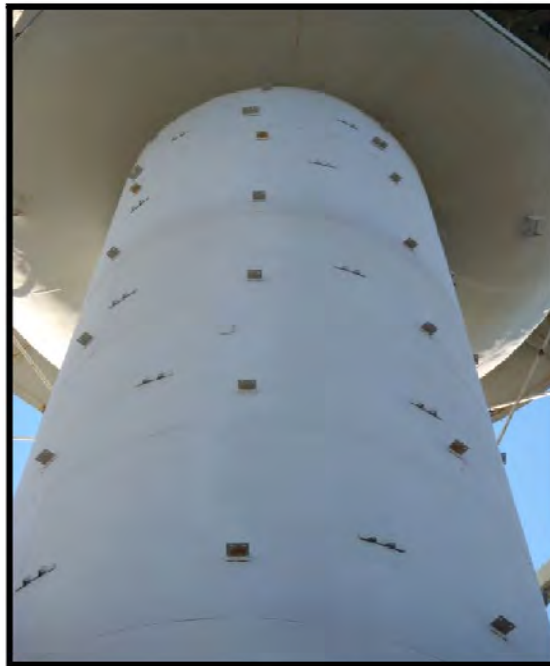
File Name: 50056

External riser frost casing

Frost casing was found to be in good condition. Typical condition photo.

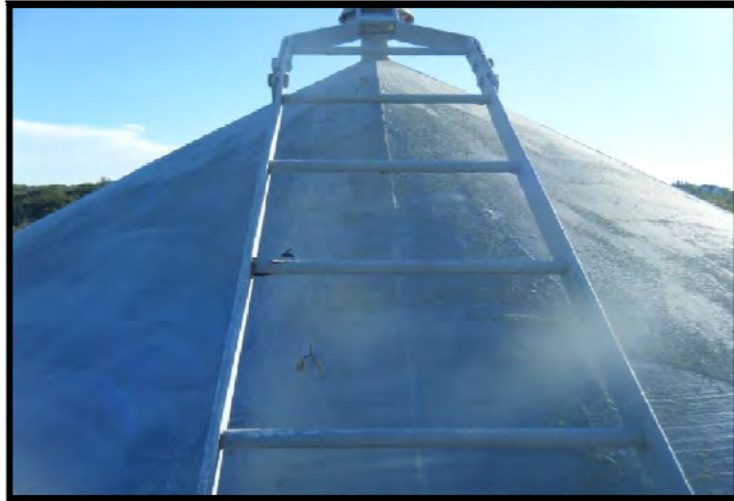
File Name: 10004

General photo. Roof was in good condition.

The roof exterior is in good condition. All roof structures are intact.

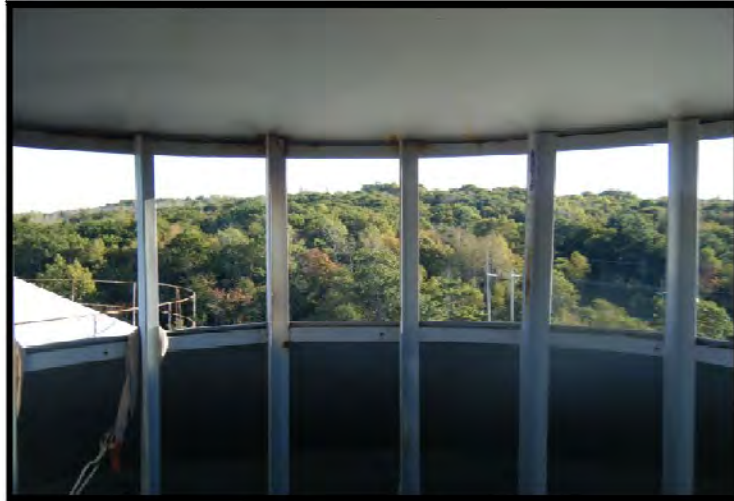
File Name: 10003

General photo of roof vent cap from inside.

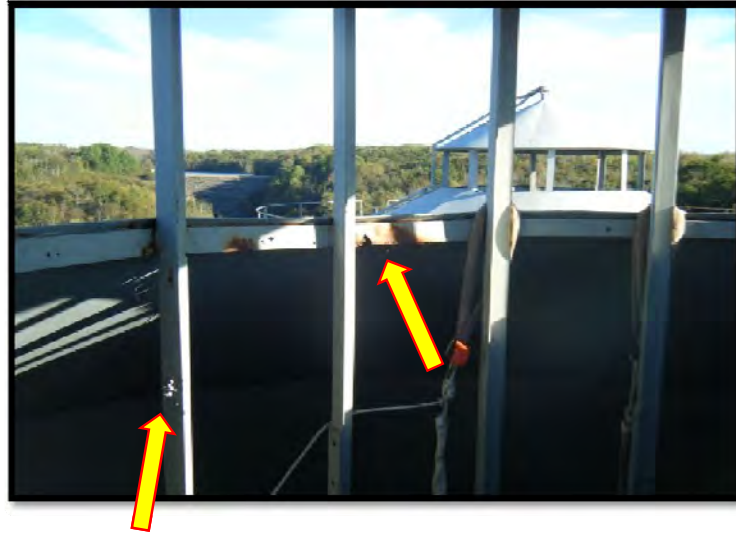
File Name: 10006

General photo, note areas of heavy and through section corrosion.

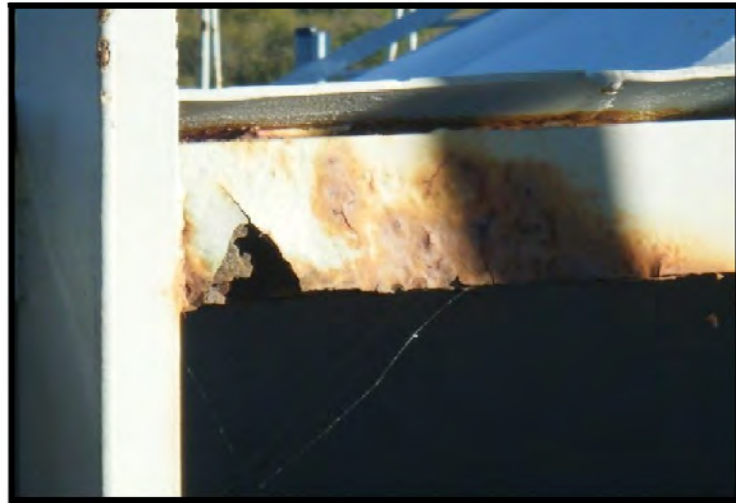
File Name: 10007

Close-up of area indicated above. Member is angle reinforcement around edge of vent opening. Member heavily corroded.

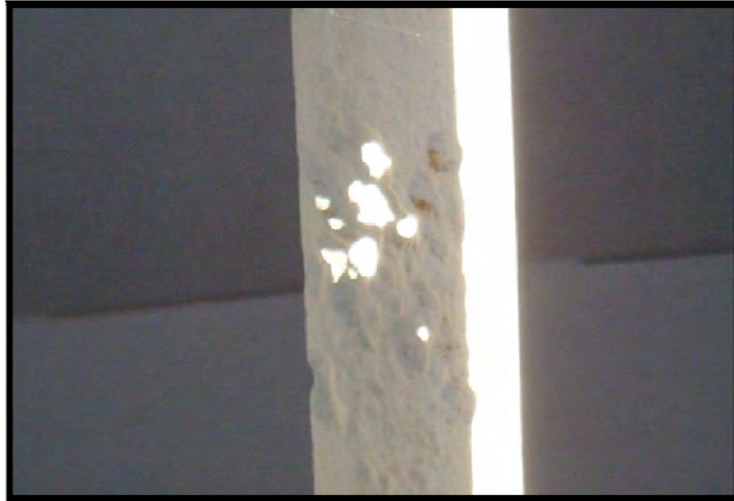
File Name: 10012

Through section corrosion on roof support.

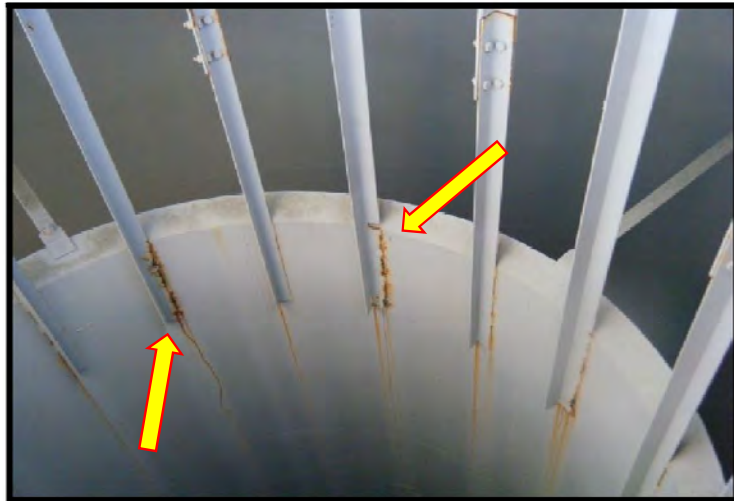
File Name: 10008

View of roof support connection to internal riser. Note areas of heavy corrosion. See following page for close-up

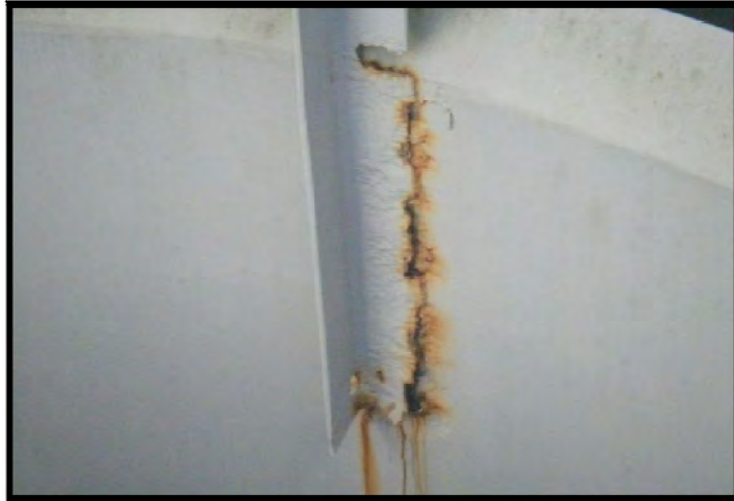
File Name: 10009

Heavy corrosion and section loss at connection.

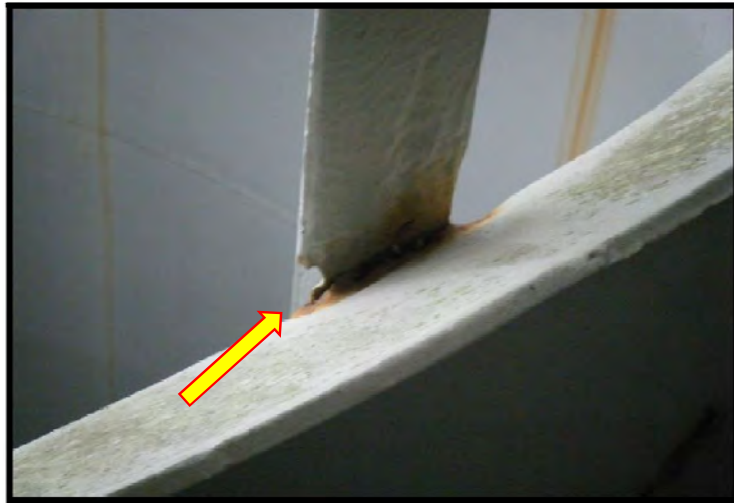
File Name: 10027

Heavy corrosion and section loss at connection.

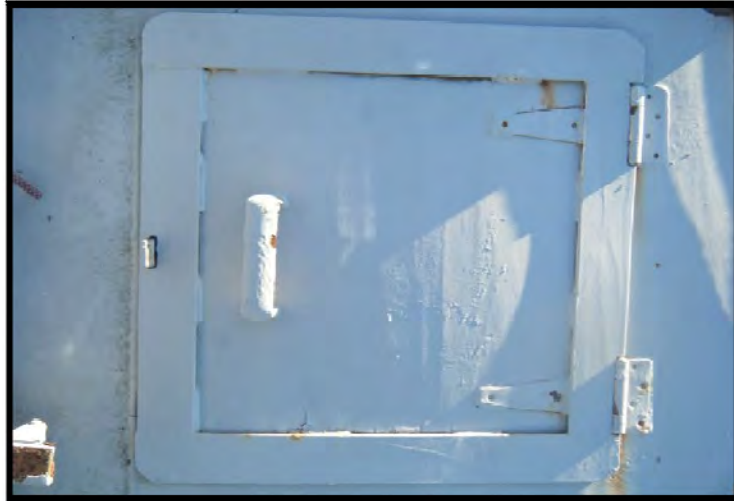
File Name: 10023

Hatch was in good working condition.

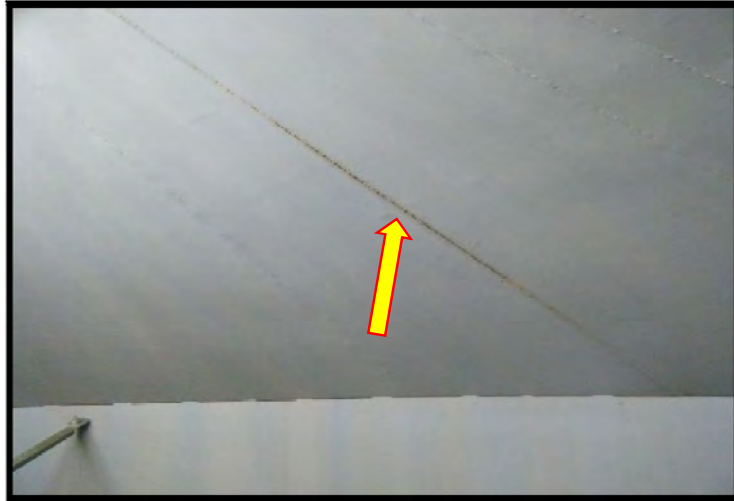
**File Name:** 10019**Photo Record: 78****Equipment:**

Roof interior in good condition. Typical condition. Close-up below.

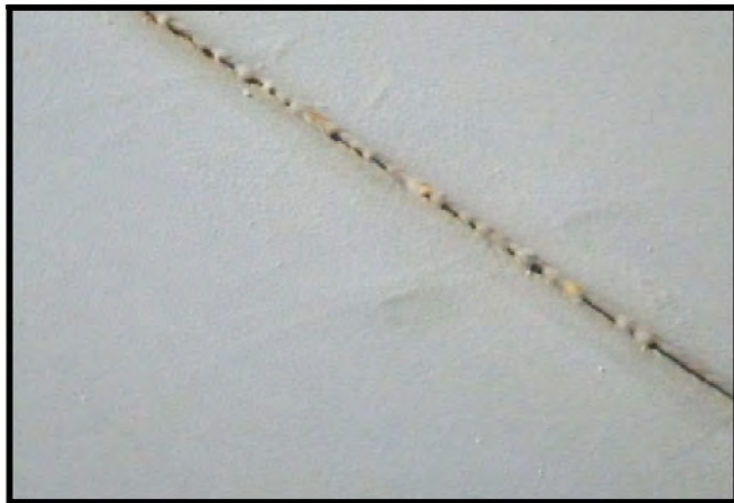
**File Name:** 10020

Coating in good condition at plate edges.

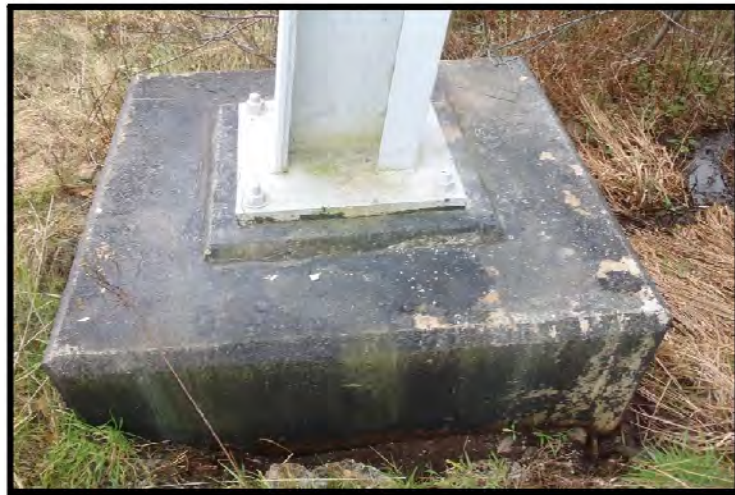
File Name: 10034

East post foundation.

Components in good condition.

The concrete post foundations are in good condition. The base of the posts have a grouted bearing surface which is intact, and the footings have been coated. There were no large cracks or evidence of scour found on the footings.

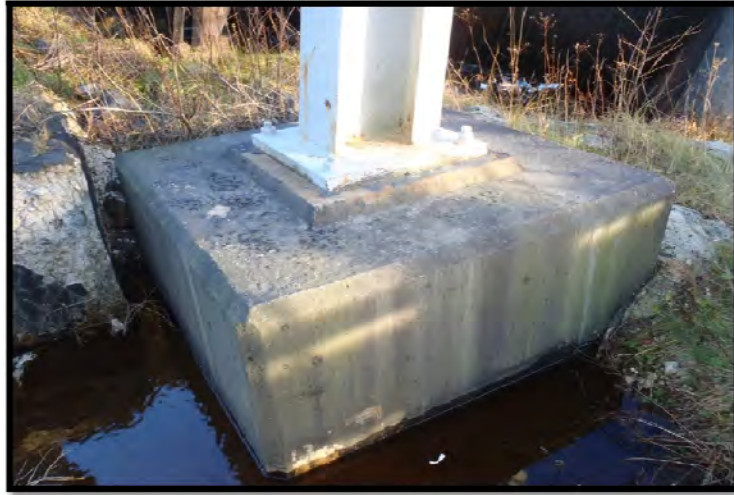
File Name: 10003

West post foundation.

Components in good condition.

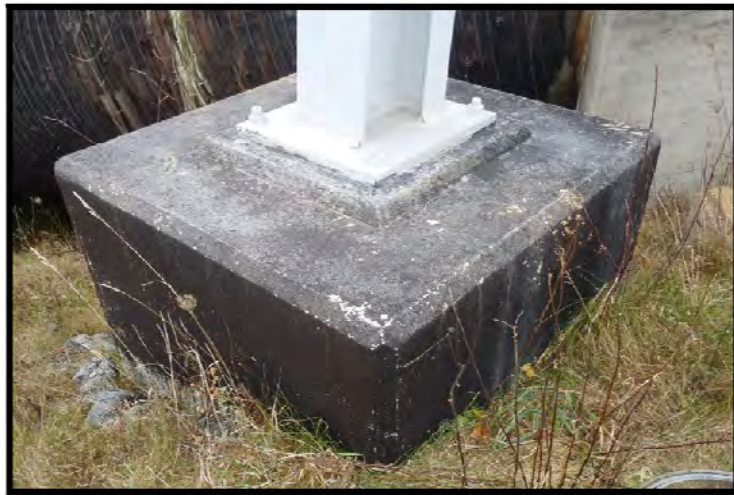
File Name: 10029

North post foundation.

Components in good condition.

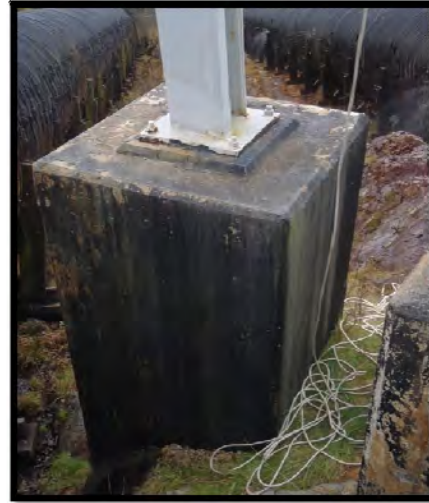
File Name: 10008

South post foundation.

Components in good condition.

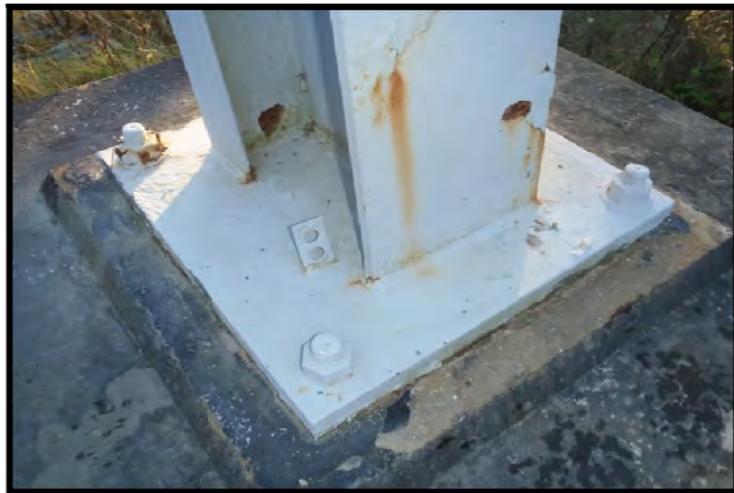
File Name: 10005

Typical condition photo.

Footings in good condition. Grouted bearing surface intact.

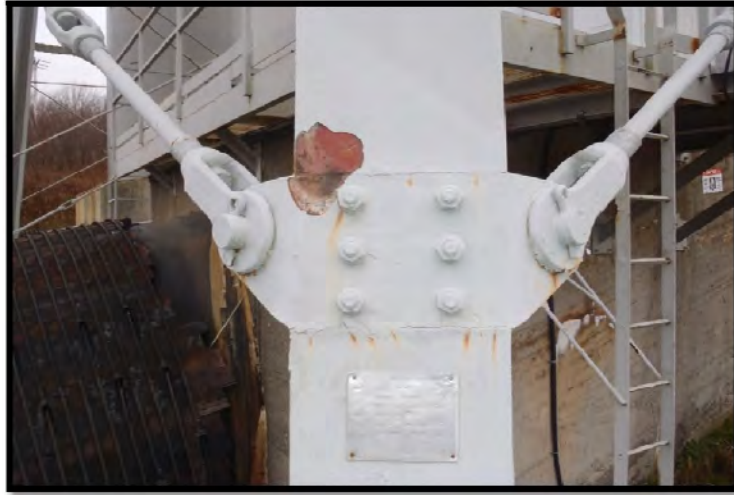
File Name: 10030

View of typical coating failure on posts. .

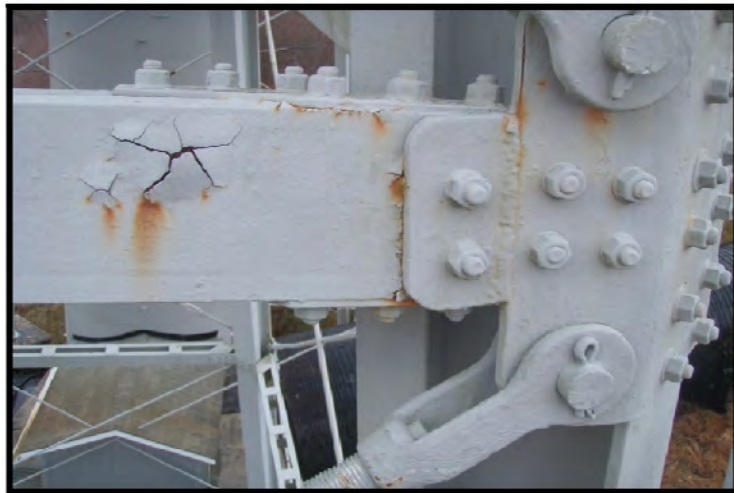
File Name: 90099

View of typical coating failure on posts.

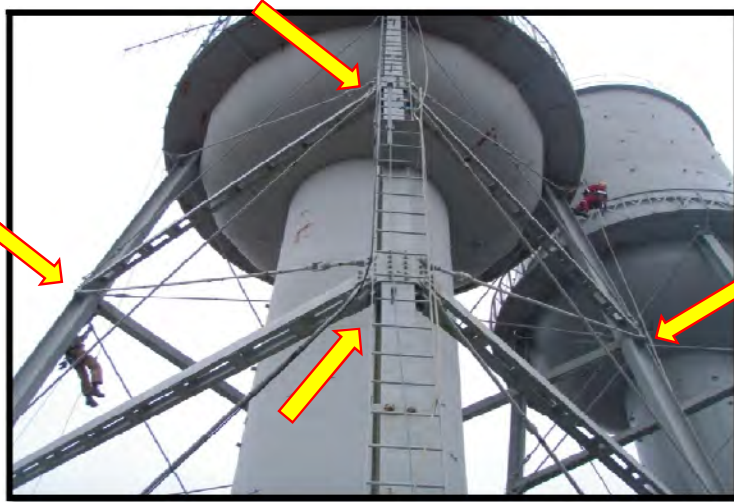
File Name: 90153

The photos to follow show a close-up typical of the connection type identified in the photo.

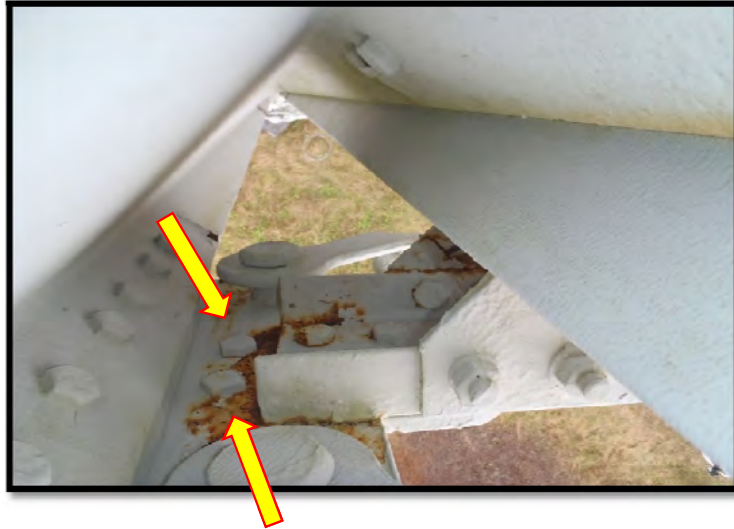
File Name: 50027

two of the six bolts in the connection are not engaging the horizontal member.

Typical of all connections of this type.

The post connections are in good condition. However, the connection of the lateral supports (secondary members) to the posts did have a consistent deficiency. At every location, 12 in total, only four of the six bolts in the connection were engaged. There were no cracks or deformed members found in or around these connections. There is some light corrosion due to coating edge failure.

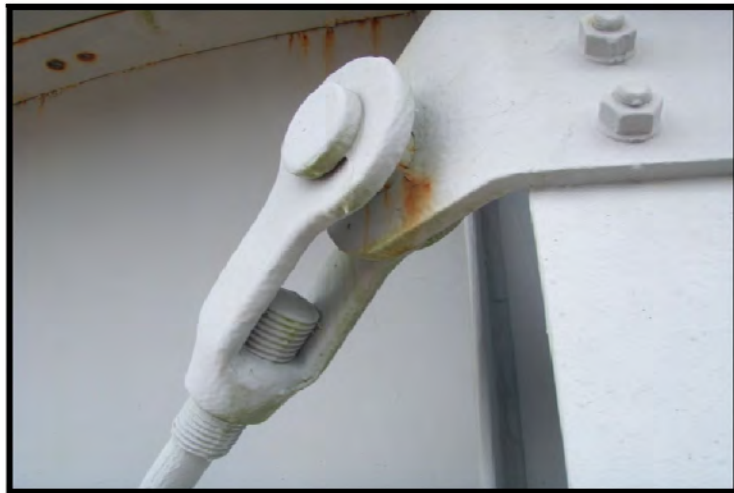
File Name: 21088

Typical condition of pin connection.

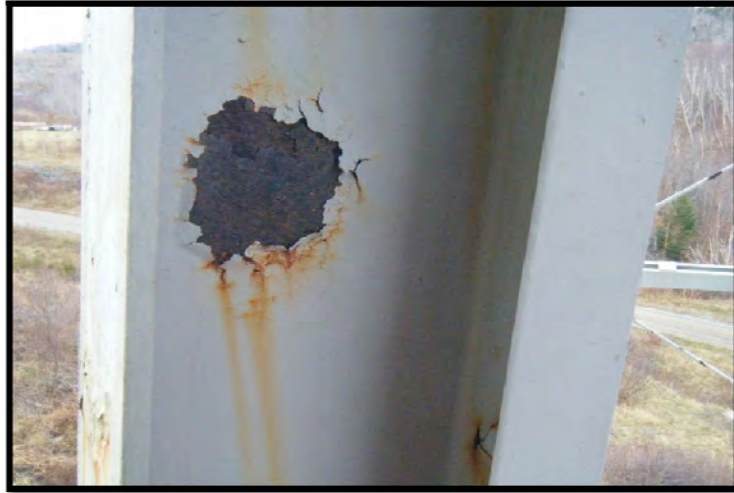
File Name: 7028

Area in photo is 12 sq inches.

Note coating primer has failed.

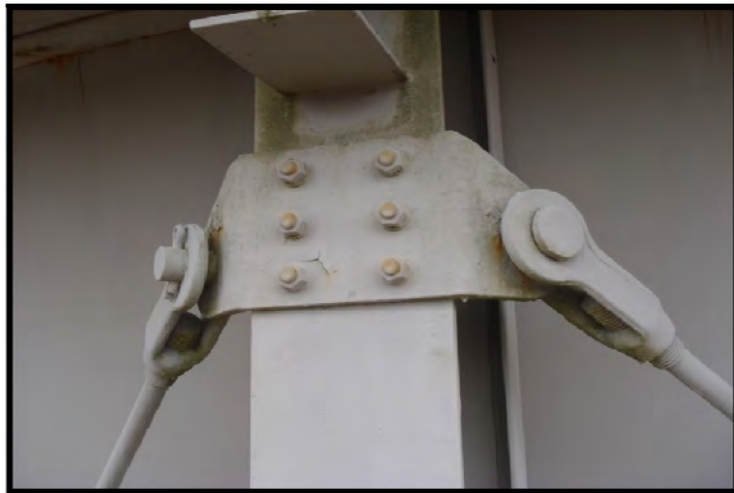
File Name: 10067

View of typical condition of post / rod connection

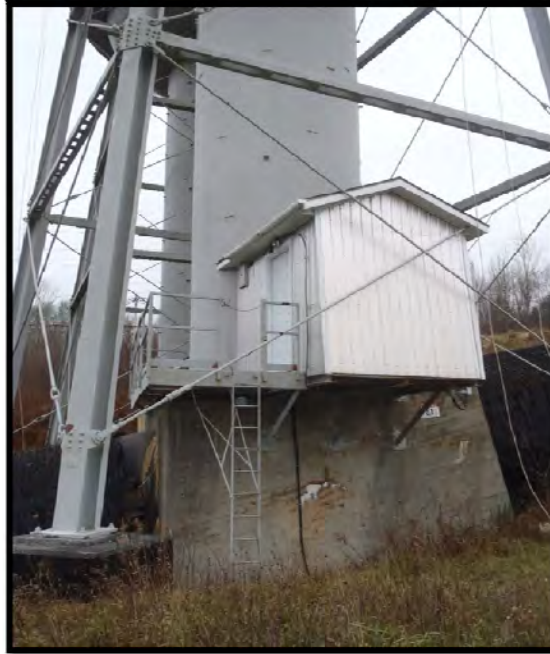
File Name: 10023

General photo. Tee foundation and bubbler house.

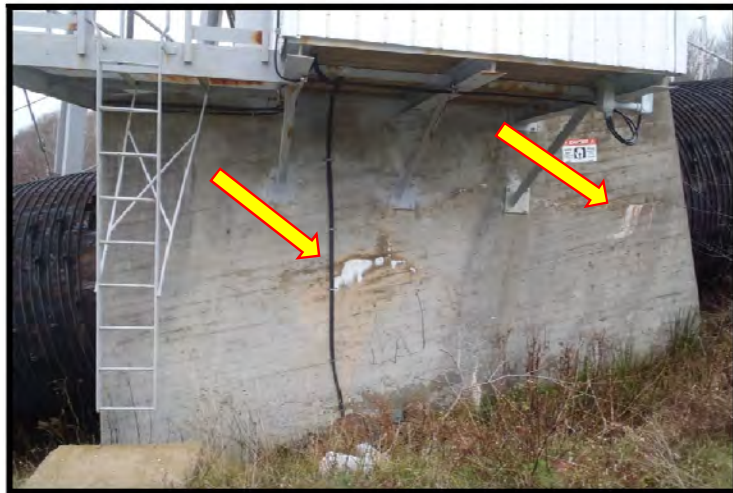
File Name: 50034

Tee foundation was found to be in good condition. No large cracks were found. Note efflorescence of the concrete.

The concrete Tee foundation is in good condition. There were 2-3 locations where heavy efflorescence is visible. This may indicate movement of moisture through the Tee foundation. If continued over time this will result in a reduction in the alkalinity of the concrete, which can cause corrosion of the subsurface rebar.

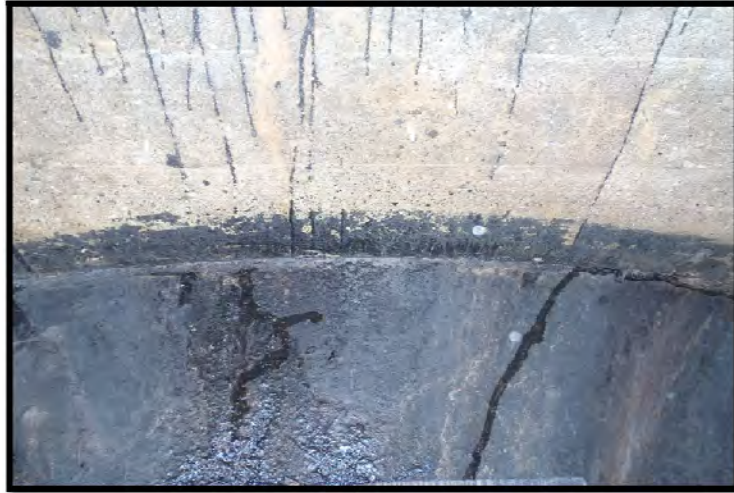
Tee foundation / Penstock intersection tight and solid.

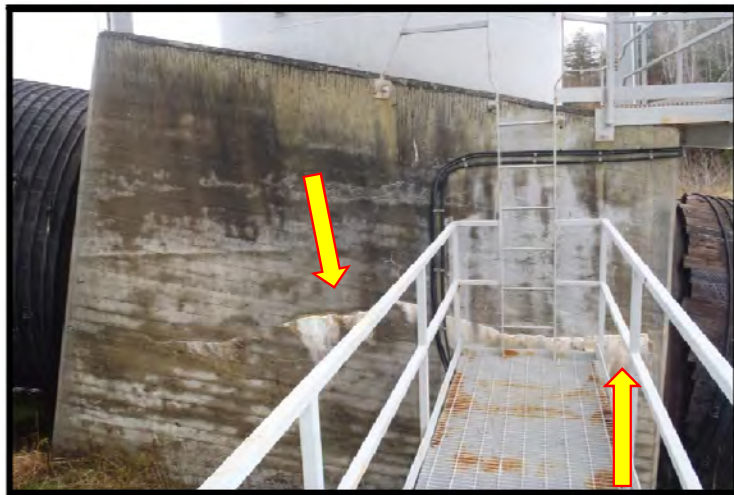
View of Tee foundation and walkway between #1 & #2. No large cracks were found. Note efflorescence of the concrete.

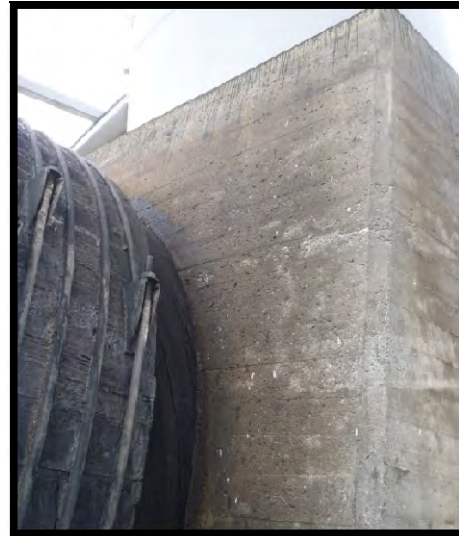
Tee foundation

General condition photo. Components in good condition,

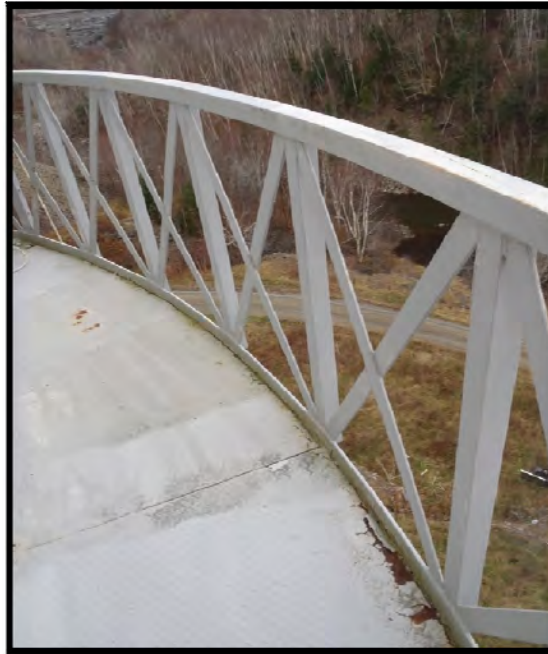
Typical condition photo.

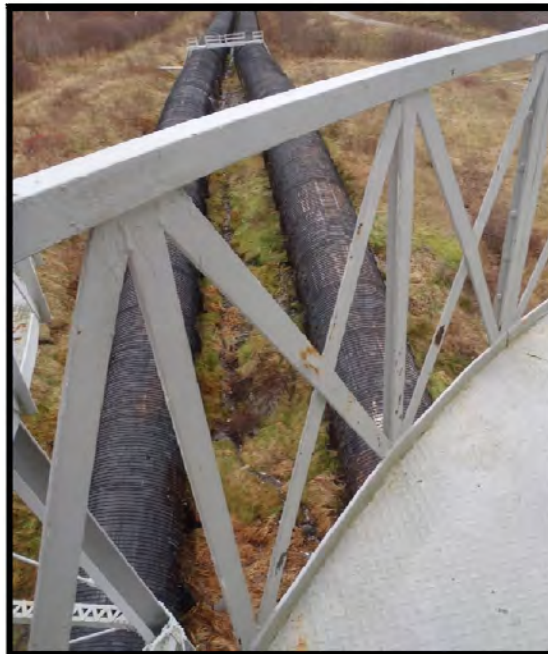
Typical condition photo.

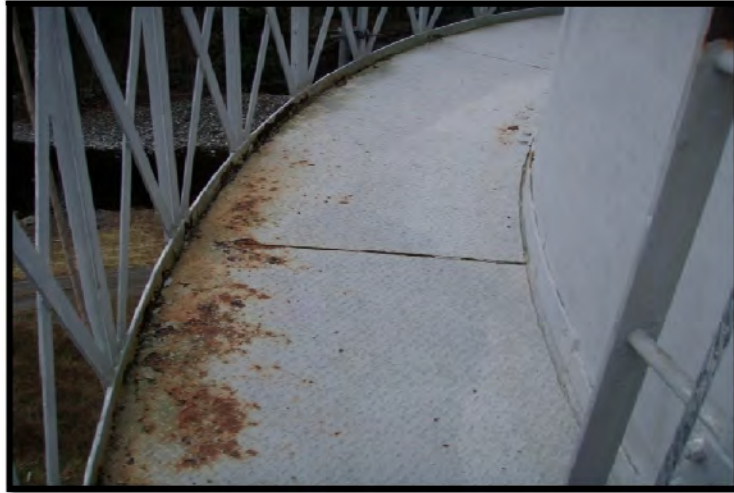
Failed coating on deck. Typical.

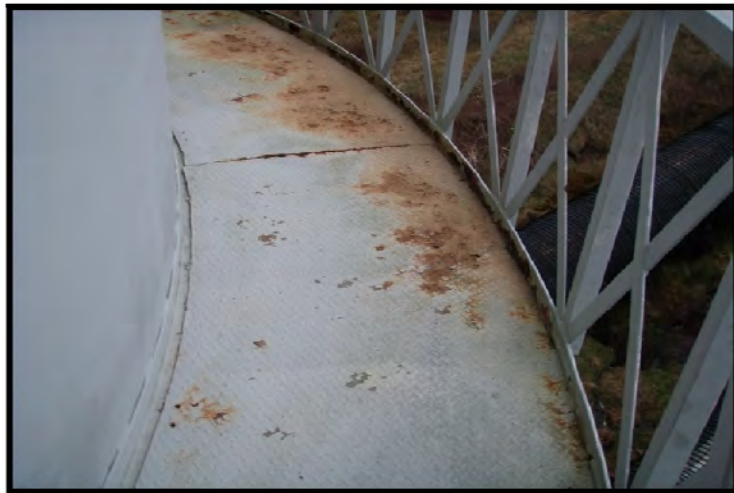
Failed coating on deck. Typical.

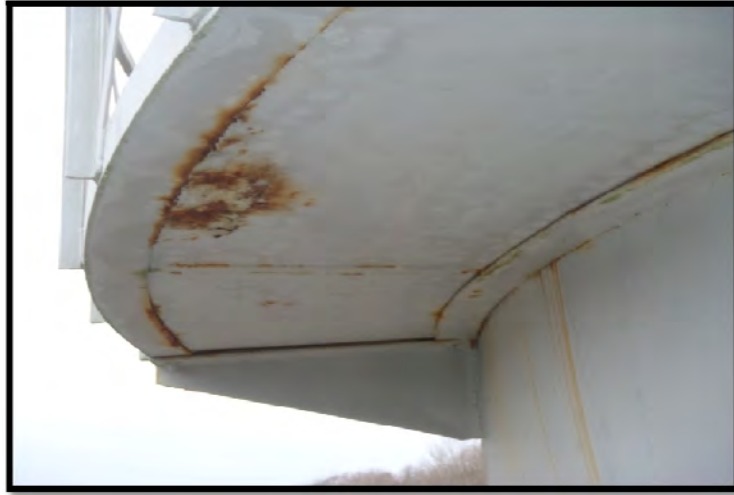
Typical condition of the balcony underside.
Areas of corrosion located where water is
ponding on the deck above.

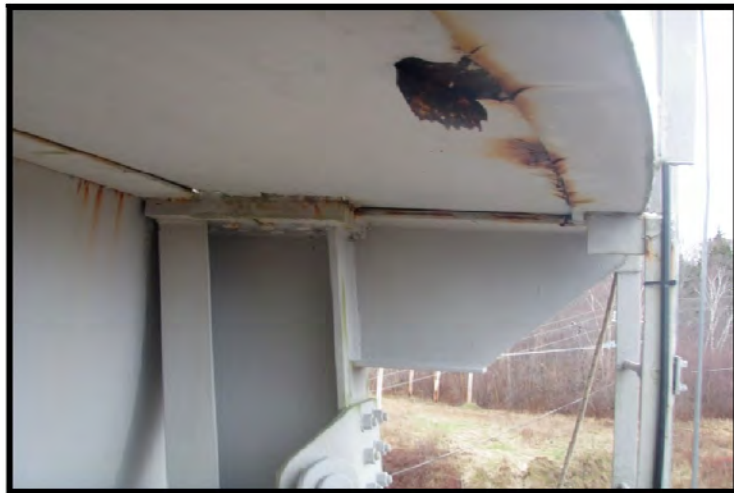
Typical condition of the balcony underside.
Areas of corrosion located where water is
ponding on the deck above.

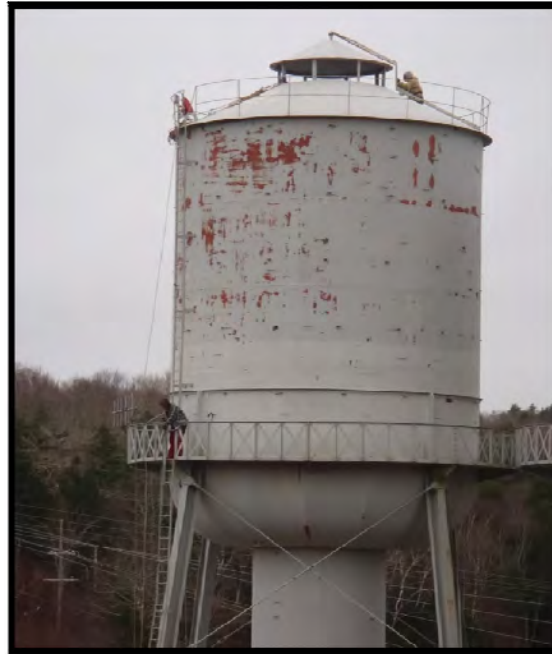
Typical condition photo.

Note coating failures, delamination and UV breakdown.

See below for close-up photos.

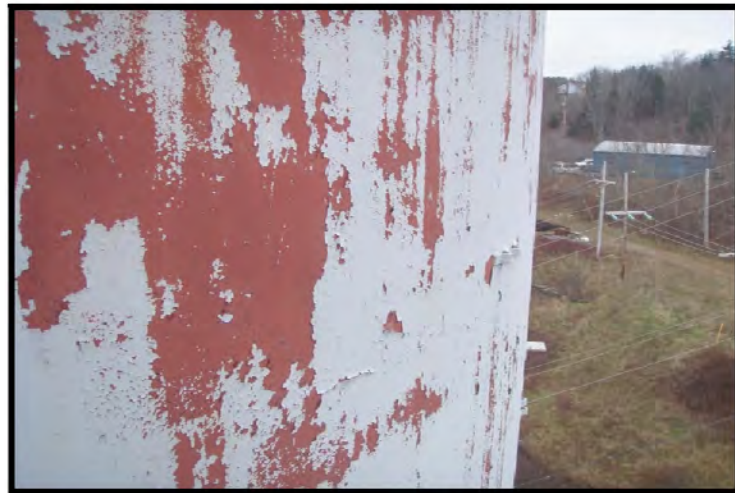
Coating failure, delamination and UV breakdown. Note the primer is still intact.

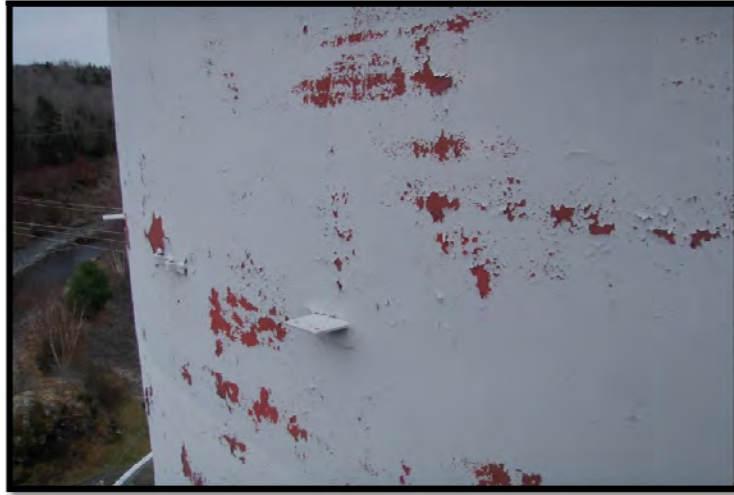
Coating failure, delamination and UV breakdown. Note the primer is still intact.

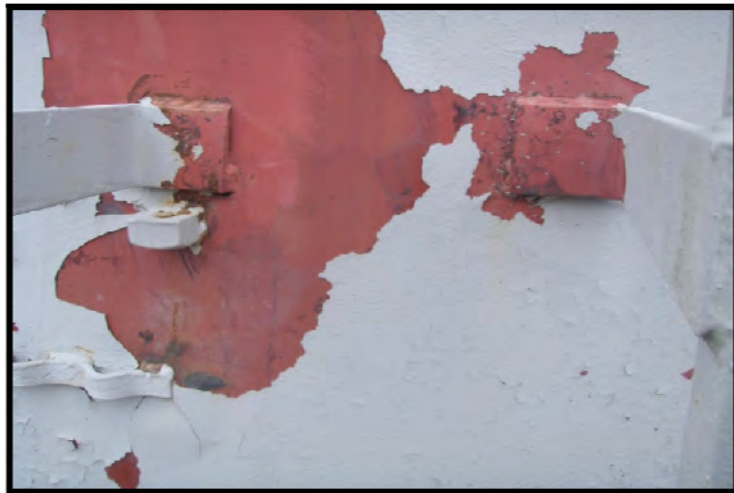
Typical coating failure, around external attachments. Note the primer is still intact.

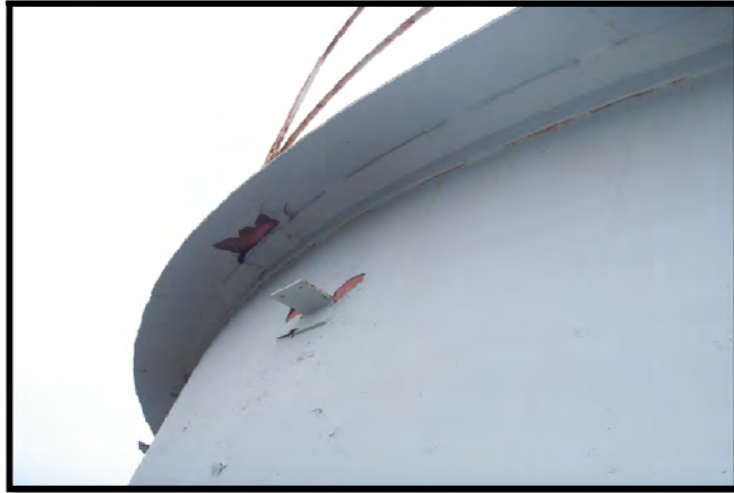
Typical condition of the roof shell intersection.

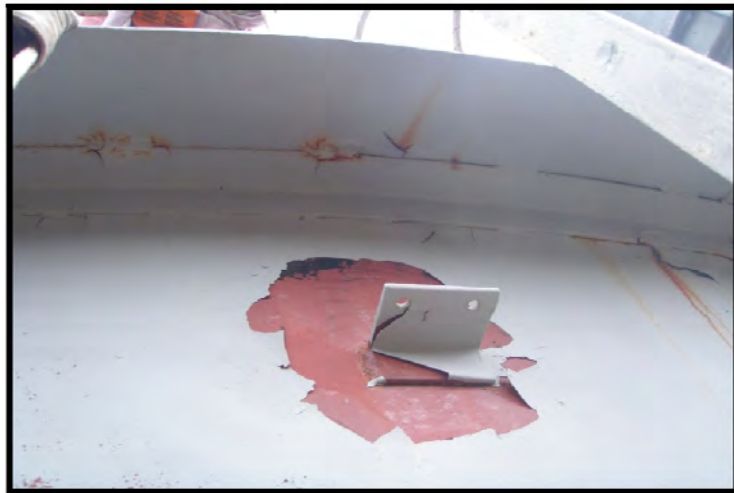
Typical condition of the roof shell intersection.

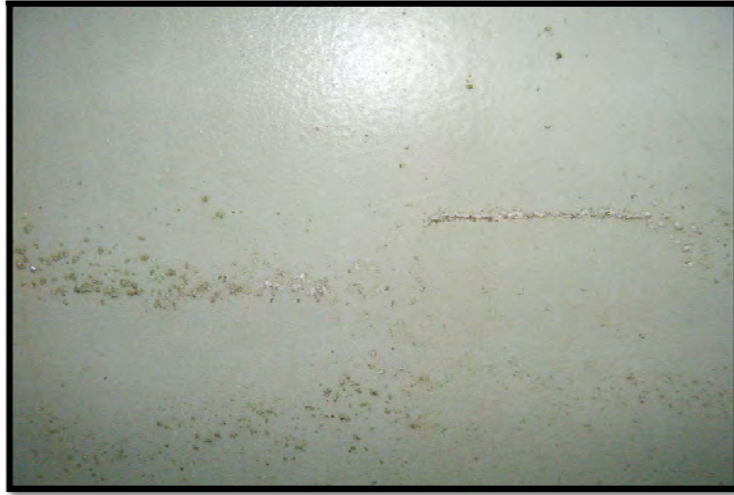
General photo showing coating intact.
Typical of interior coating condition.

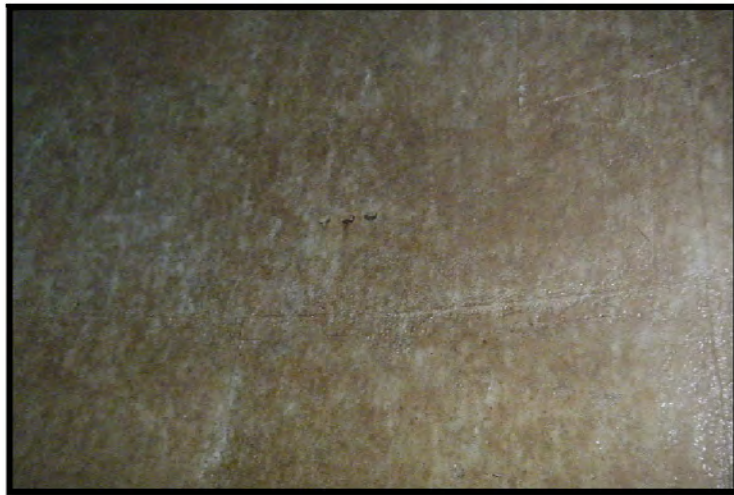
Tank interior below water line. Coating in
good condition.

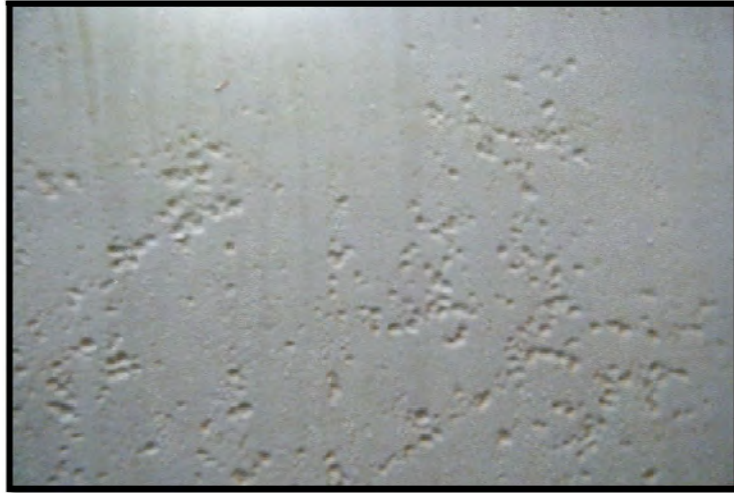
Surface pitting which covers the entire tank bowl. Approx 1/8" deep and 3/8" diameter. Tank bowl coating is 100% intact, no area of active corrosion were found.

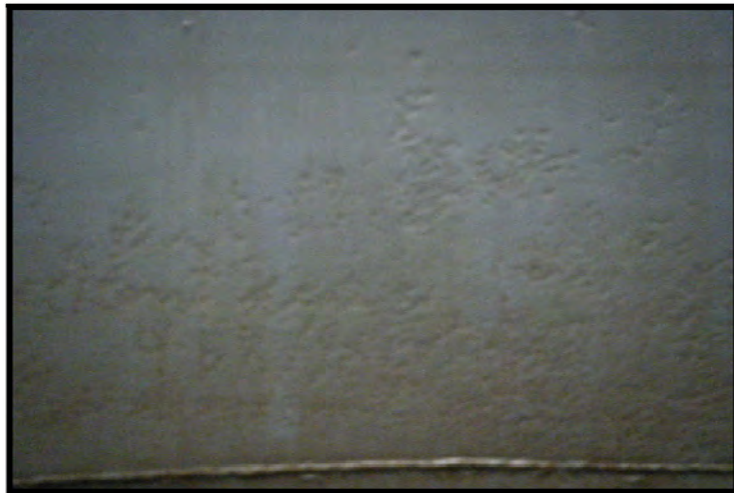
Additional photo of above description.

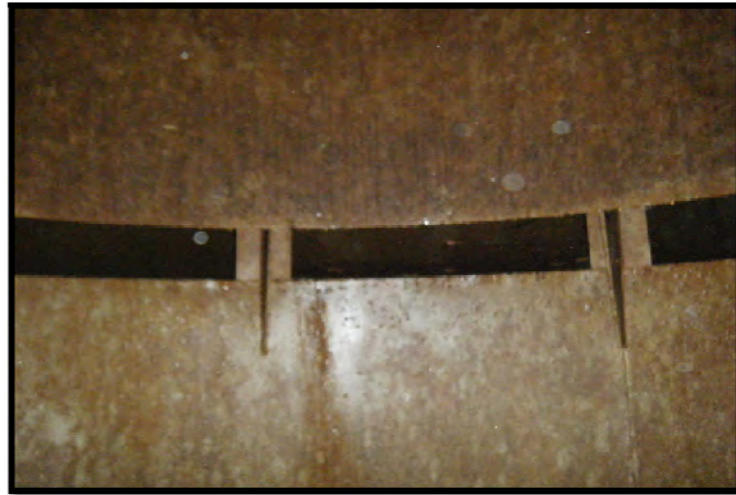
Connection between tank bowl and internal riser. Area in good condition, coating in good condition.

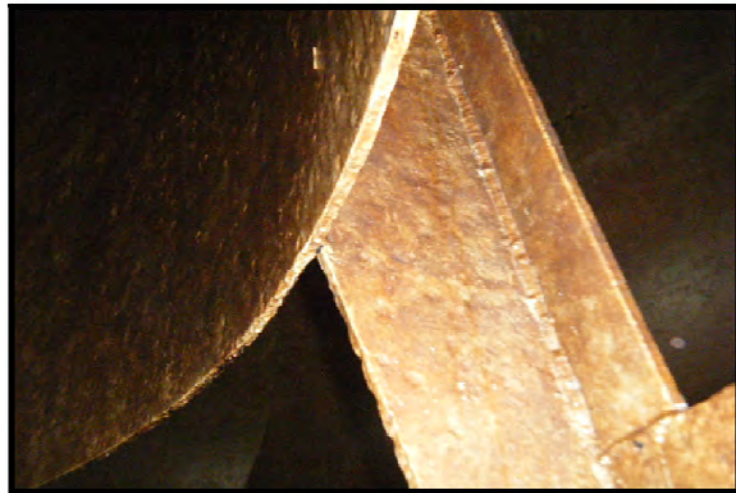
Intersection between tank bowl and external riser. Area in good condition, coating in good condition. View from inside

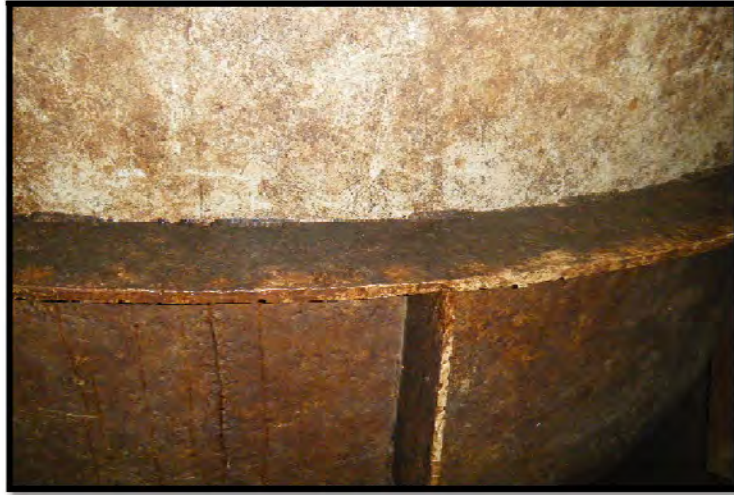
Internal riser in good condition. View of stiffening member below the water line.

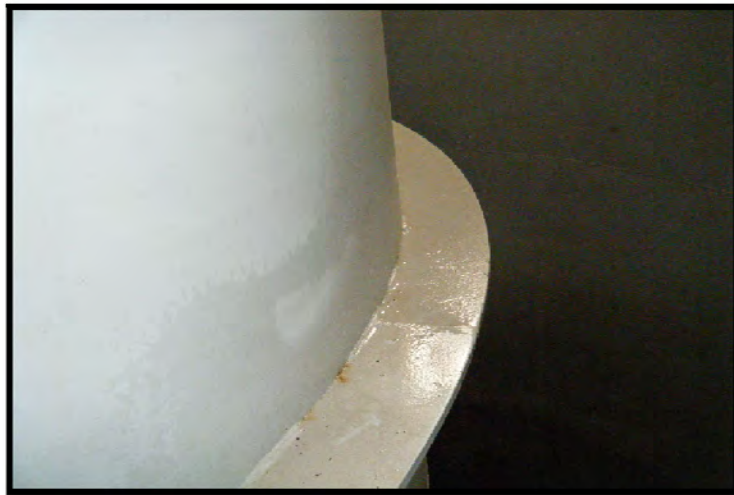
Typical condition photo. Coating in good condition.

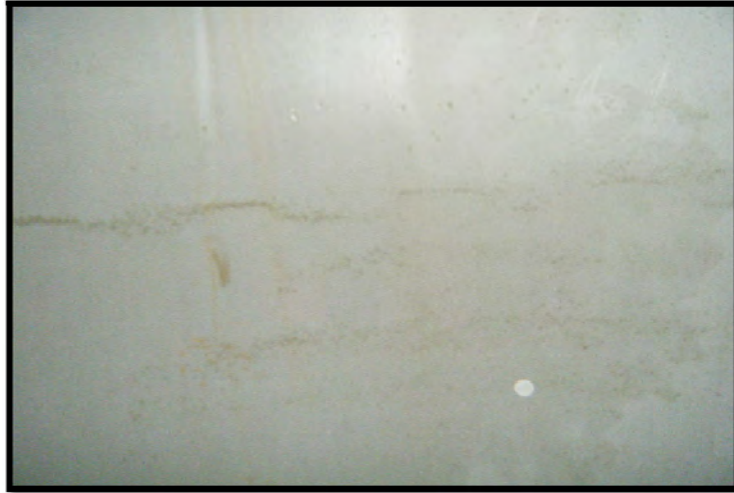
View above water line. Coating in good condition.

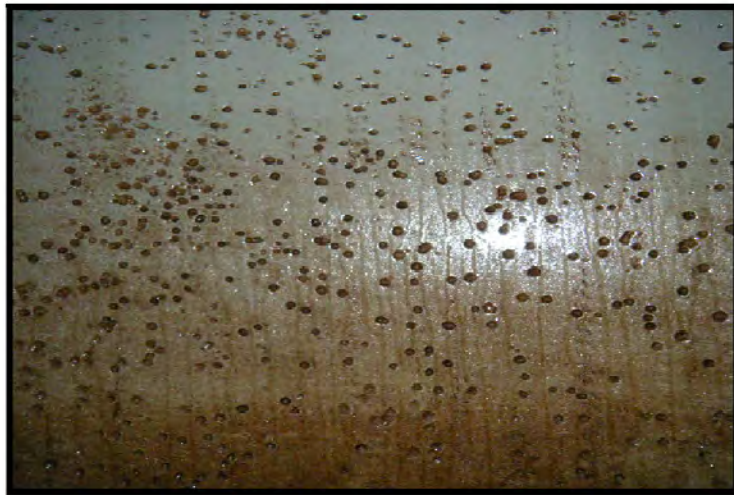
View below the water line. Coating in good condition.

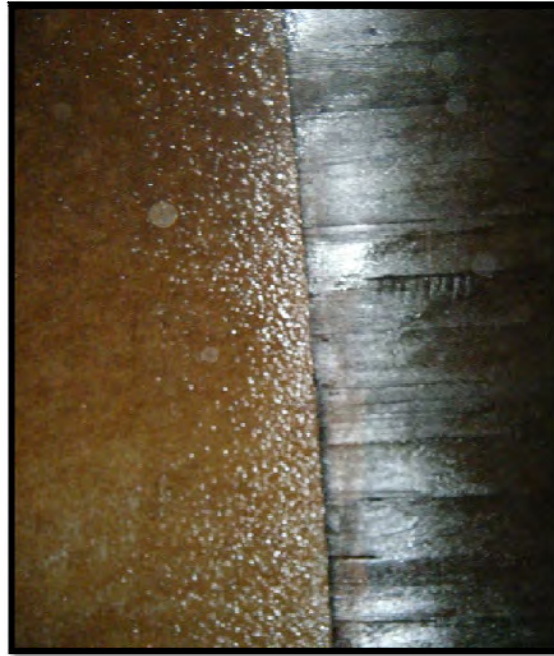
Intersection between Tee and wooden penstock, area in good condition.

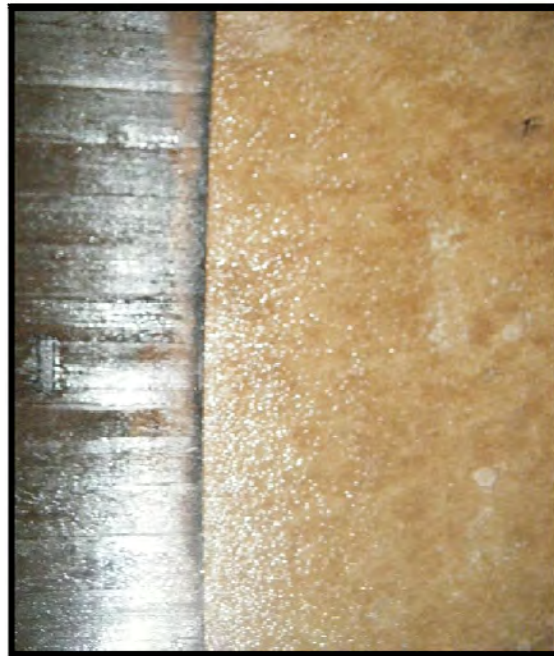
Intersection between Tee and wooden penstock, area in good condition.

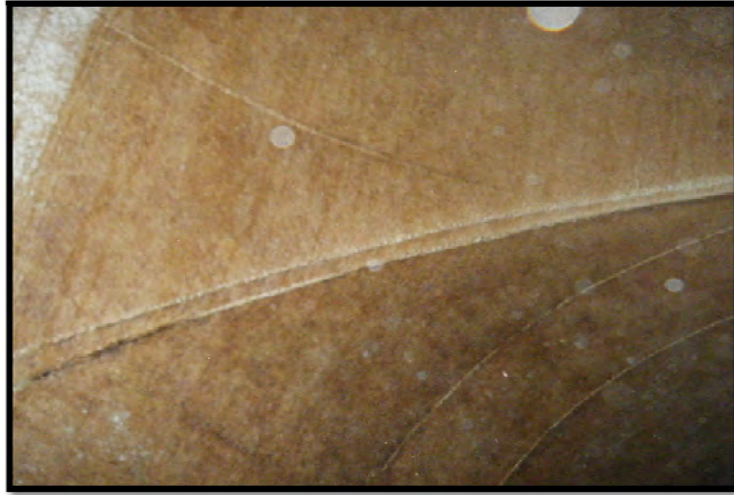
General photo of steel tee intersection. Area was found to be in good condition. Coating in good condition.

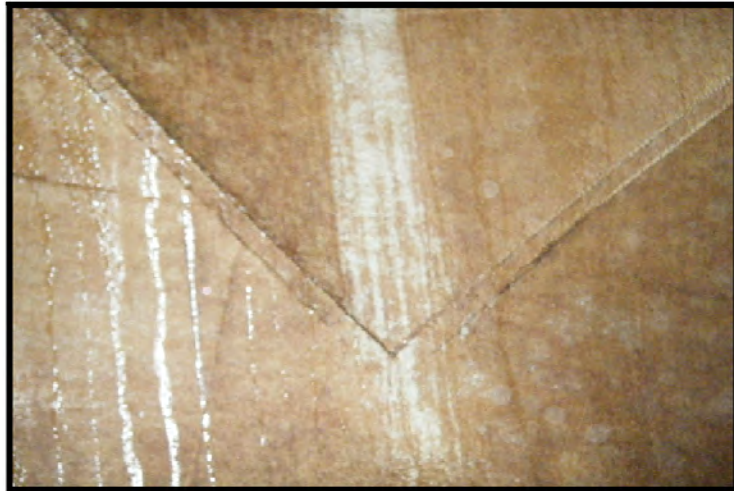
General photo of steel tee intersection. Area was found to be in good condition. Coating in good condition.
