IN THE MATTER OF an Application by Nova Scotia Power Inc. for
Approval of the **2013 Annual Capital Expenditure (ACE) Plan**

2013 ACE Plan

2013 Annual Capital Expenditure Plan

Weymouth Surge Tank Inspection

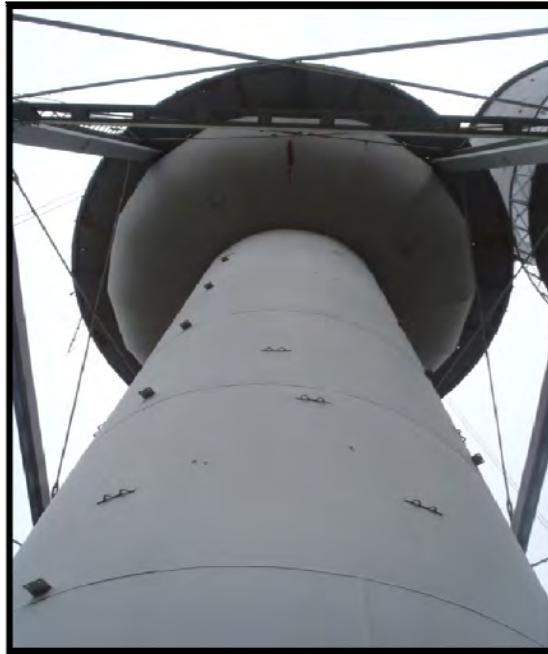
External riser was found to be in good condition. Typical condition photo.

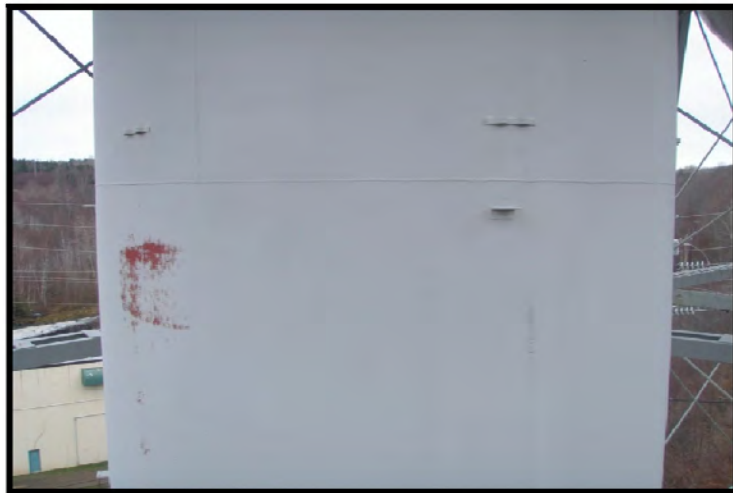
External riser was found to be in good condition. Typical condition photo.

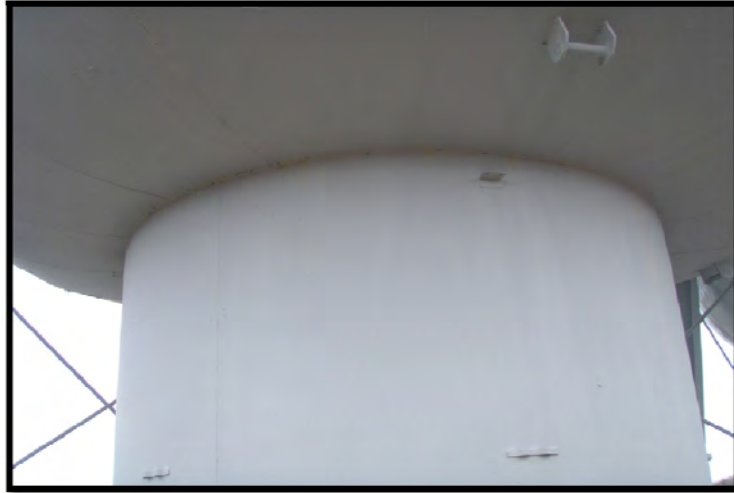
External riser intersection to the Tank bowl was found to be in good condition. Typical condition photo.

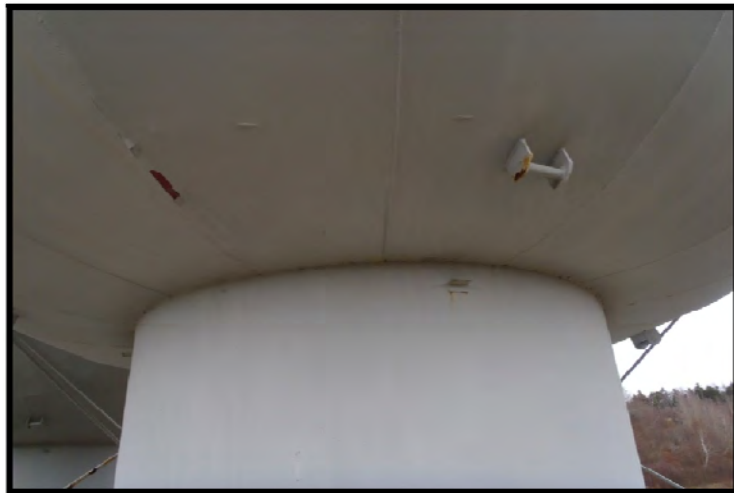
External riser intersection to the Tank bowl was found to be in good condition. Typical condition photo opposite side from photo above.

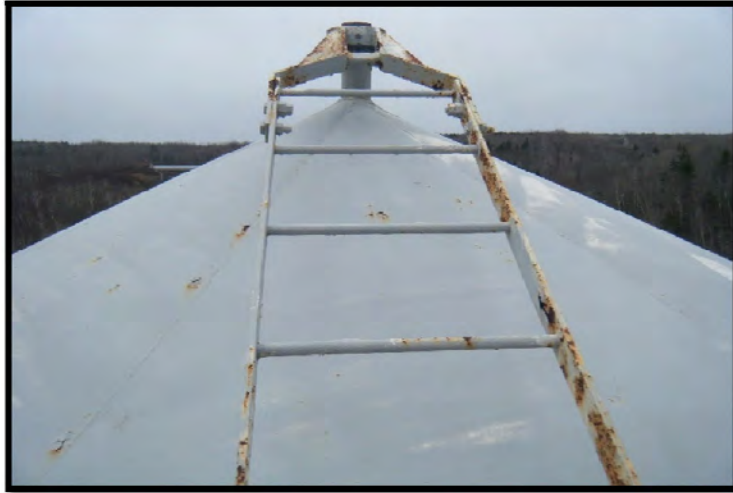
General photo. Roof was in good condition.

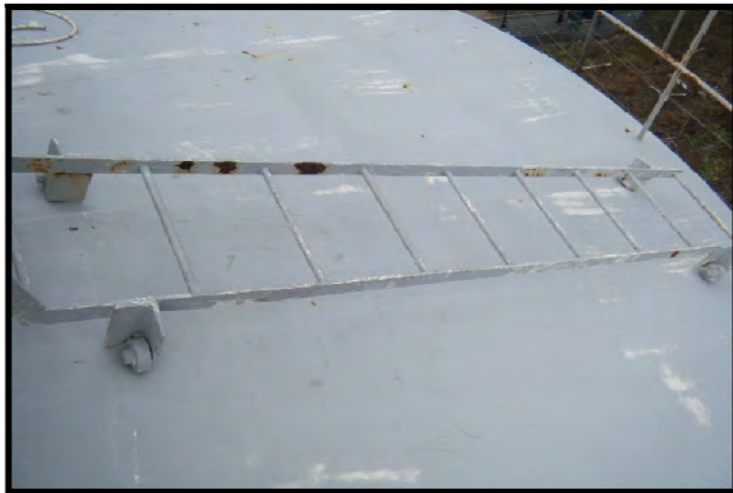
Typical condition photo.

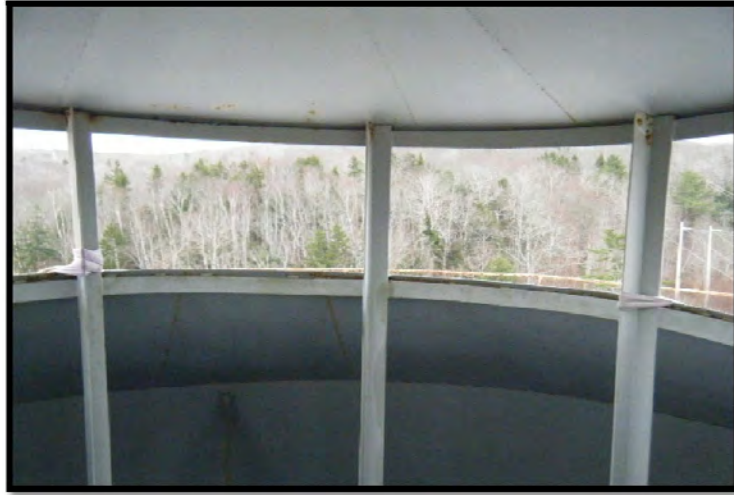
General photo of roof vent cap from inside.

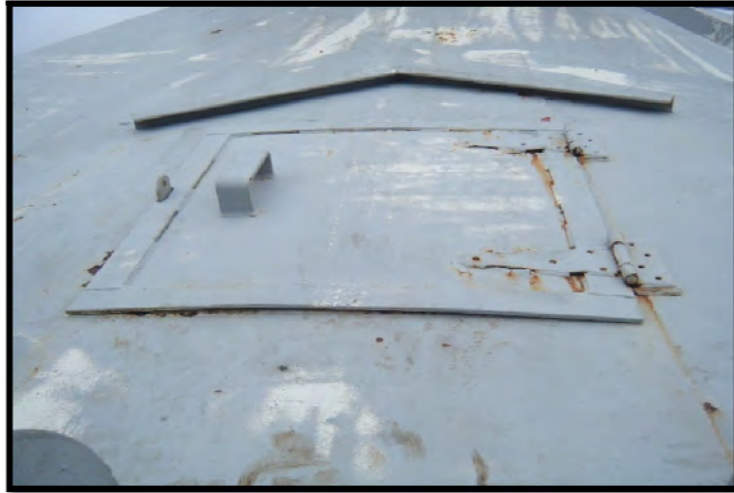
File Name: 7019

Hatch was in good working condition.

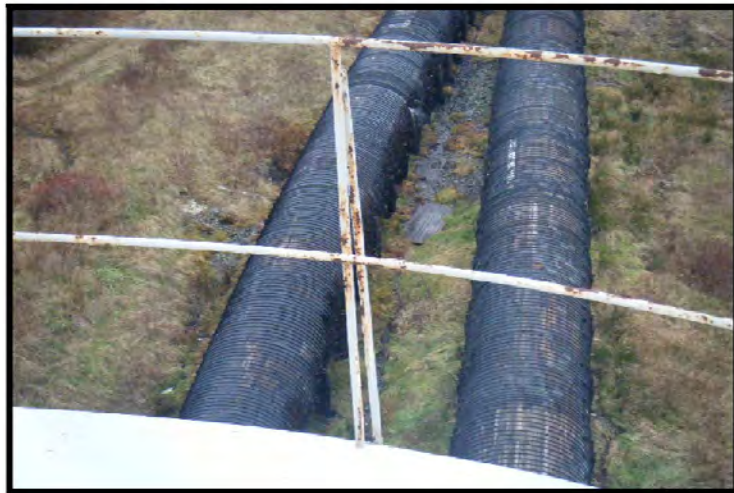
File Name: 7008

General photo of roof top railing. Material quite light but is intact and secure.

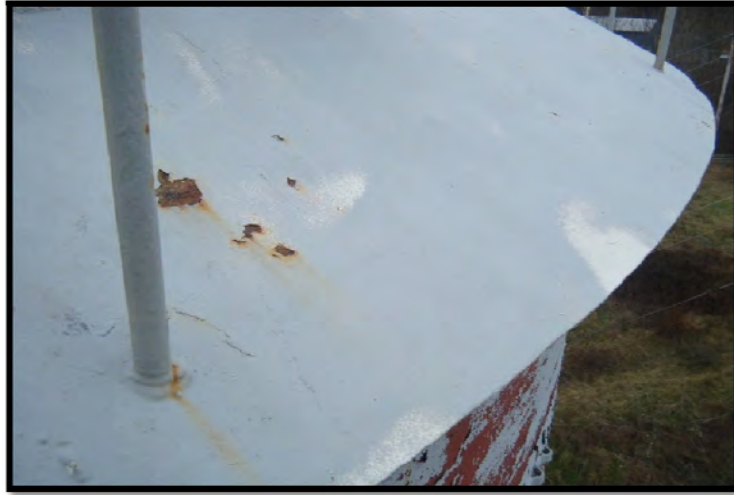
File Name: 7023

View of roof top connection of hand rail.

Note no toeboard.

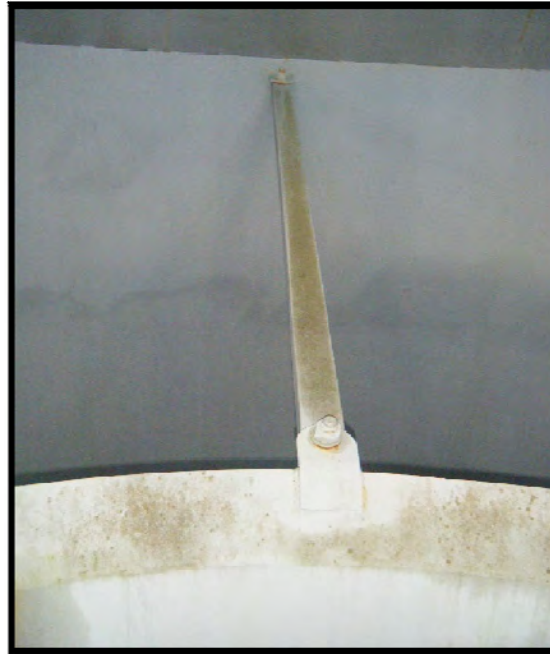
File Name: 10003

Spider rod connections to tank were in good condition. Typical condition photo.

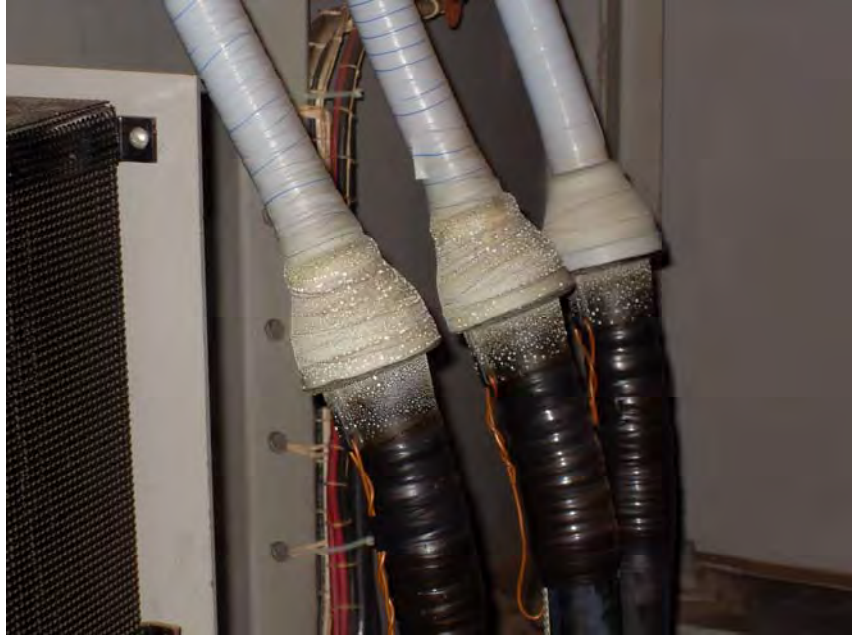
1. 6.9 kV cables to outdoor substation

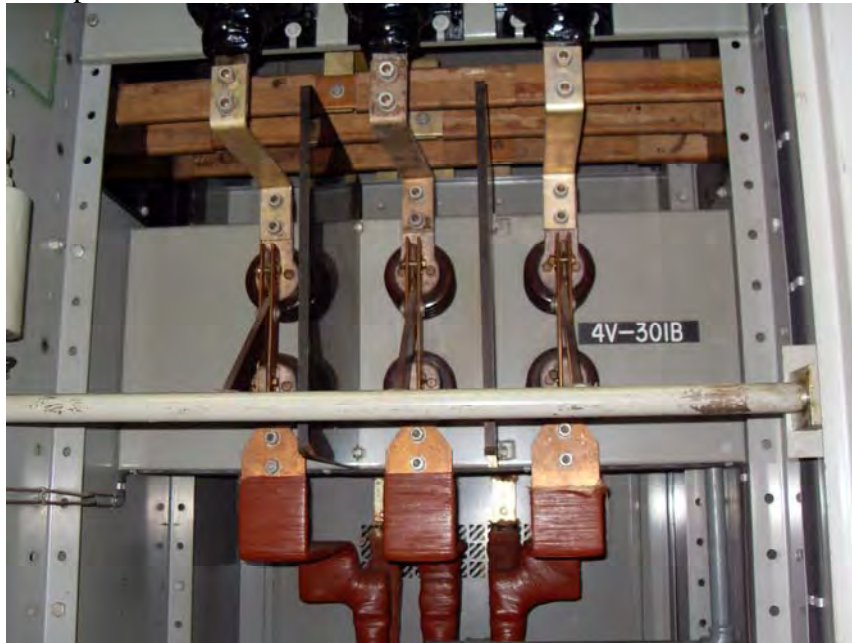
2. Exposed buswork

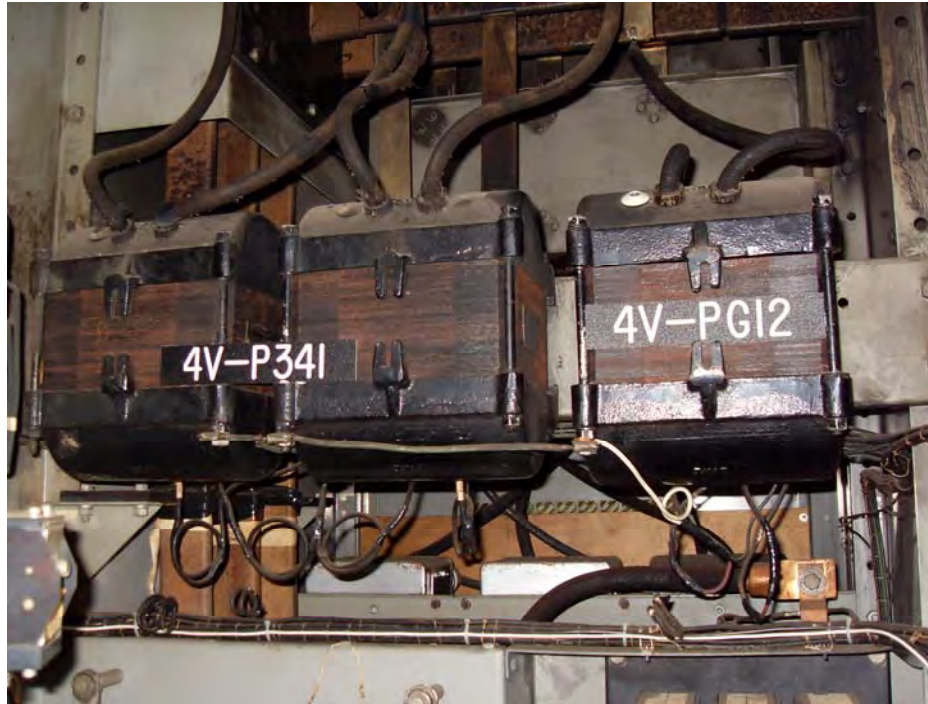
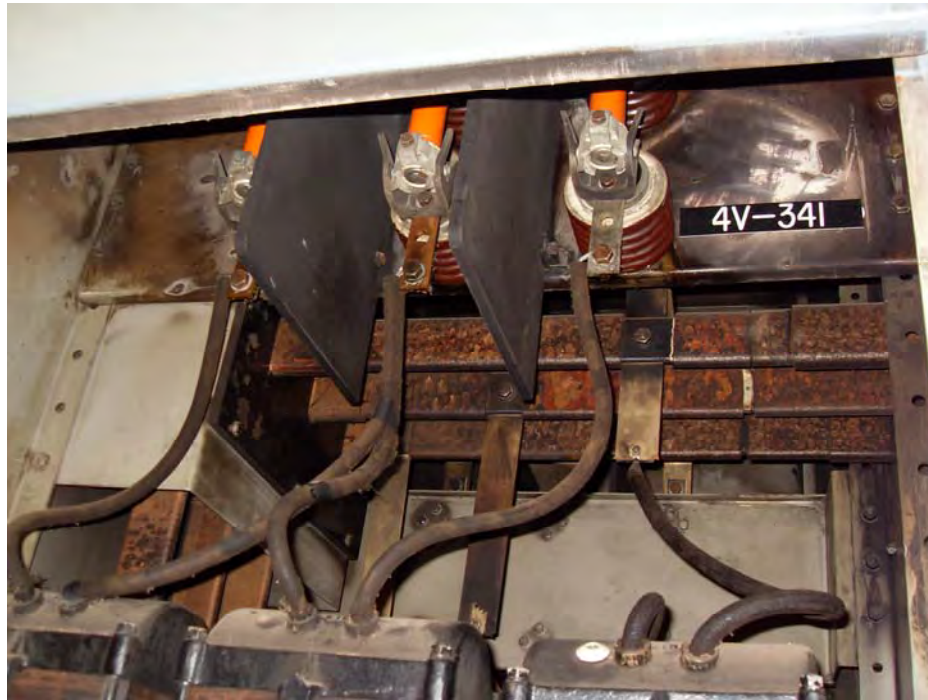
3. Bus PT's

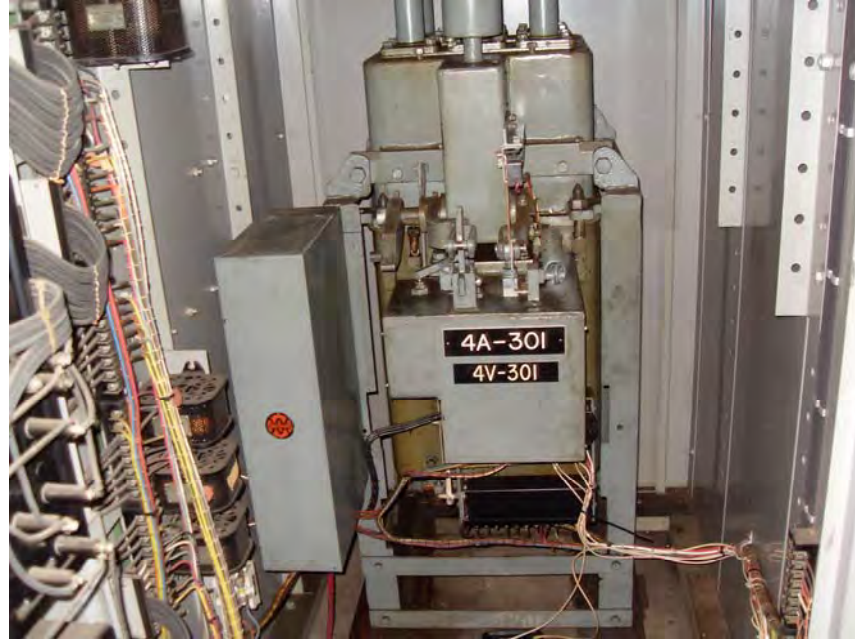
4. Generator Breaker

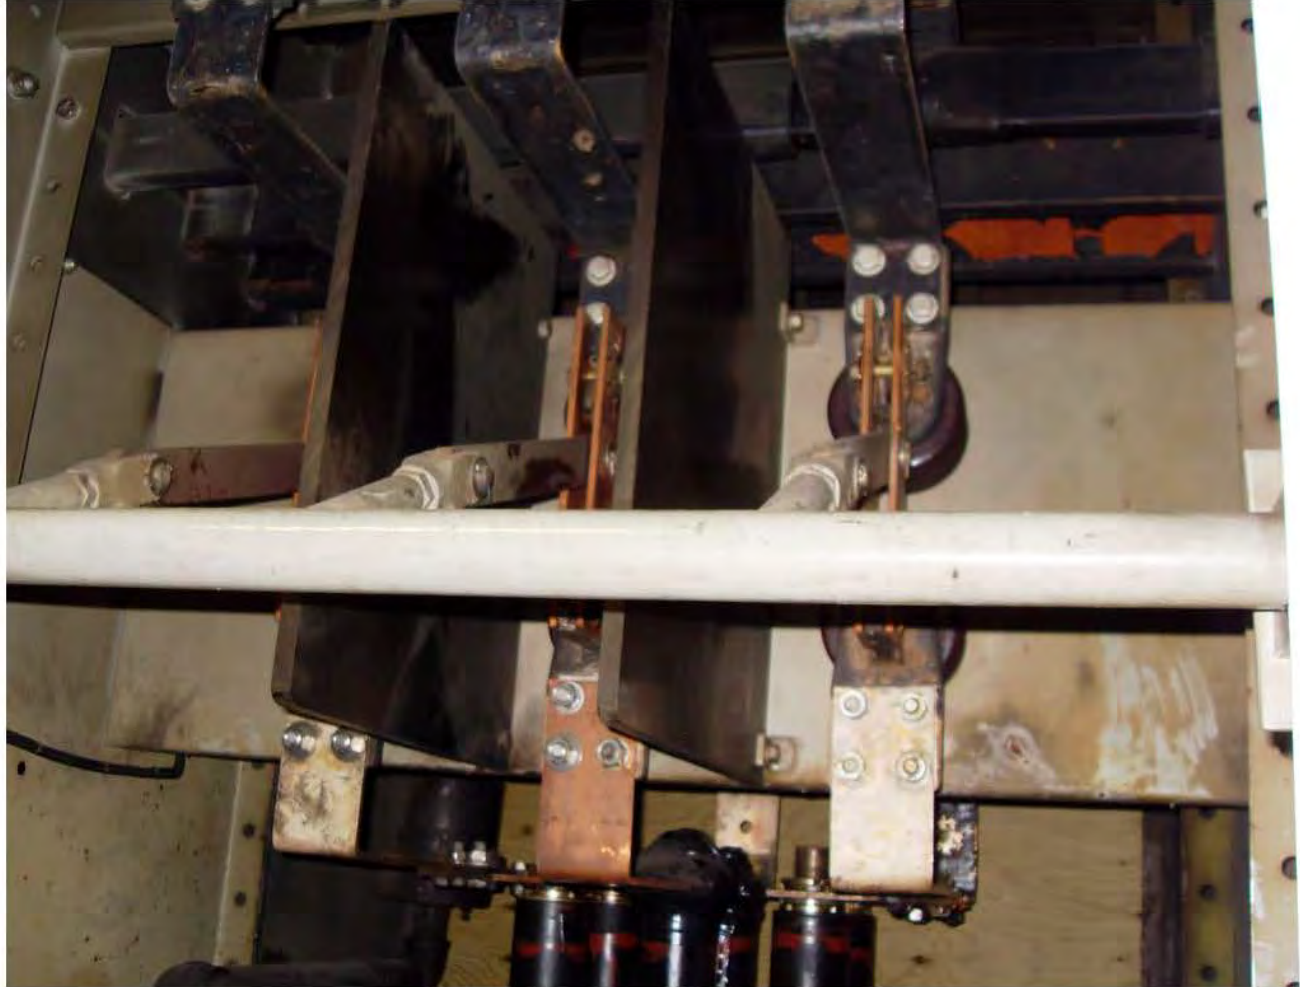
1. Exposed 6.9 kV Bus (note evidence of corona discharge on left side bus support.)

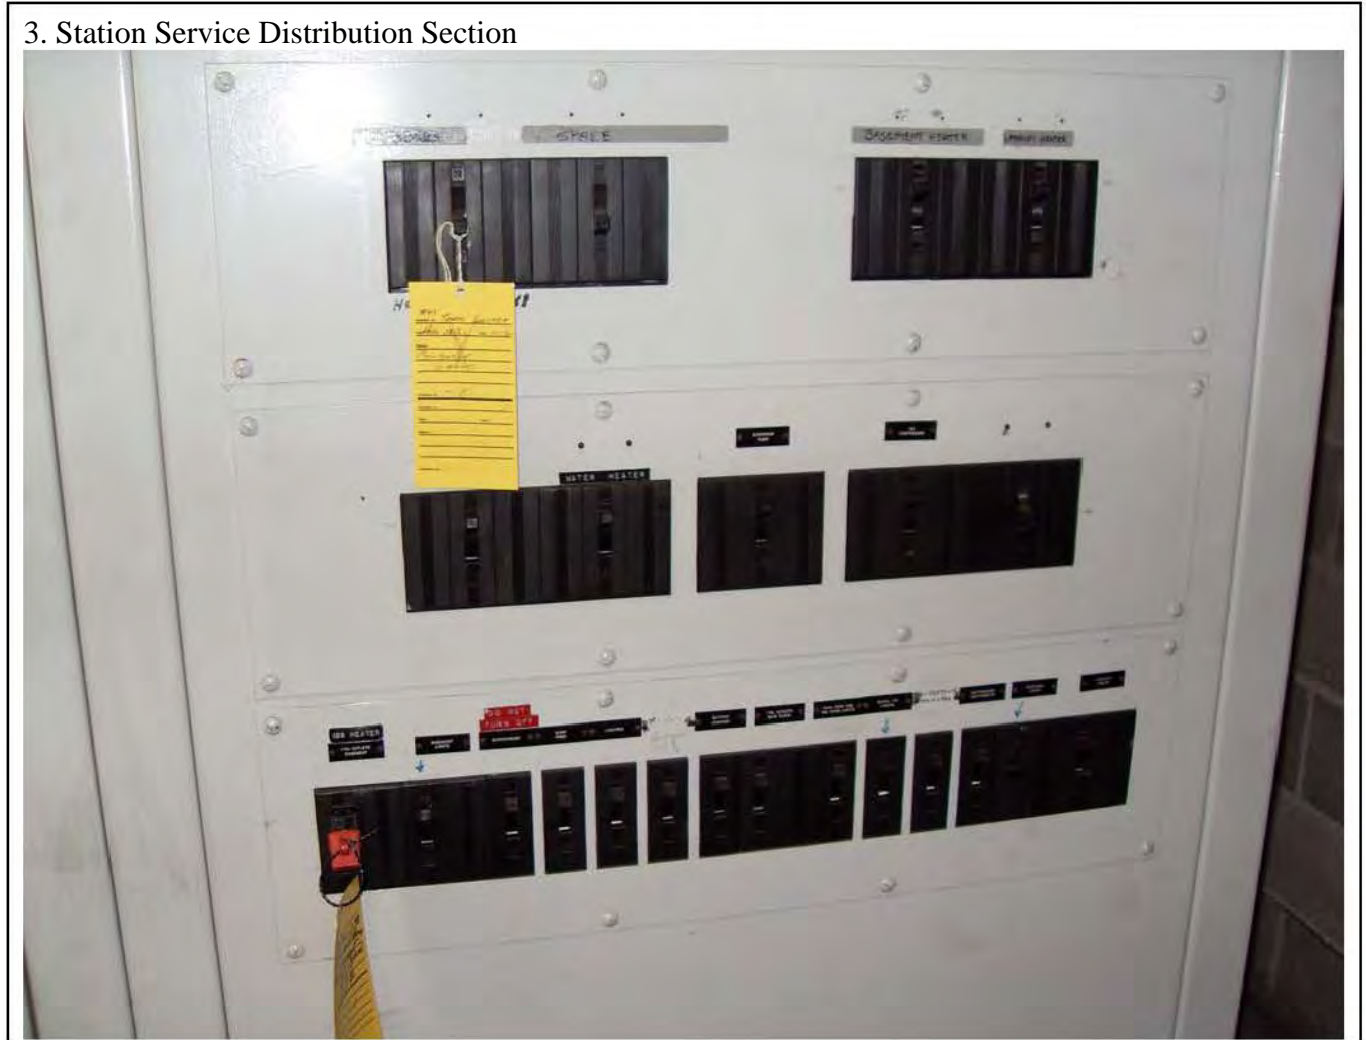
3. Station Service Distribution Section

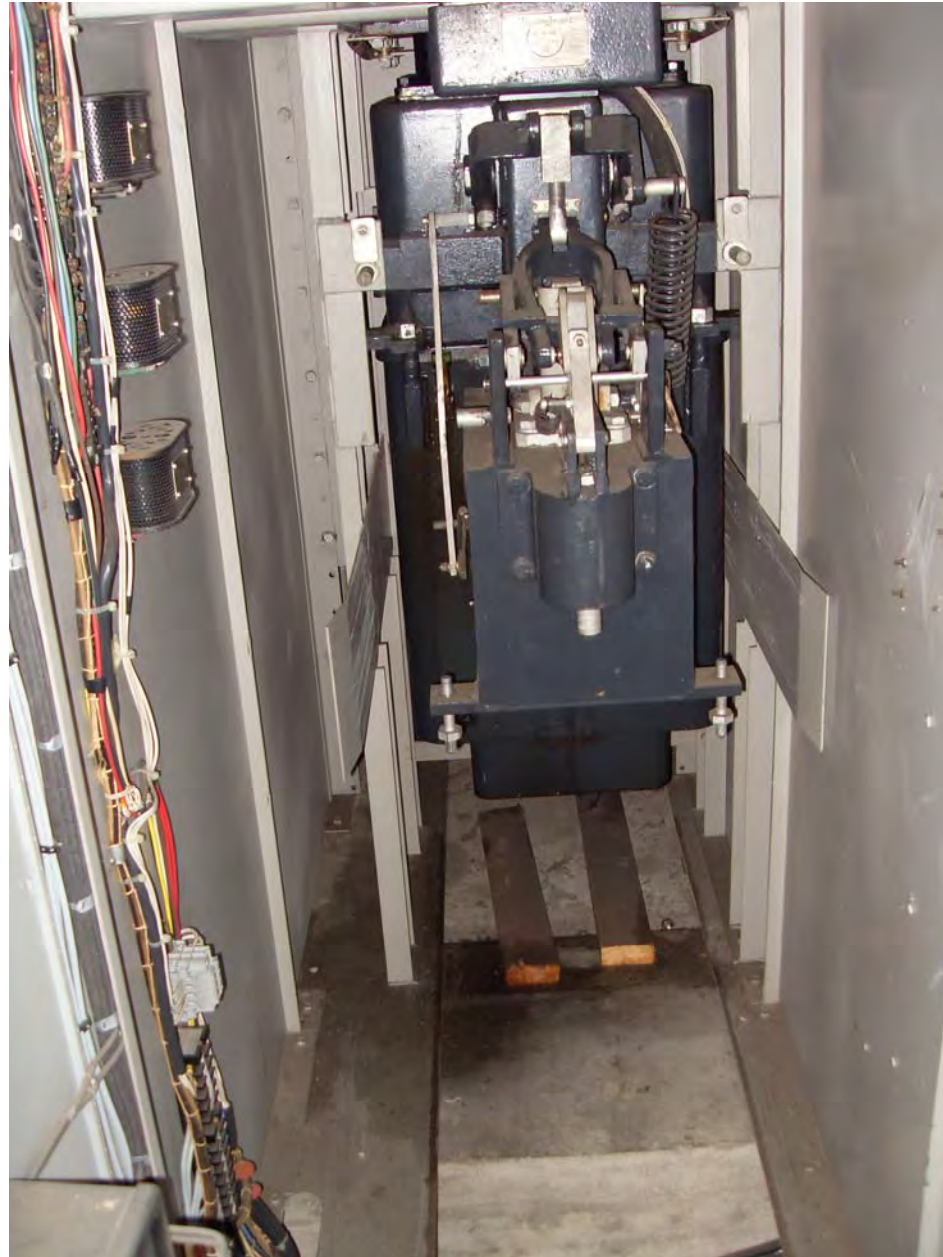
1. Generator No.1 600A Breaker

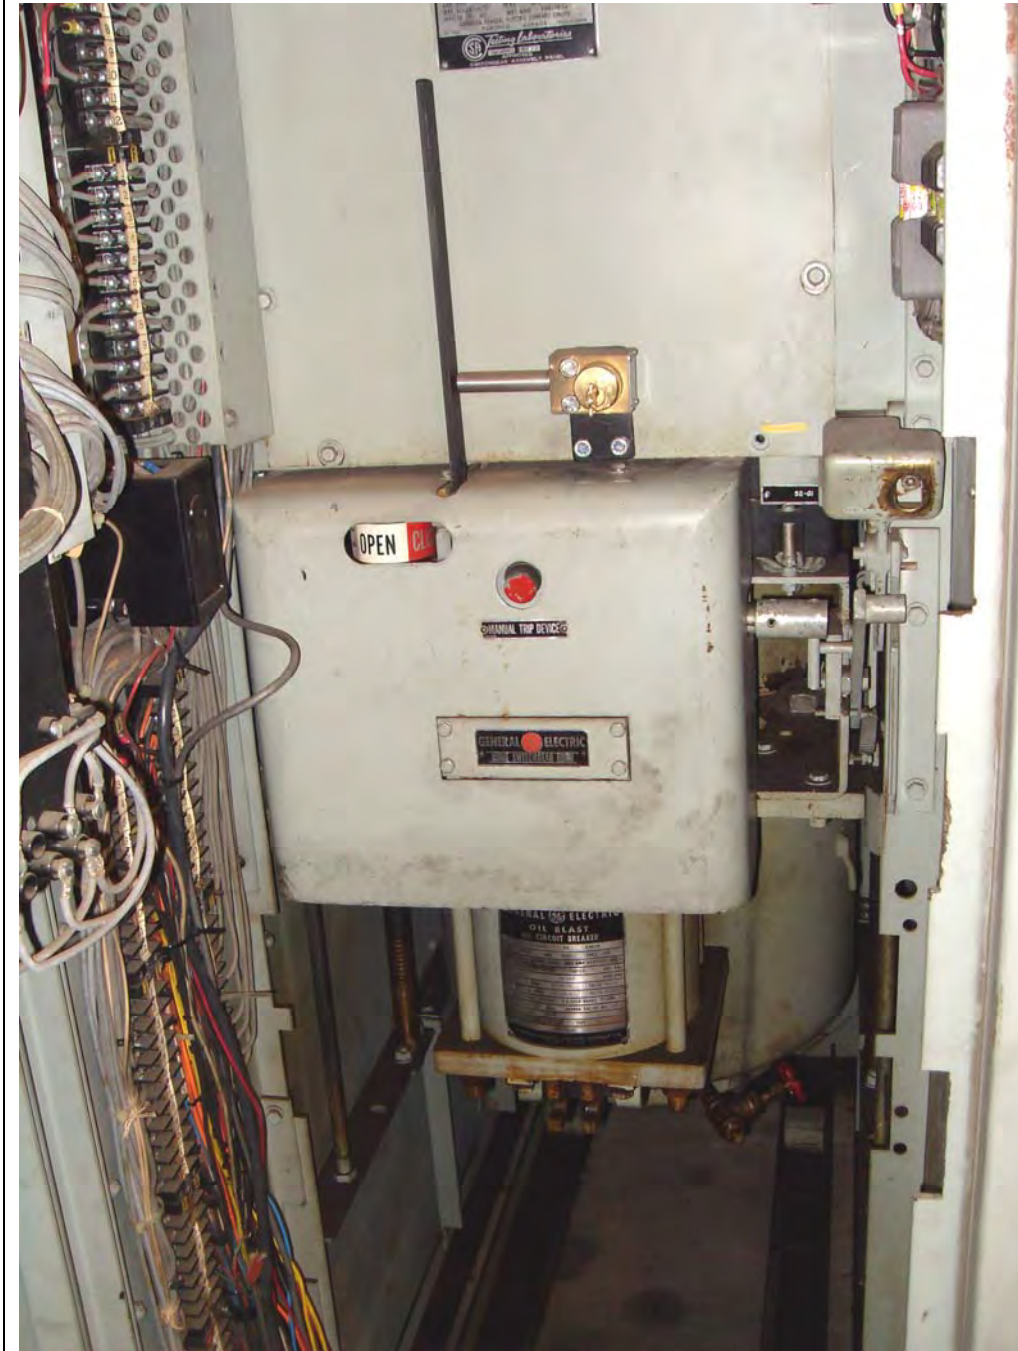
1. Generator No.1 600A Breaker

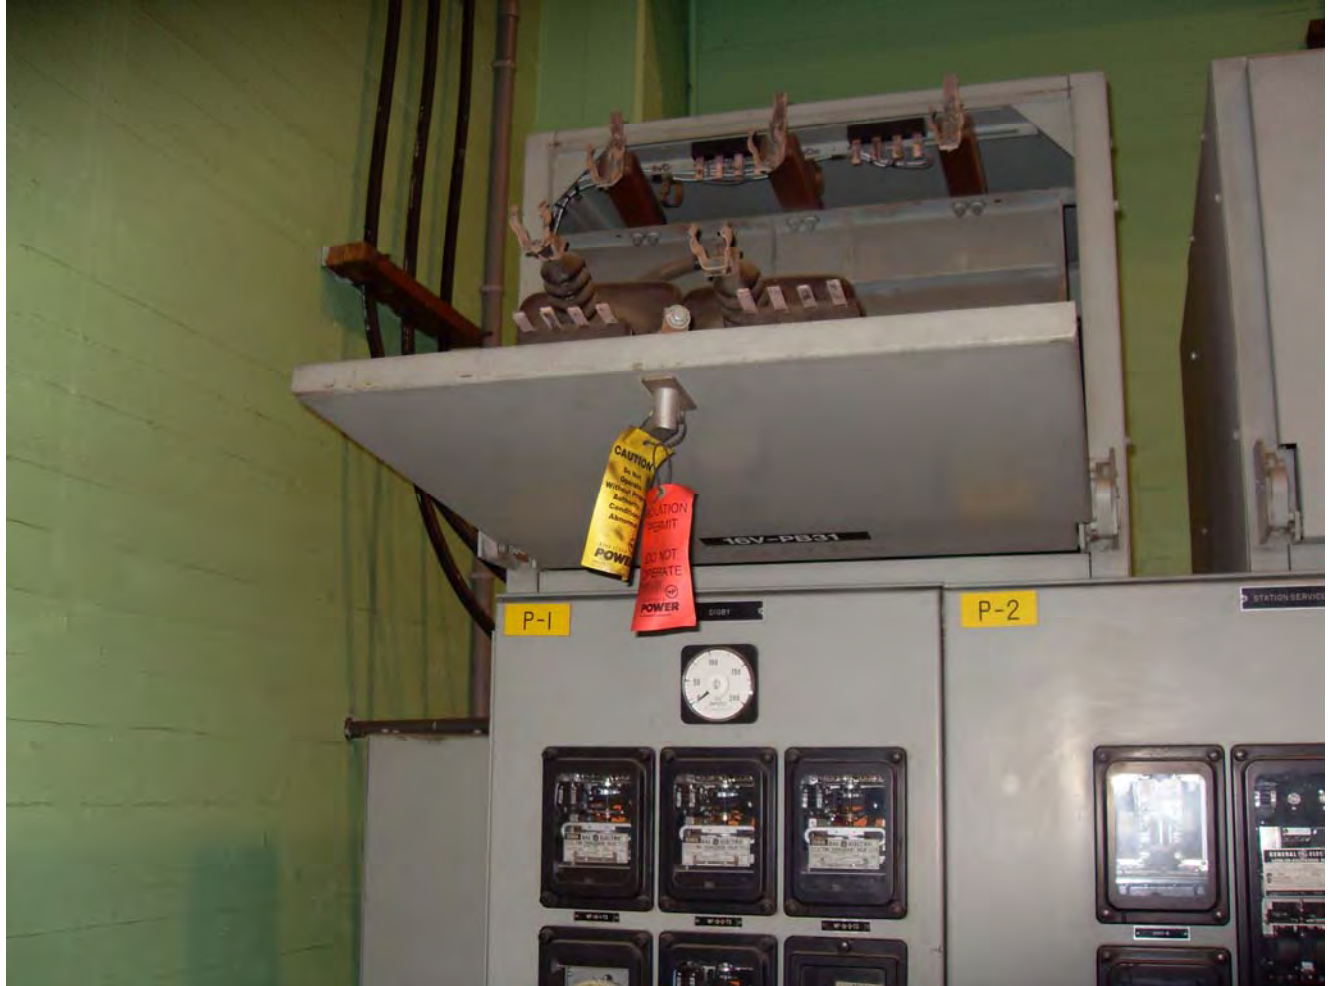
2. Bus PT's

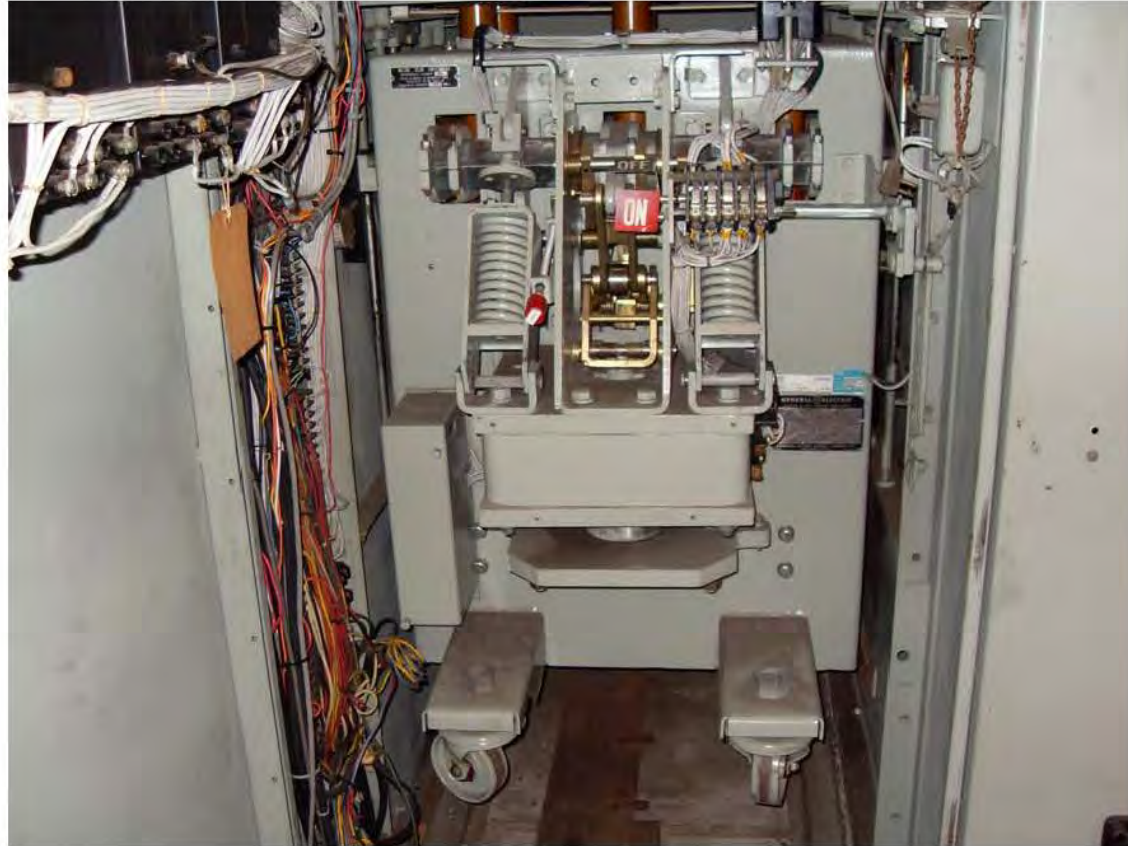
3. Generator No. 2 breaker

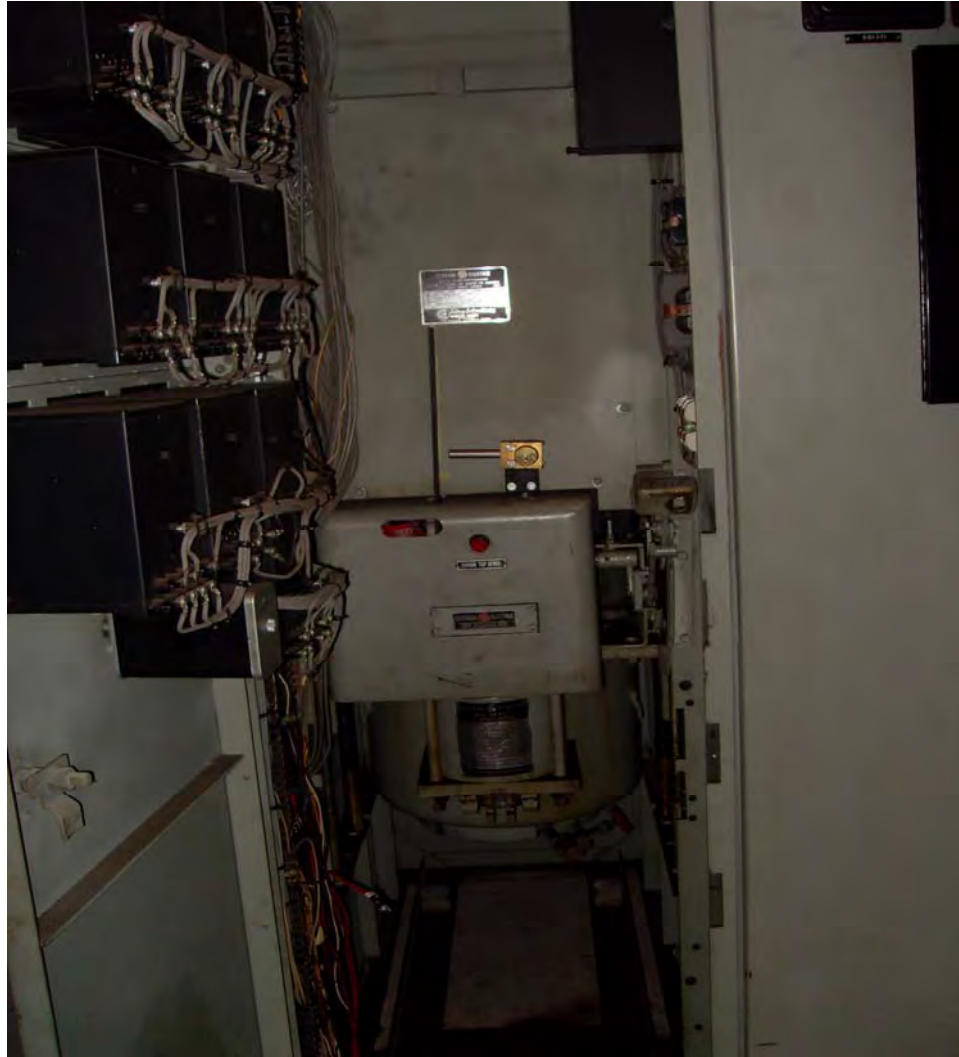
1. Generator Breaker (15V-301)

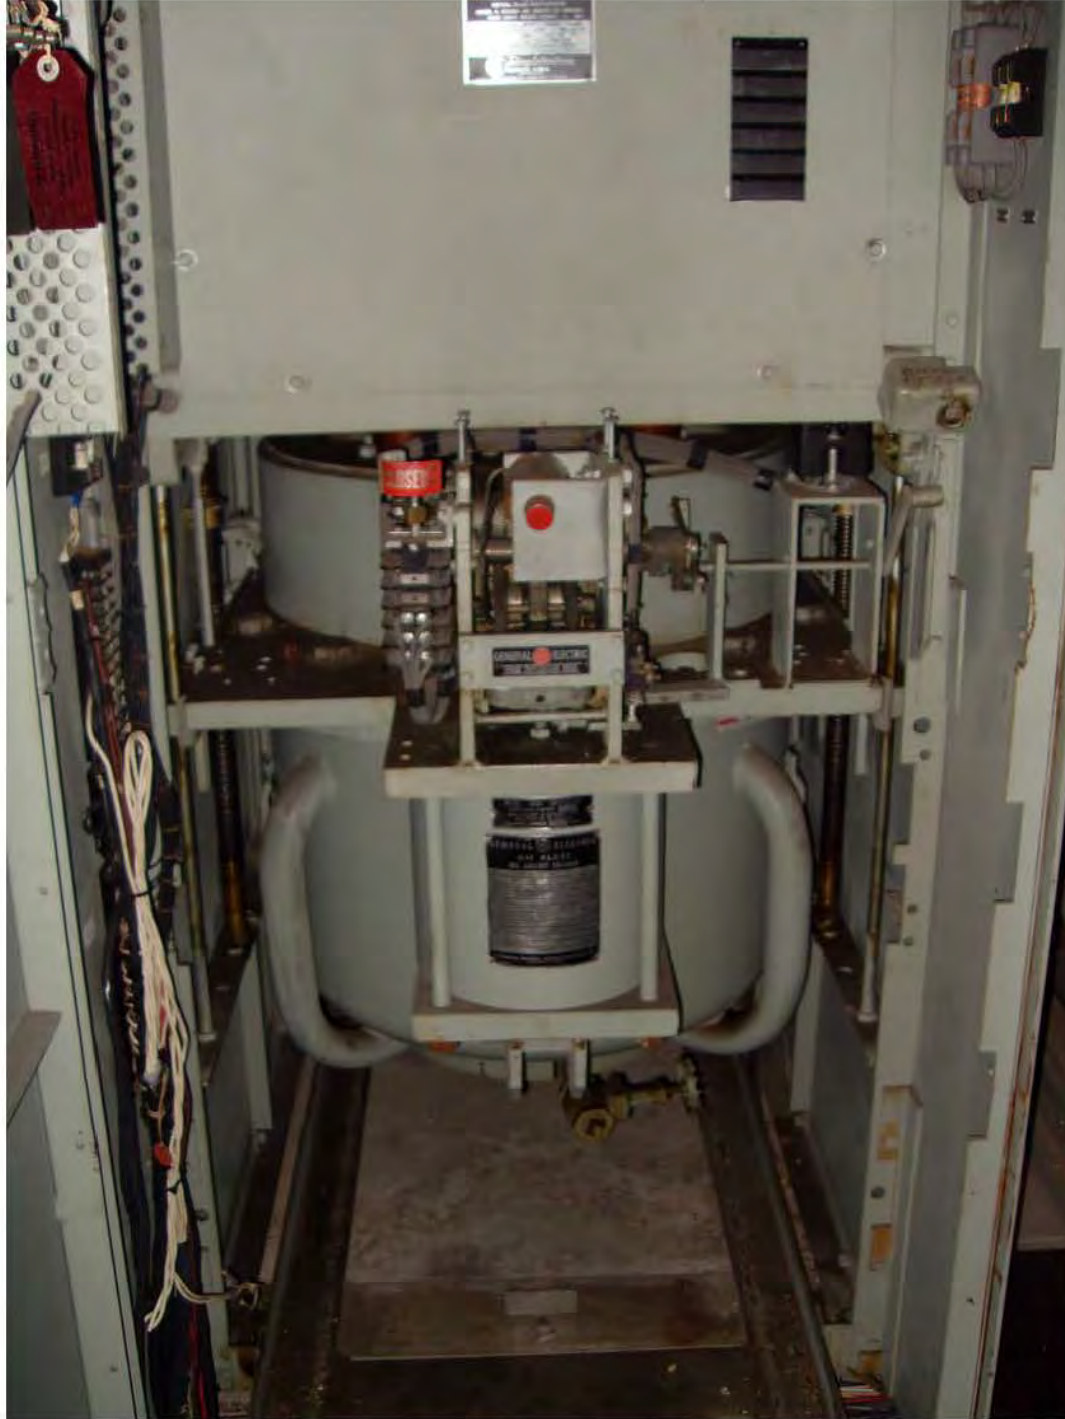
2. TL Breaker (15V-311)

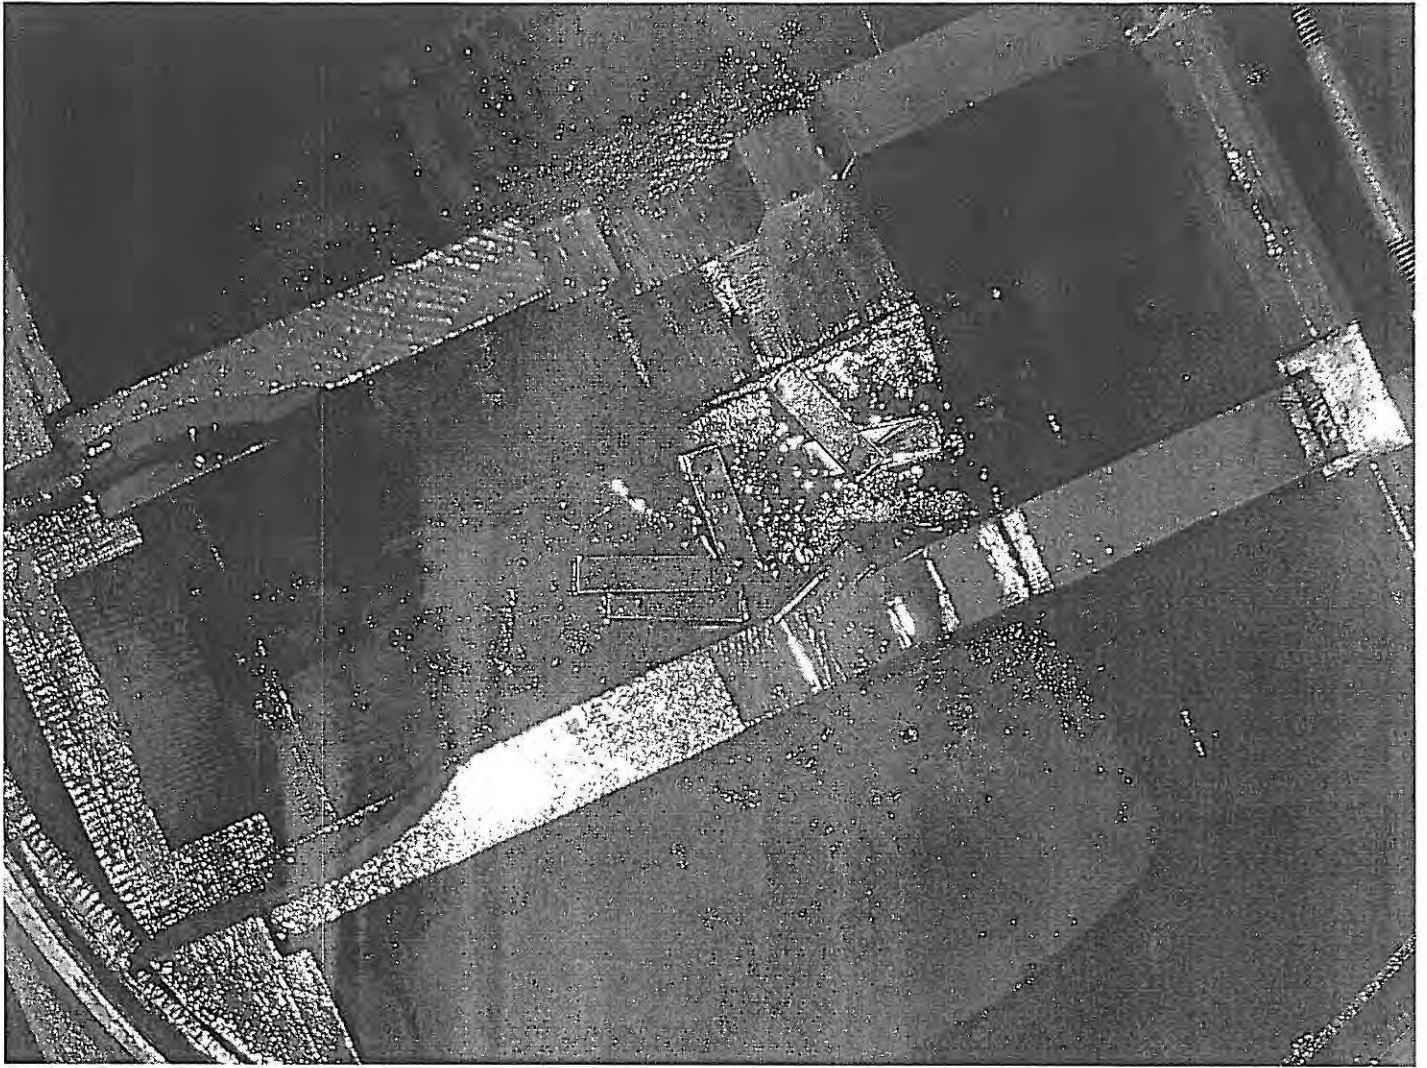
Springs laying in bottom of tank 1

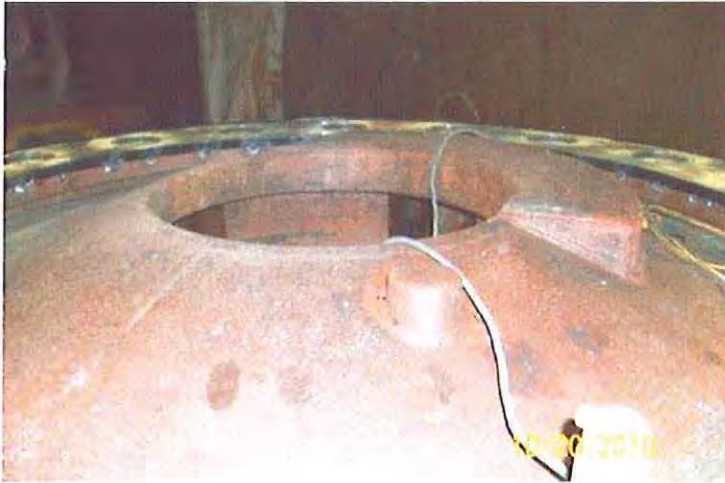
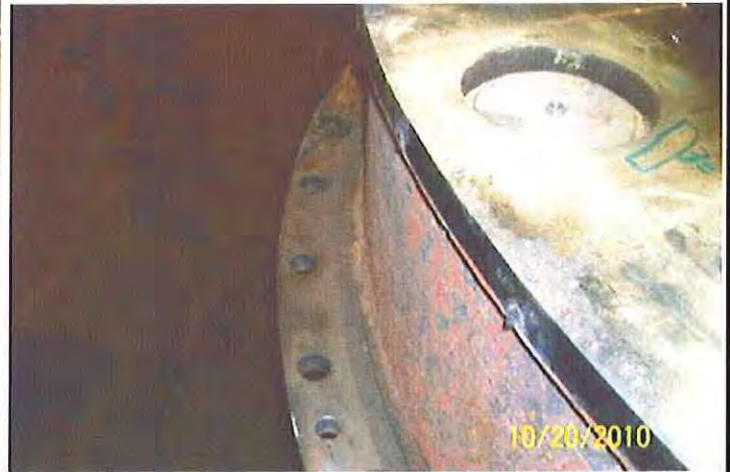
A dry powder method of magnetic particle inspection was performed on the Weymouth # 1 Headcover concentrating on the machined surface. Numerous indications were observed during this inspection. For more information on the indications observed refer to the following pages. A total of 26 linear indications have been recorded varying in lengths from 1" to approx. 90% of the circumference of the hole.

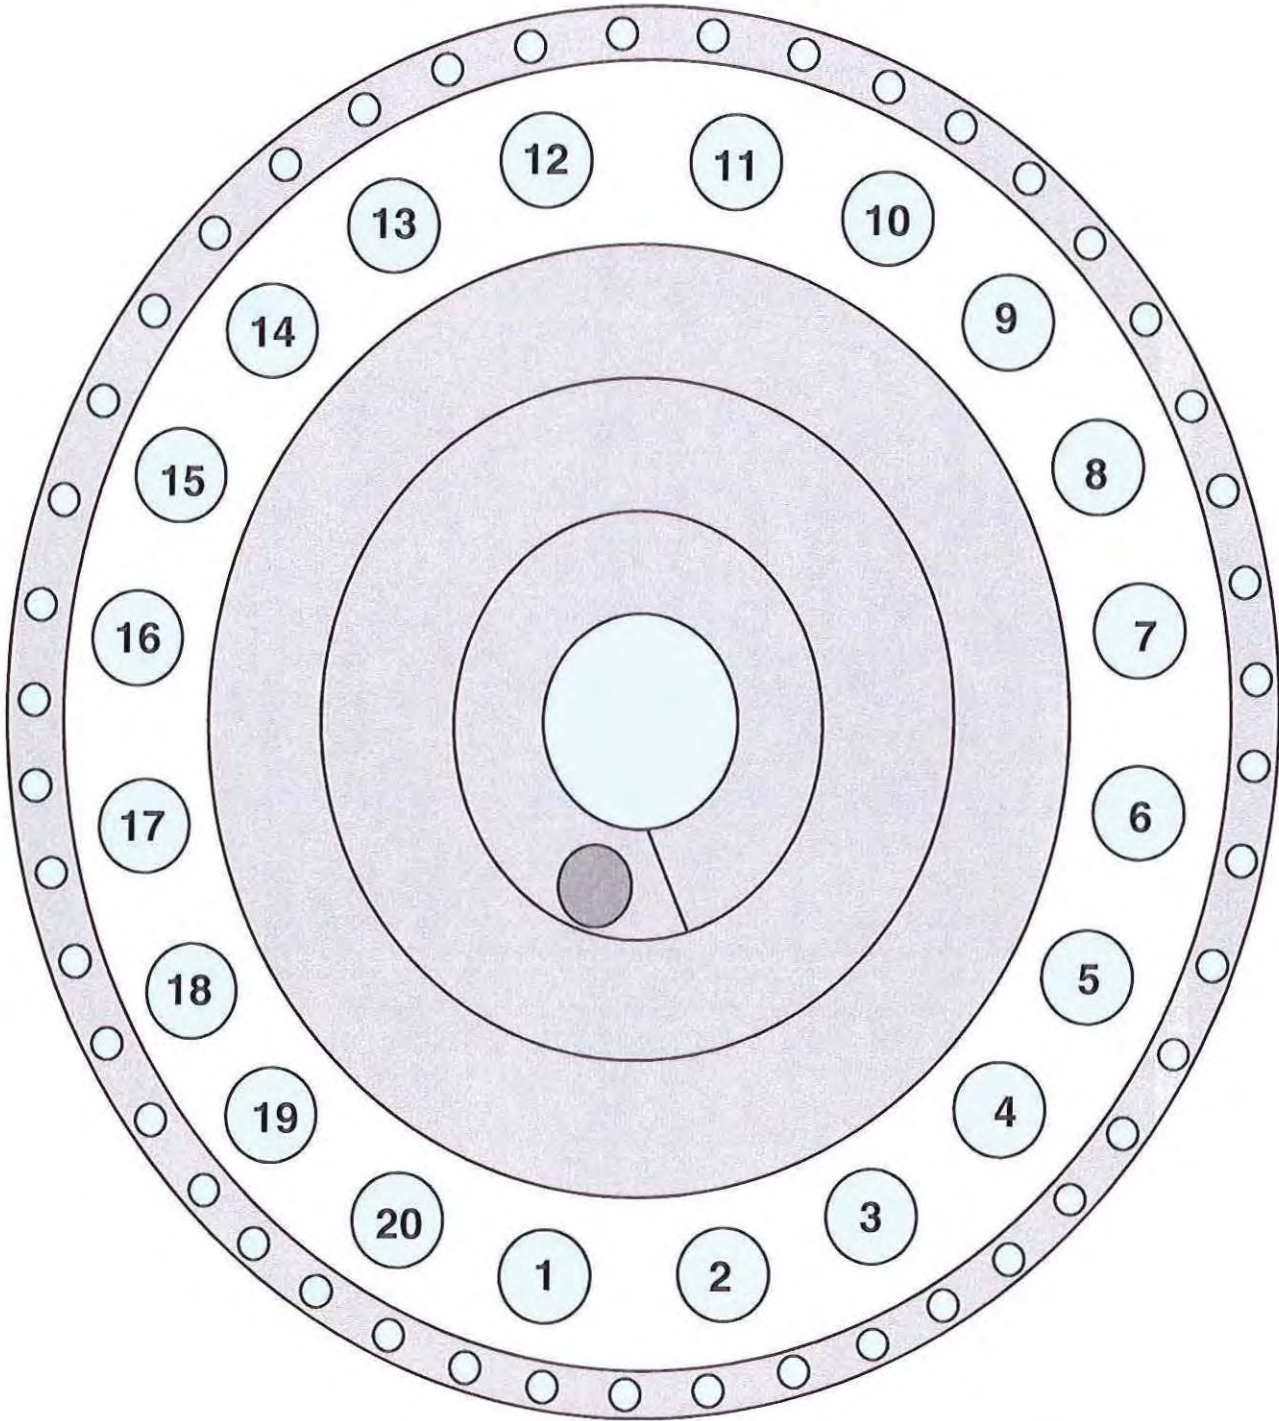
INSPECTION REPORT		REPORT No.:	441281001-001
PROJECT No. 441281001	CUSTOMER NOVA SCOTIA POWER	PAGE 2 OF 6	
LAYOUT VIEW OF CASTING

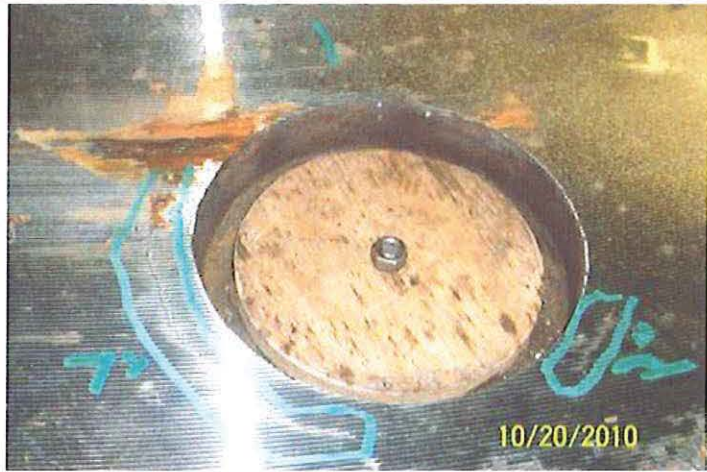
HOLE #1 WITH 7" AND 2" LINEAR INDICATION AROUND HOLE

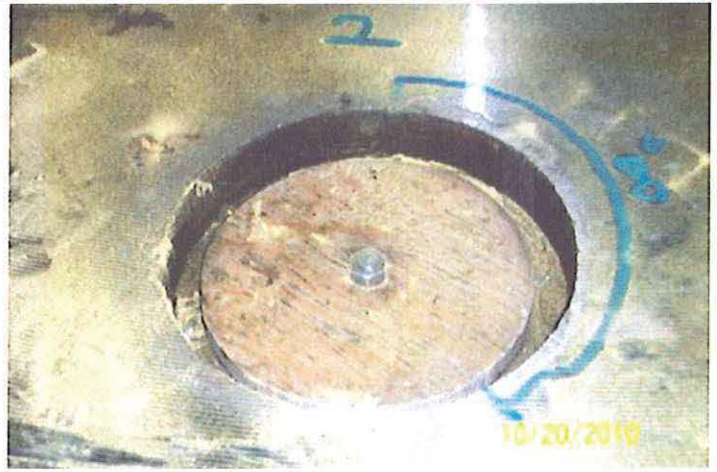
HOLE #2 WITH 8" LINEAR INDICATION AROUND HOLE

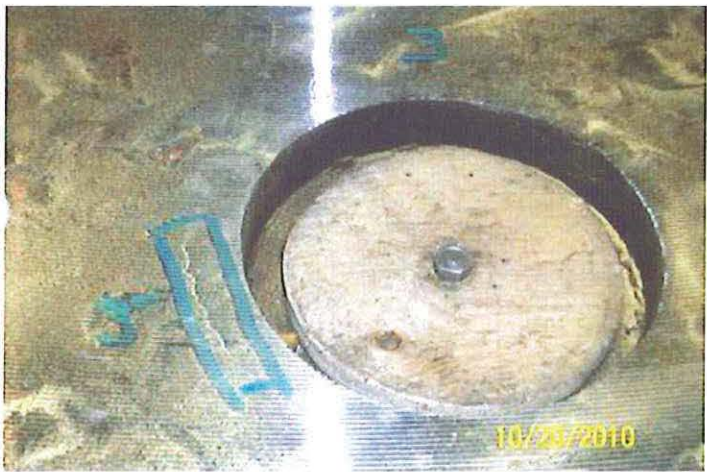
HOLE #3 WITH 5" LINEAR INDICATION AROUND HOLE

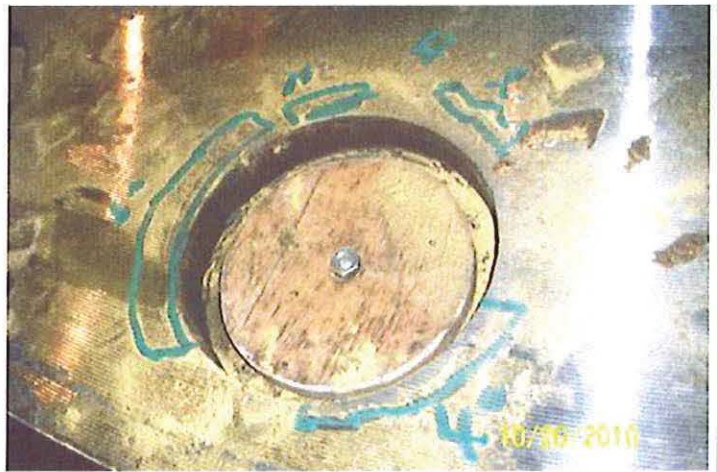
HOLE #4 WITH 7", 1", 2" & 4" LINEAR INDICATION AROUND HOLE

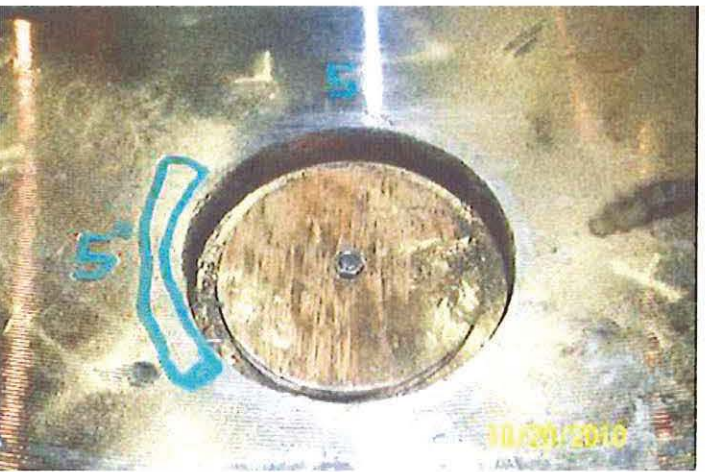
HOLE #5 WITH 5" LINEAR INDICATION AROUND HOLE
