IN THE MATTER OF an Application by Nova Scotia Power Inc. for
Approval of the **2013 Annual Capital Expenditure (ACE) Plan**

2013 ACE Plan

2013 Annual Capital Expenditure Plan

Weymouth Surge Tank Inspection

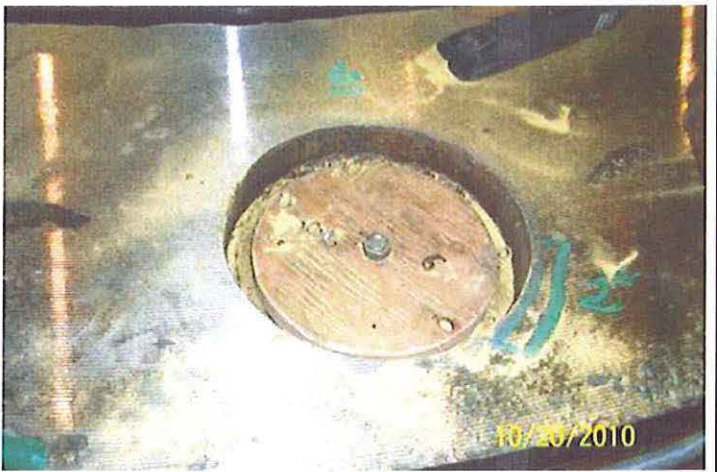
HOLE #6 WITH 2" LINEAR INDICATION AROUND HOLE

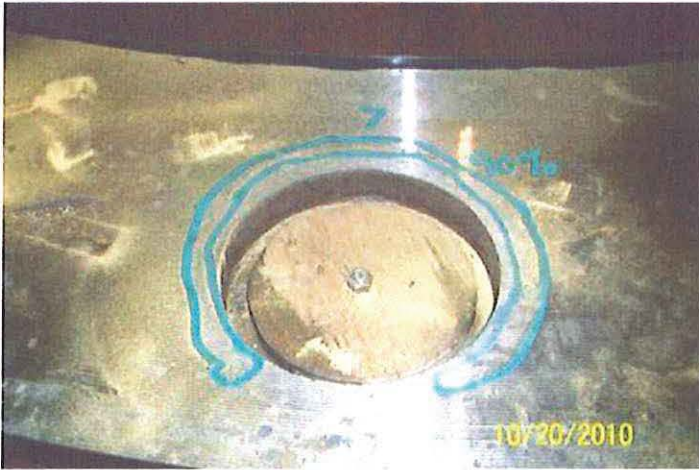
HOLE #7 WITH LINEAR INDICATION 90% AROUND HOLE

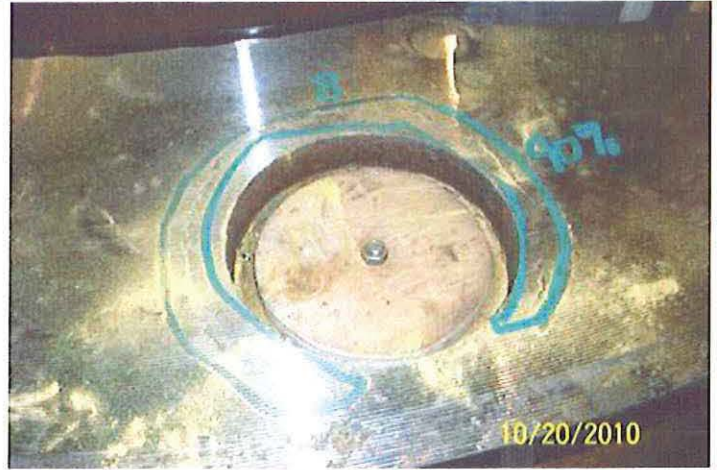
HOLE #8 WITH LINEAR INDICATION 90% AROUND HOLE

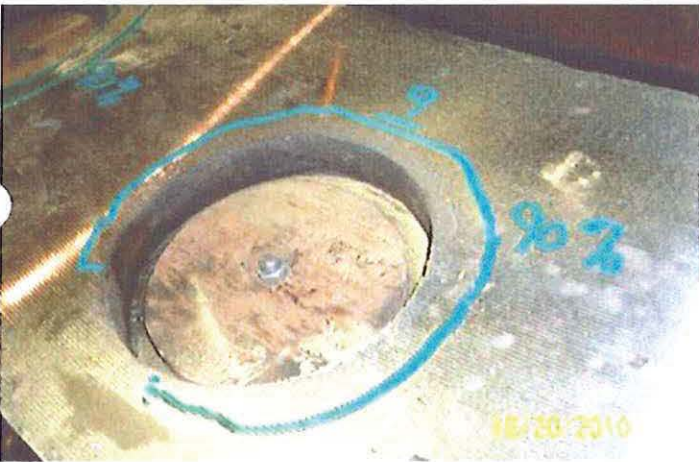
HOLE #9 WITH LINEAR INDICATION 90% AROUND HOLE

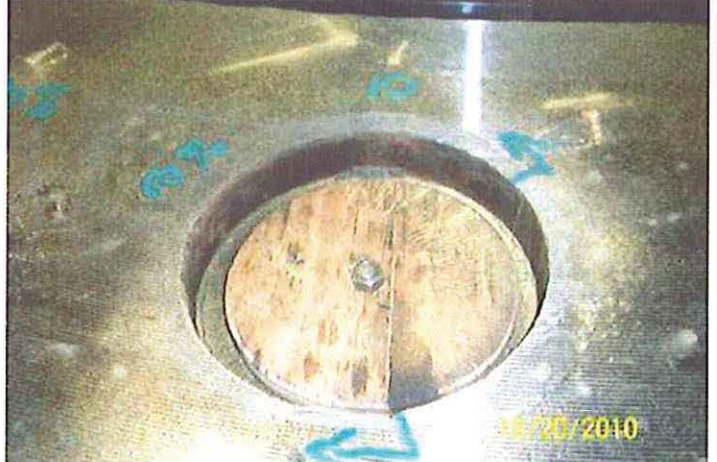
HOLE #10 WITH LINEAR INDICATION 60% AROUND HOLE

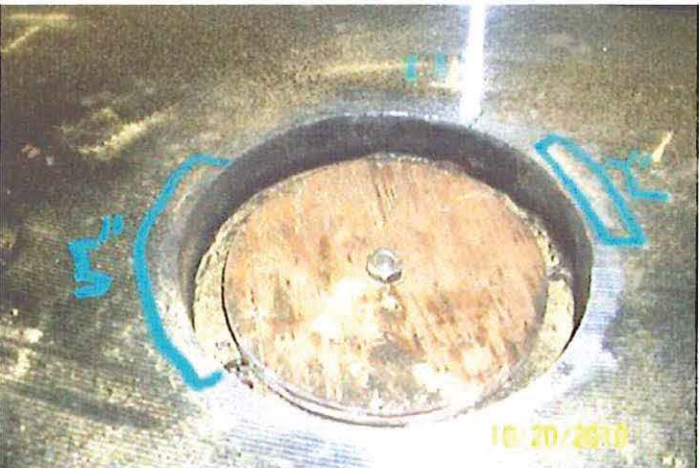
HOLE #11 WITH 5" & 2" LINEAR INDICATION AROUND HOLE

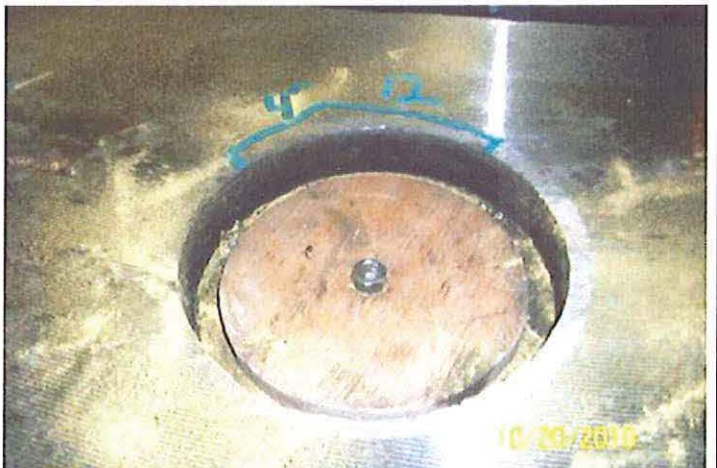
HOLE #12 WITH 4" LINEAR INDICATION AROUND HOLE

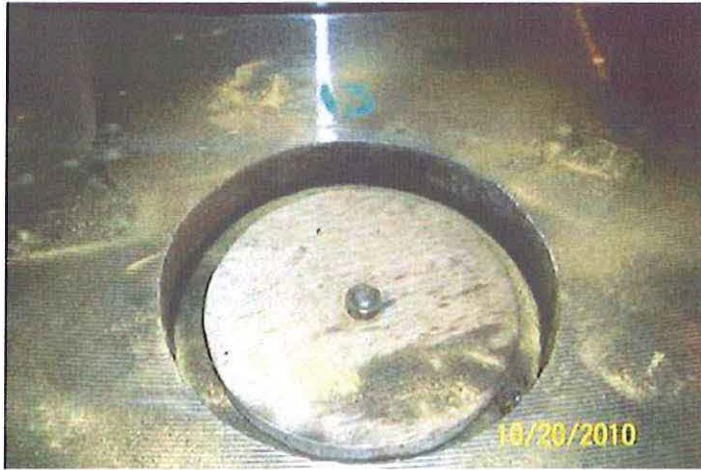
HOLE #13 WITH NO INDICATIONS

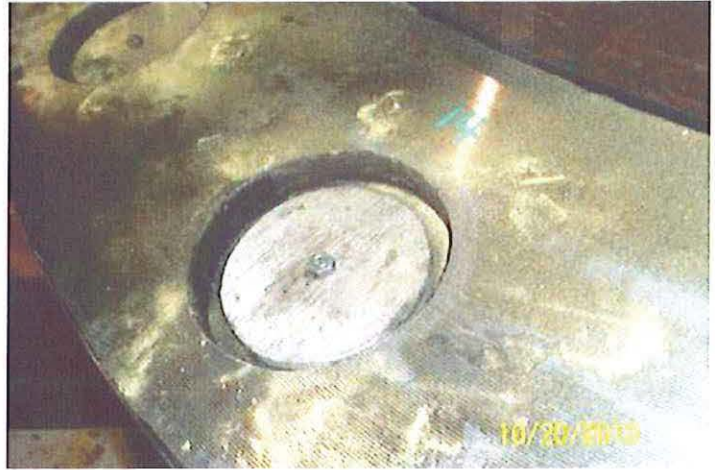
HOLE #14 WITH NO INDICATIONS

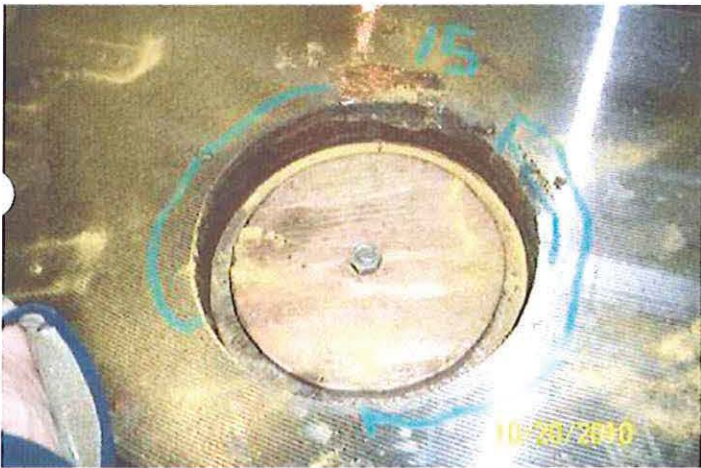
HOLE #15 WITH LINEAR INDICATION 60% AROUND HOLE

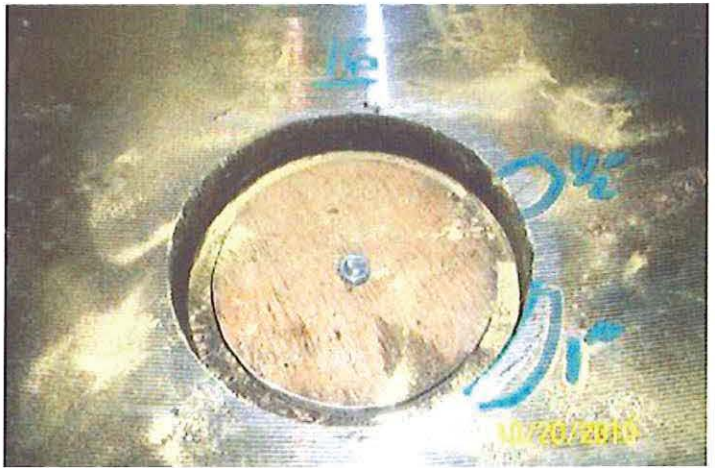
HOLE #16 WITH 1/2" & 1" LINEAR INDICATION AROUND HOLE

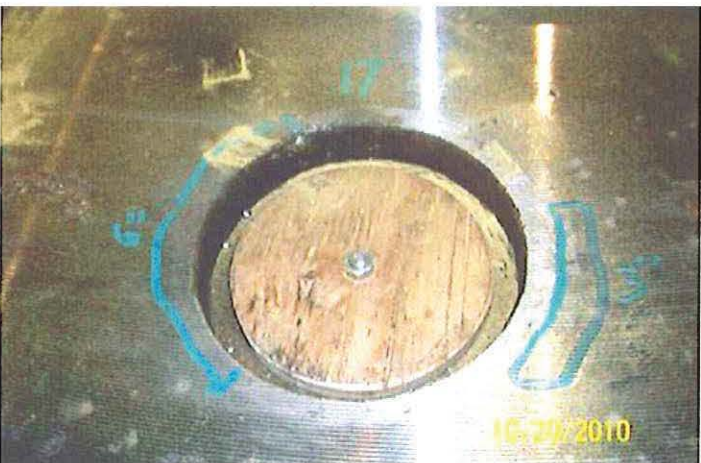
HOLE #17 WITH 6" & 3" LINEAR INDICATION AROUND HOLE

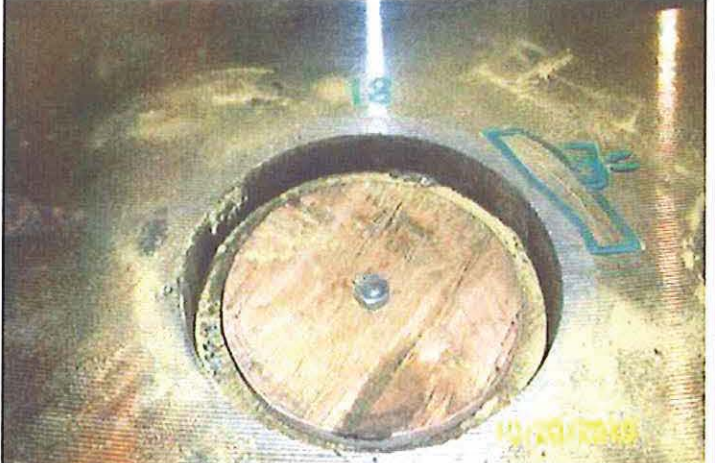
HOLE #18 WITH 3" LINEAR INDICATION AROUND HOLE

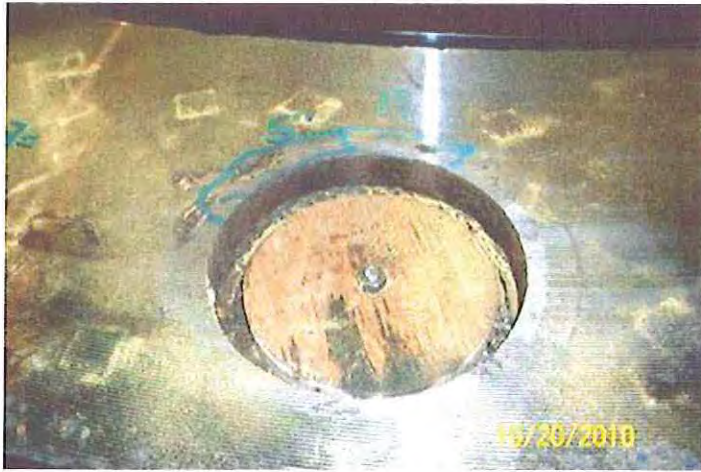
HOLE #19 WITH 5" LINEAR INDICATION AROUND HOLE

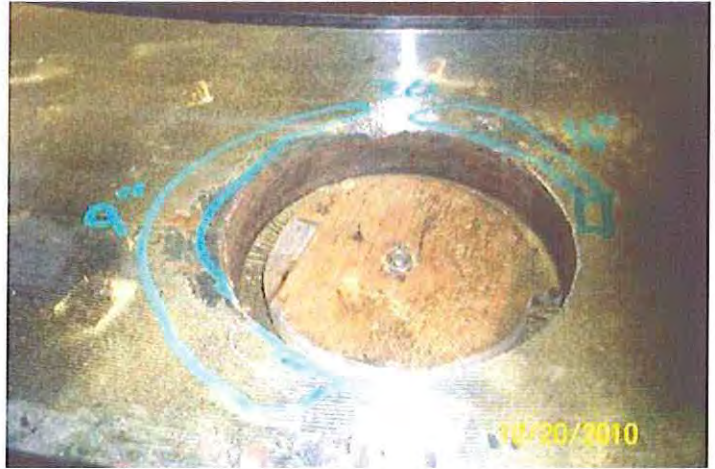
HOLE #19 WITH 9" & 4" LINEAR INDICATION AROUND HOLE

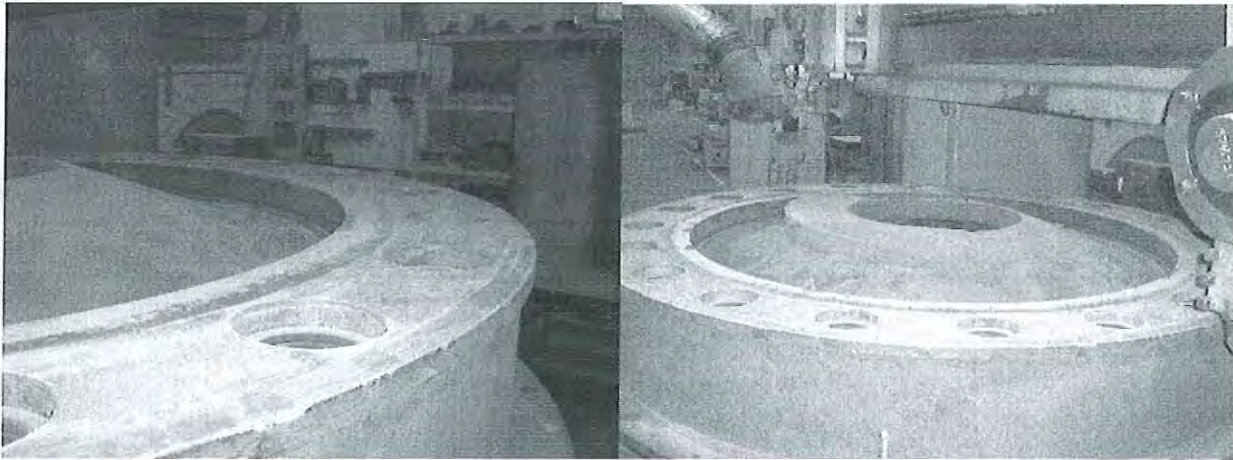
MACHINE SHOP INSPECTION REPORT		REPORT NUMBER: 7491 - 3
CUSTOMER NS POWER	DISCRIPTION. Weymouth #1 Head cover	
WORK ORDER No. 441281001	ST No.	CUSTOMER DWN No. 520-138 F

BELZONA ON TOP SURFACE WAS MACHINED AS PER FIG 1
 HEIGHT 14.865" – ACTUAL MACHINED DIMENSION WAS 14.865" / 14.871"
 ANGLES & STEPS AS PER FIG 1
 NO MACHINING WAS REQUIRED ON THE INSIDE DIAMETER AS IT WAS OVERSIZE &
 MEASURED 74.958" / 74.965"

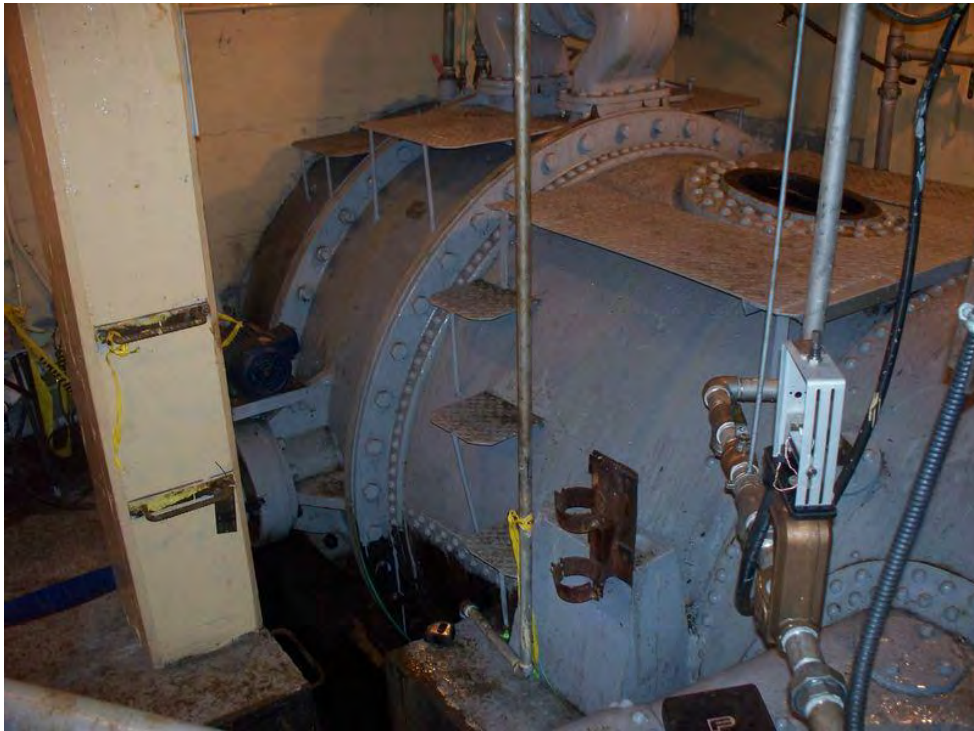
3285

Unit 3 penstock, butterfly valve to scroll

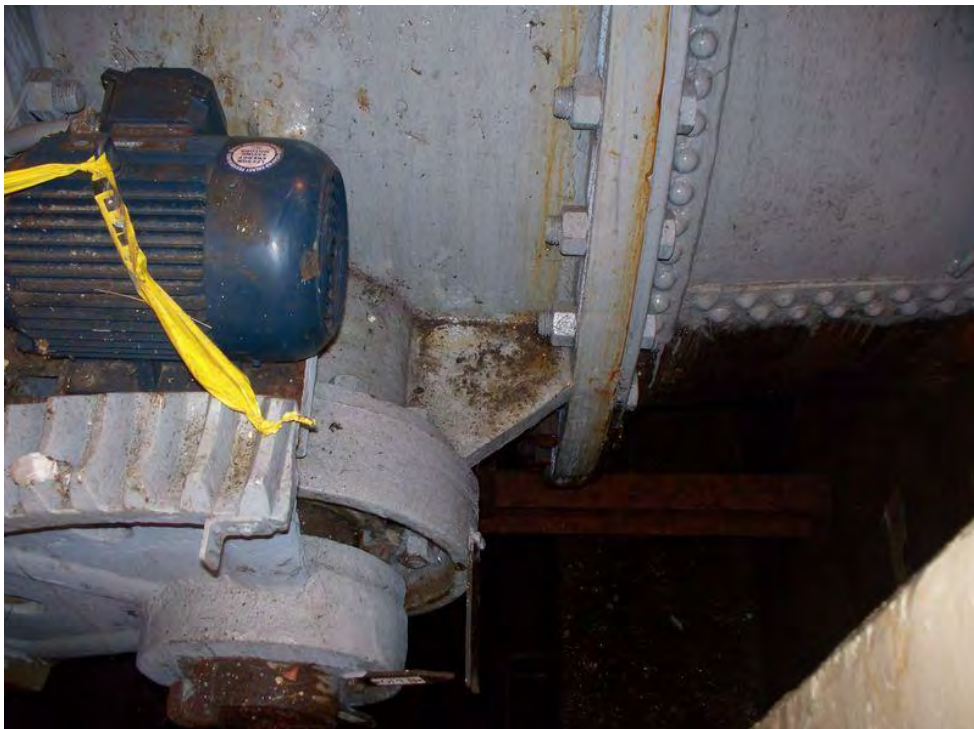
3289

Control side of butterfly valve – cracks noted at gusset/stiffener to upstream and downstream flange, both sides, 4 areas in total

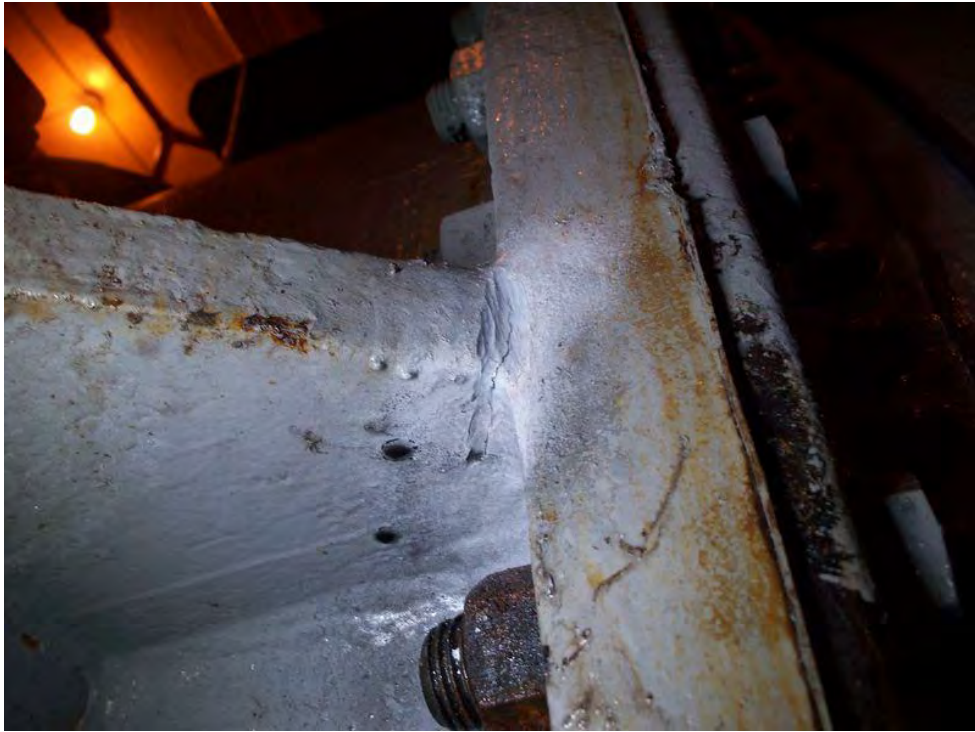
3291

Close-up of crack (MPI) indication in area of photo 3289

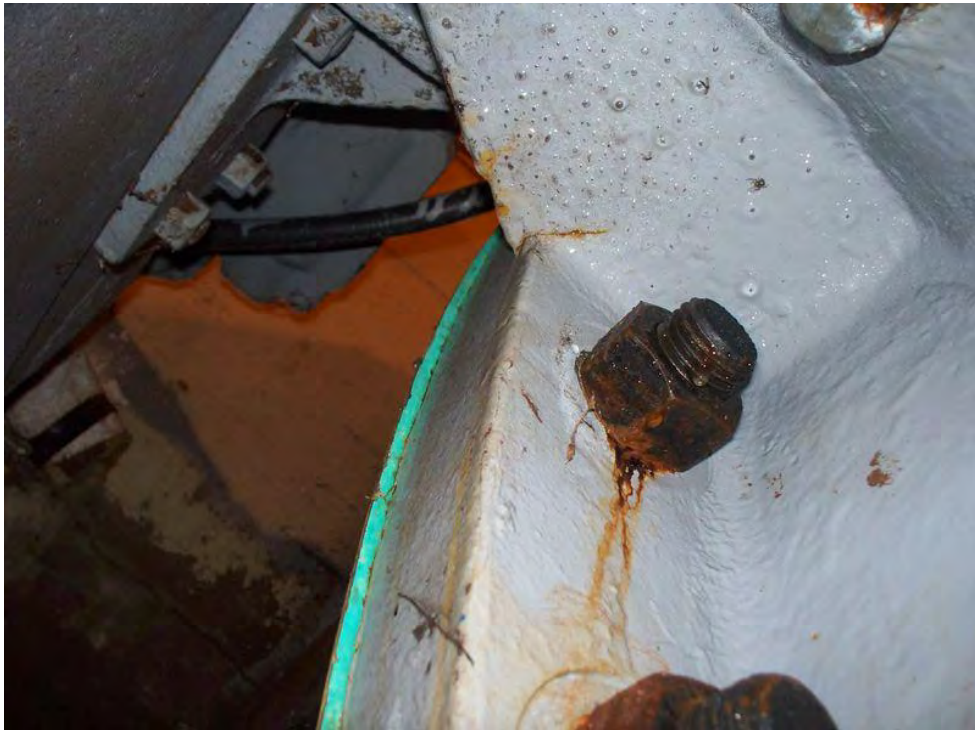
3274

Crack through coating in area opposite flange (from area above in photo 3291)

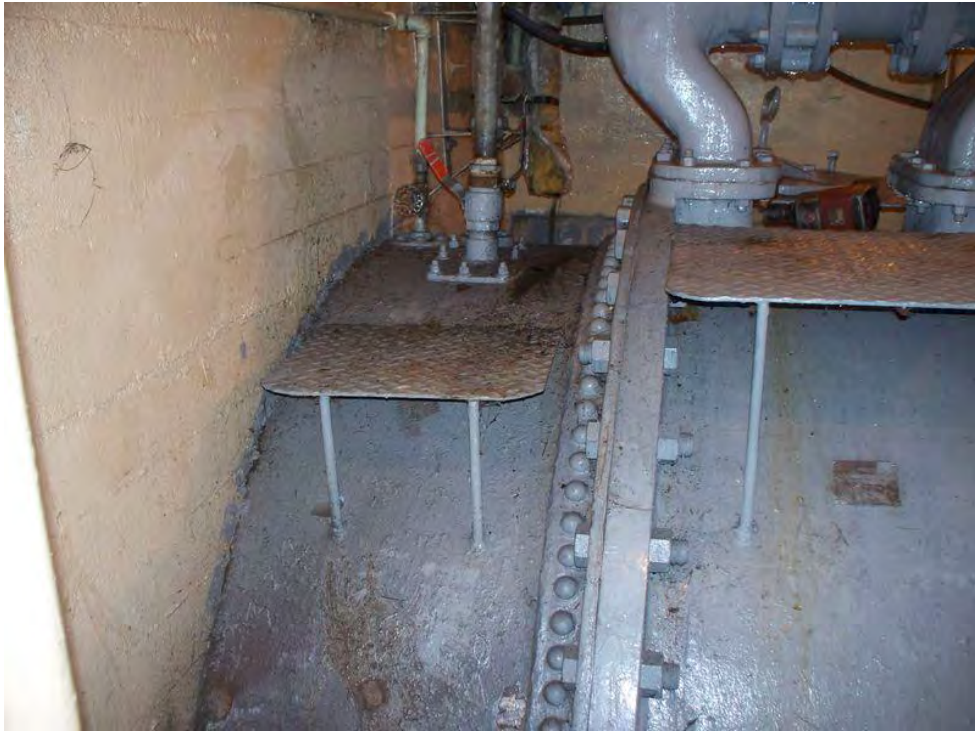
3287

Penstock at concrete wall top side

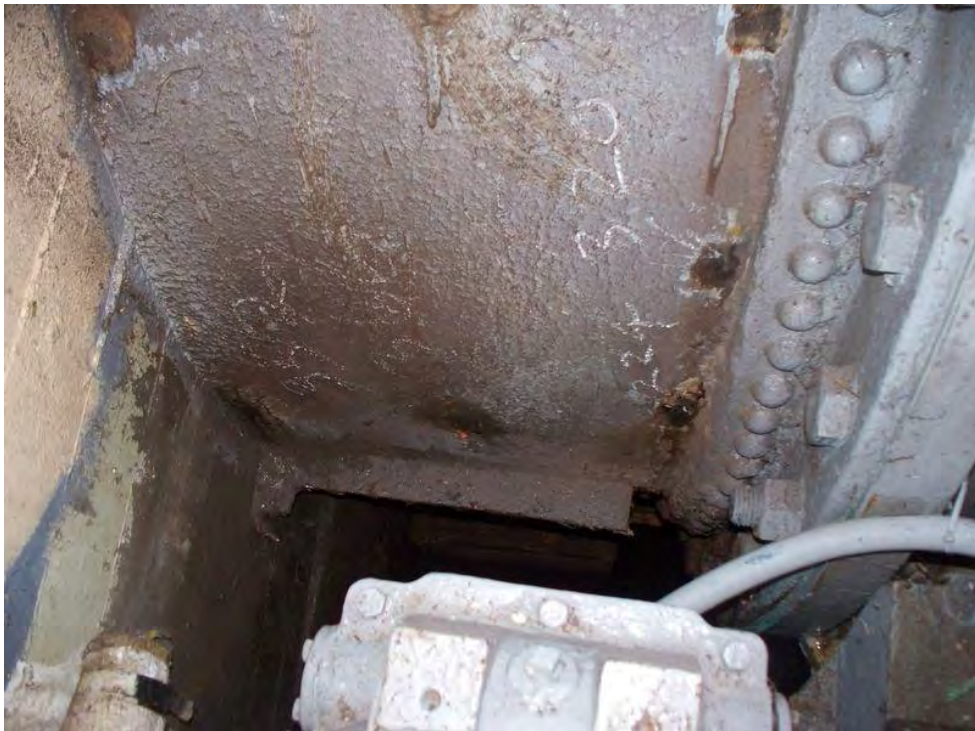
3288

As above, side view, corrosion noted at lower areas per report info

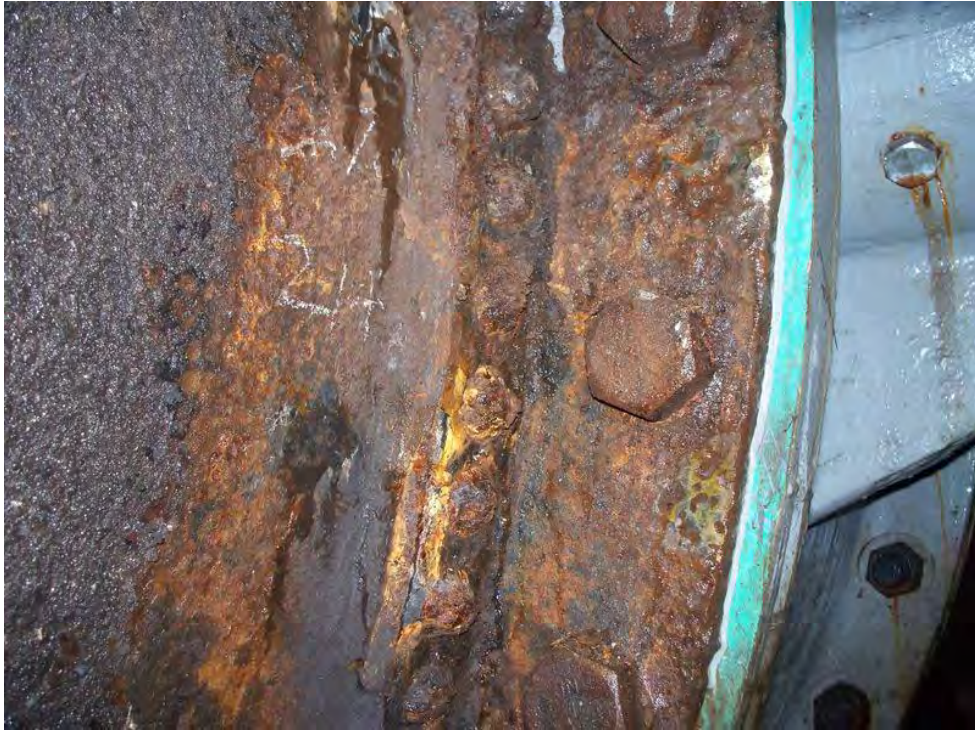
3275

General corrosion just below area viewed in photo 3288. Flange and penstock corroded significantly

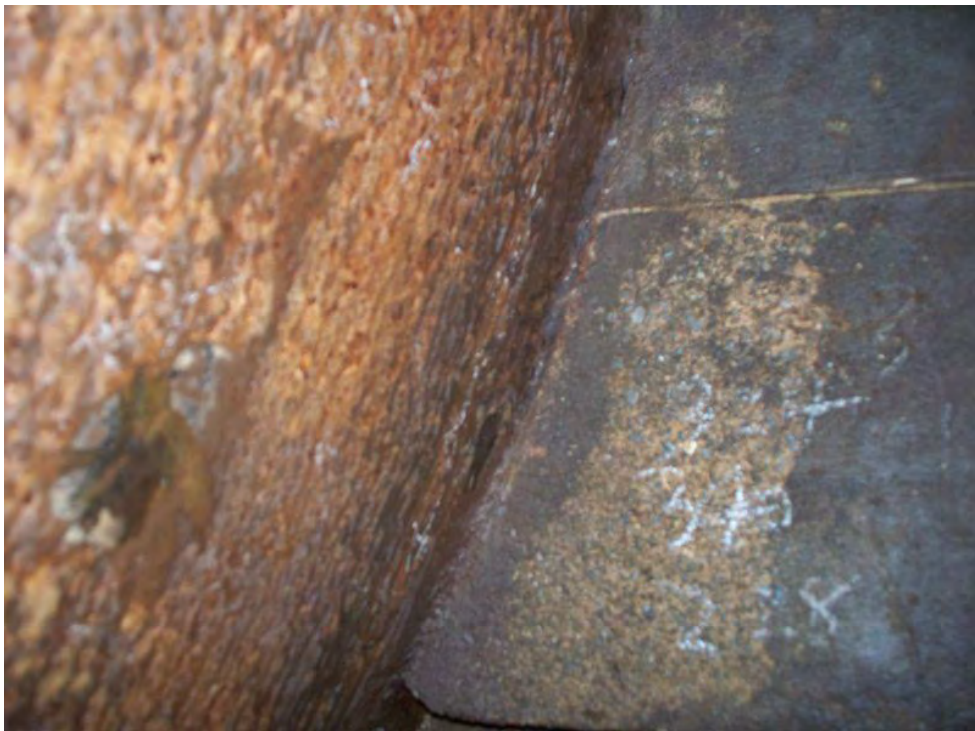
3279

Penstock opposite side at concrete wall – significant corrosion noted

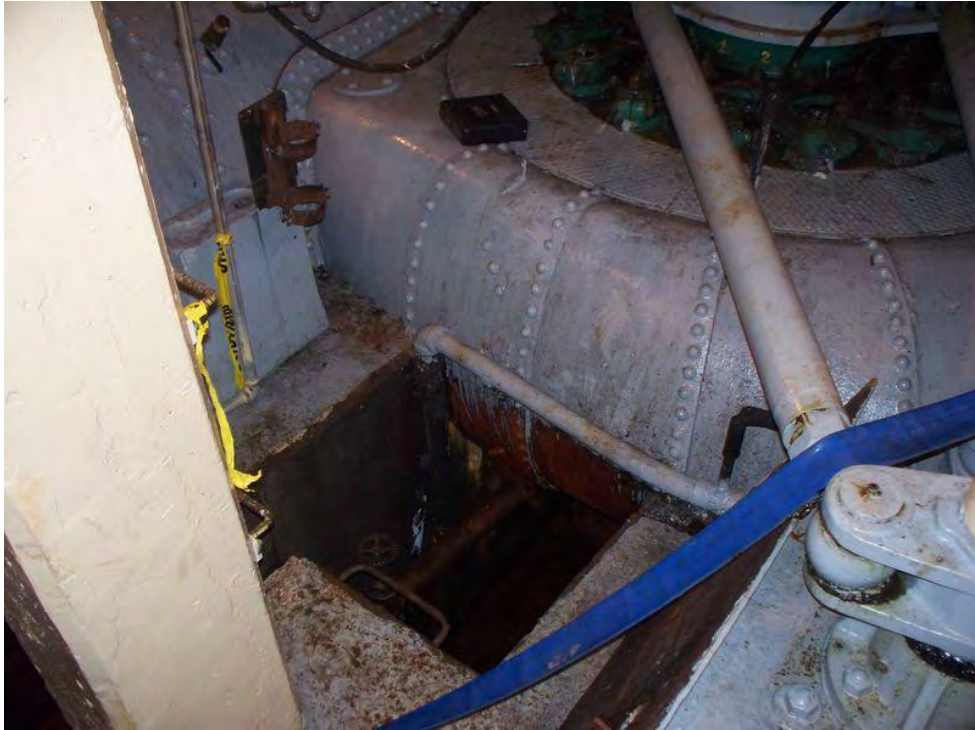
3284

Scroll case – draft tube access area

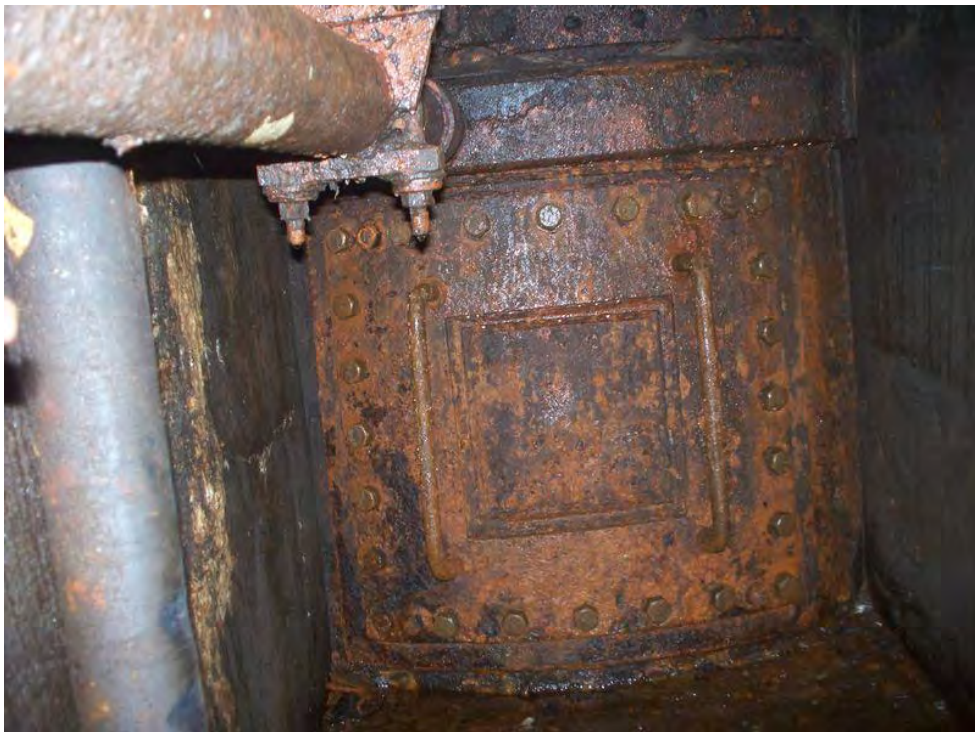
3282

Draft tube access hatch, general surface corrosion noted

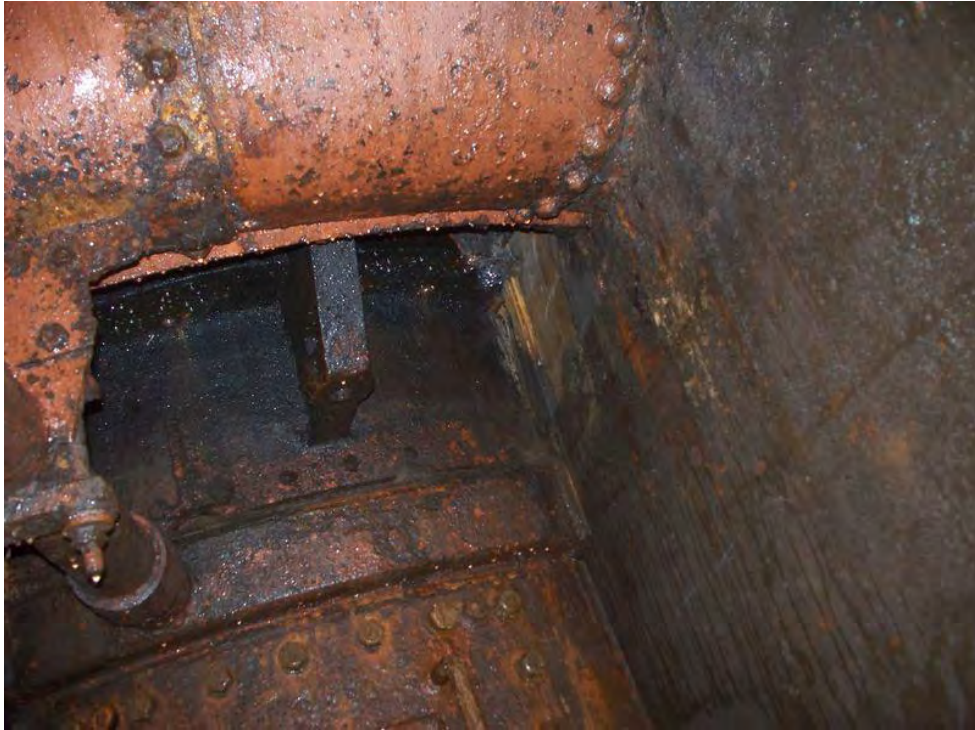
3283

View upward from hatch – note 5 rivets missing at joint above hatch

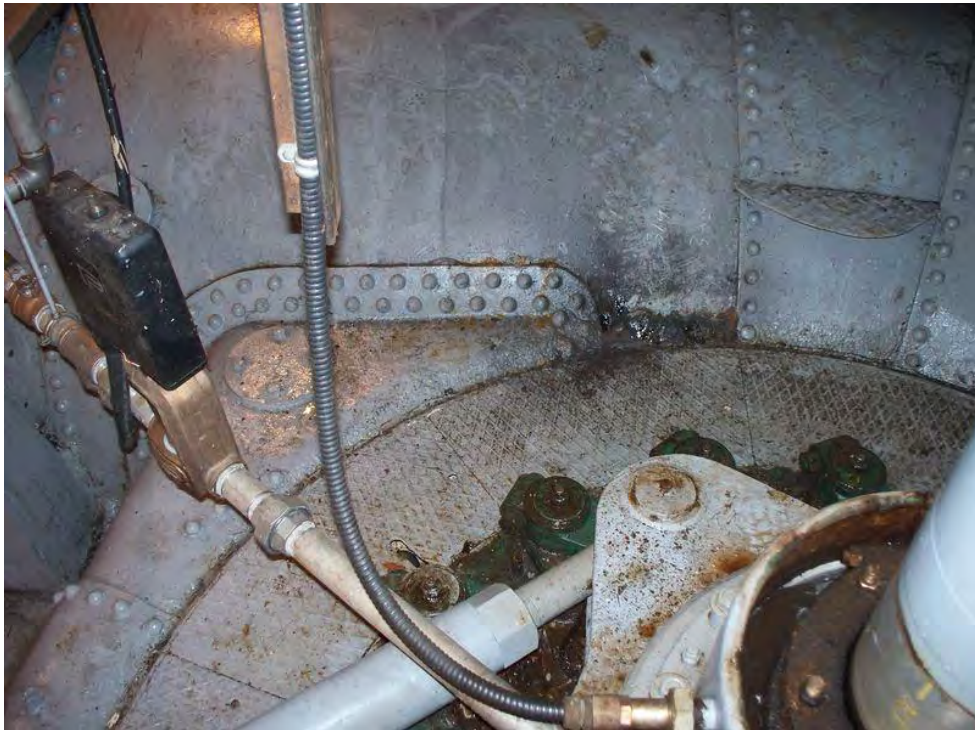
3294

Top side view of scroll – good general condition, minor corrosion/pitting at edge of checker plate on scroll

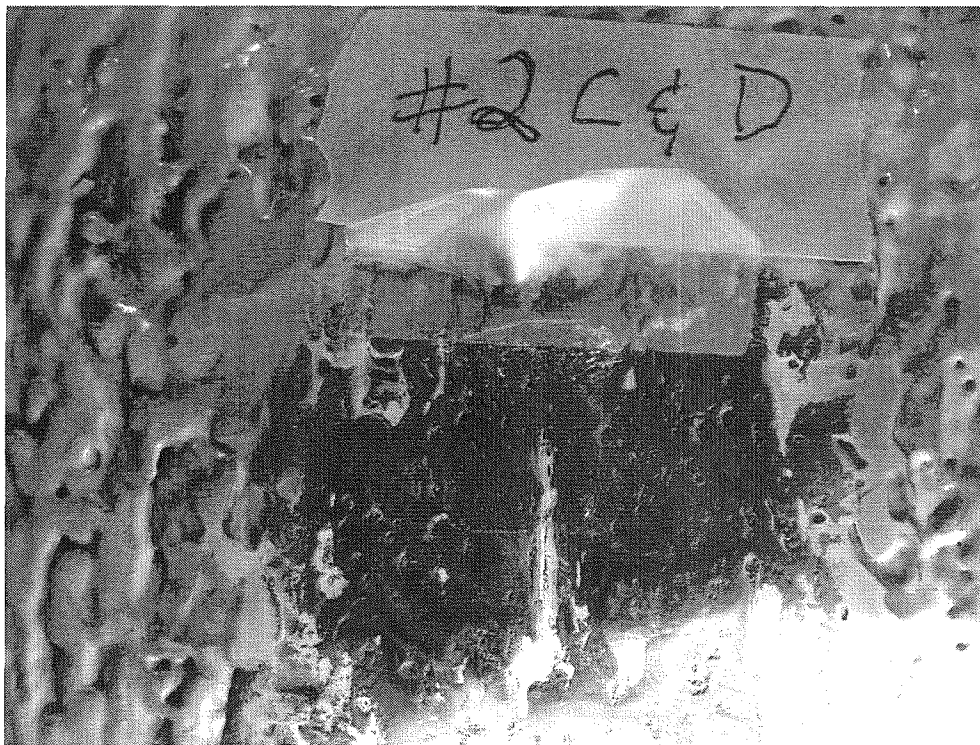
Figure 2– Photograph of the area on Valve 2 shown in Figure 1 after polishing

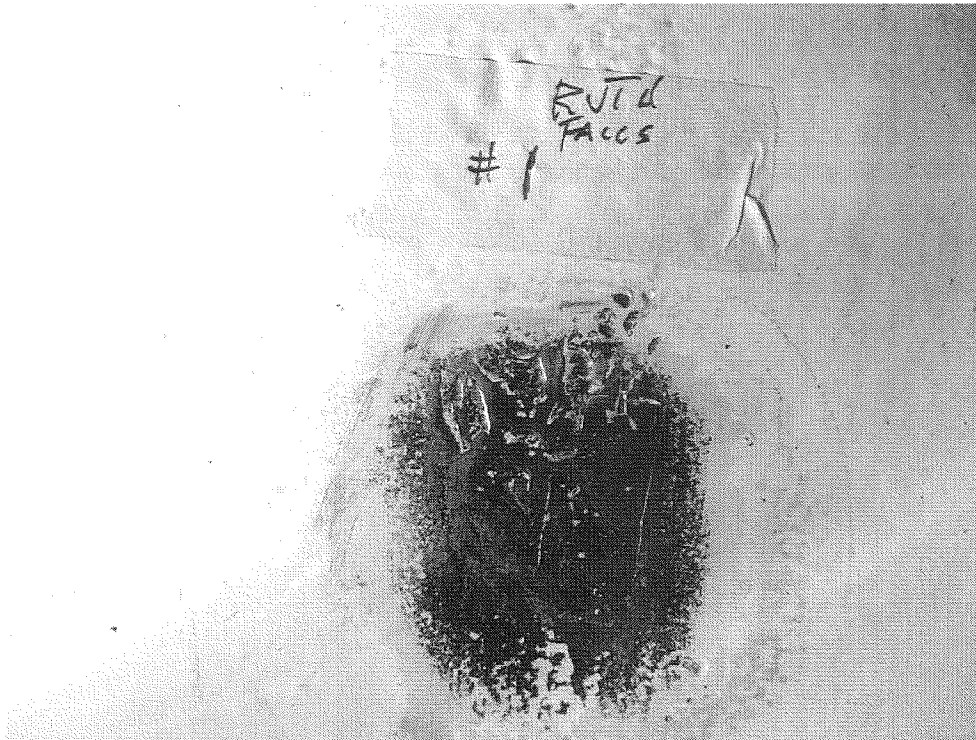
Figure 7 - Photograph of the area of Valve 1 shown in Figure 3 after polishing

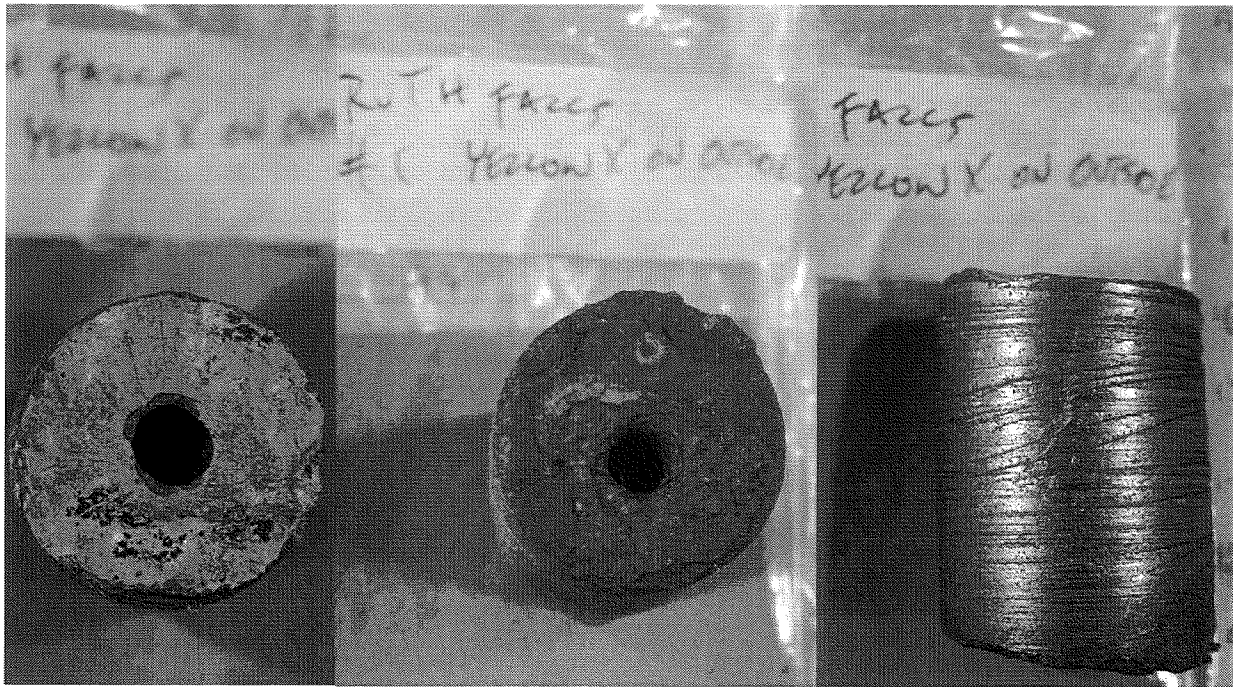
Figure 11 Photographs showing the painted side, scale side, and profile of the core sample taken from Valve 1

The “core” sample from the #1 valve butterfly shown in the composite photograph in Figure 11 was prepared for metallography and tensile testing as the #2 core previous. Upon completion of polishing the core samples were examined under the metallurgical microscope and notes were made regarding the general microstructure and the nature of the corrosion.

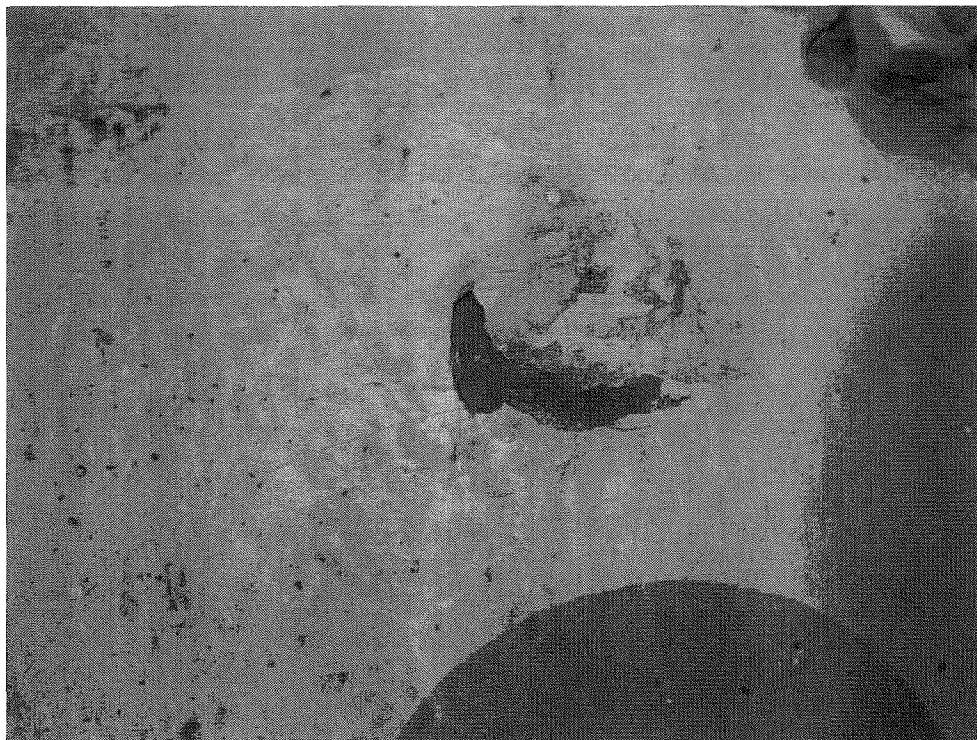
Figure 13 - Photograph showing the area of Valve 3 that was selected to be polished and have Replicas made.

The final valve inspection was on Valve #3. The site selected, and shown in Figure 13 was chosen because there was a break in the paint with what appeared to be corrosion underneath. The corrosion blister was opened at the lower portion, revealing red corrosion product. This area was ground and polished as were the previous locations from an angle grinder to 0.25 μm then etched with 9% Nital to reveal the microstructure. Figure 14 shows the site on Valve #3 prepared for Replication. The microstructure apparent in the replica from the #3 Valve Body was not easily discernible. In fact, no graphite was identified in the microstructure as seen in Figure 15. There appears to be a script-like cementite phase that is similar to unresolved pearlite. At this point it is

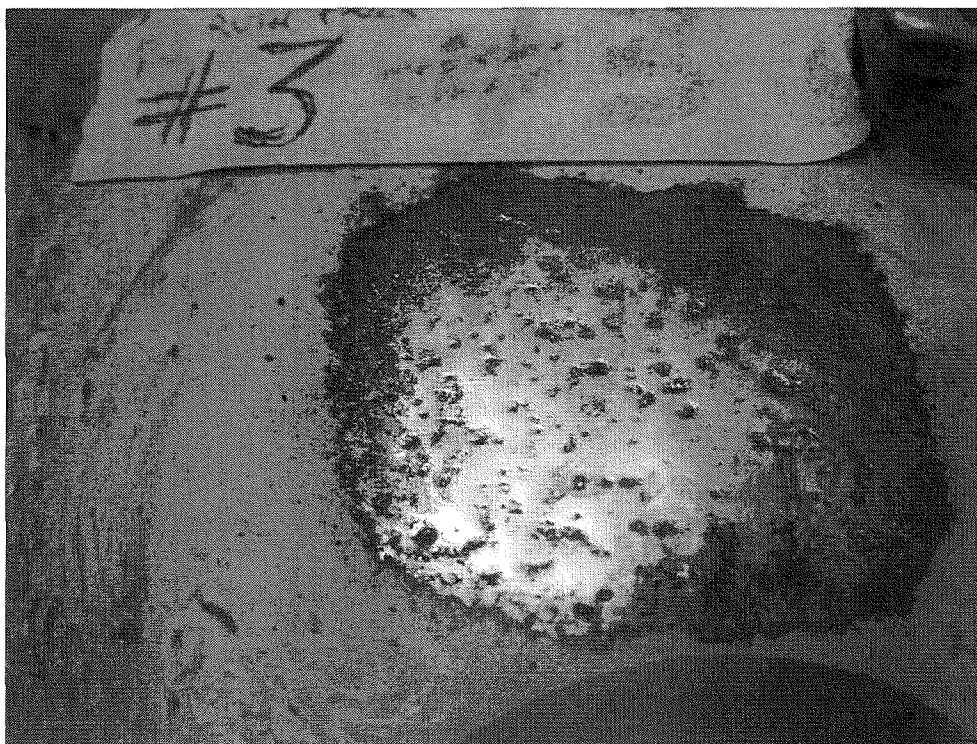
Figure 14 - Photograph of the area on Valve 3 shown in Figure 5 after polishing

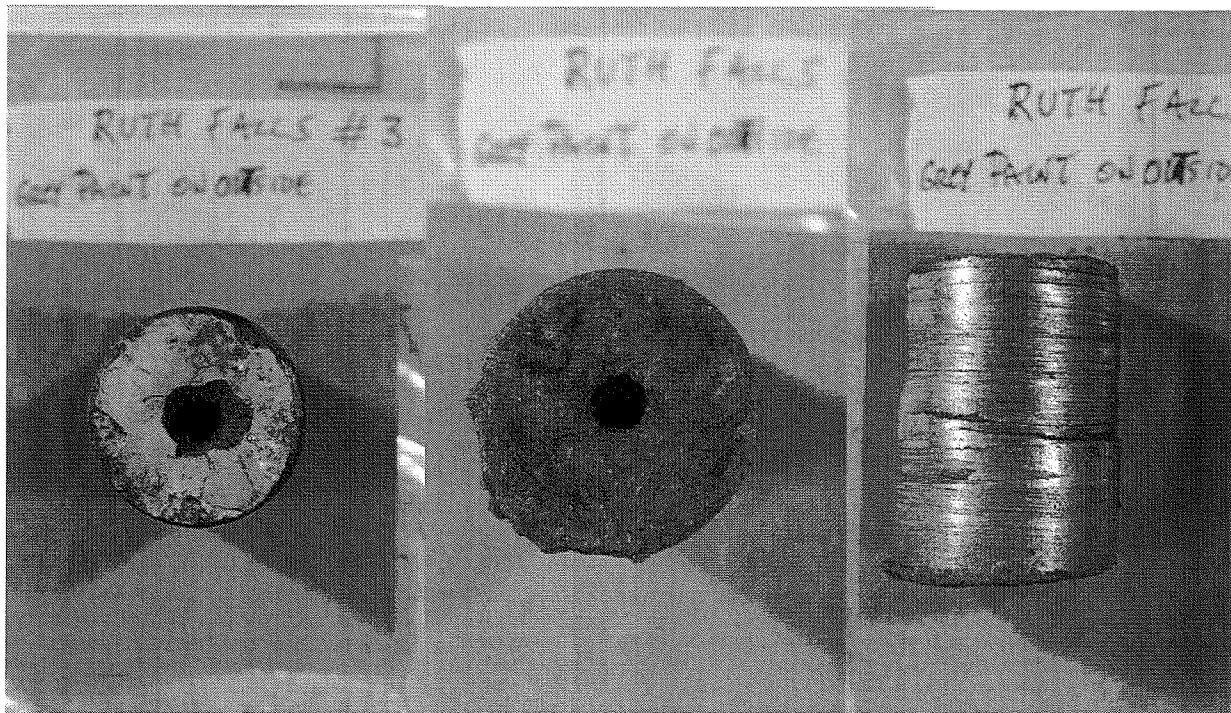
Figure 16 - Photographs showing the painted side, scale side, and profile of the core sample taken from Valve 3

The “core” sample from the #3 Valve Butterfly shown in the composite photograph in Figure 16 was prepared for metallography. As with previous samples a longitudinal section of this core sample was ground and polished in stages starting with 120 grit, and finishing with 0.05 µm alumina powder. The microstructure of the Butterfly material is shown in Figure 17. The graphite flakes evident in the microstructure are as expected for a cast iron, similar to that seen in the #1 and #2 Butterflies. The matrix material was pearlitic with Type A graphite flake morphology and a flake size for the majority of 2-7 and a maximum flake size of 1-2. This flake size appears to be quite large. As with the #1 Butterfly it was noted that the flake size was relatively smaller at the surfaces and at mid thickness randomly distributed flakes tended to be larger.

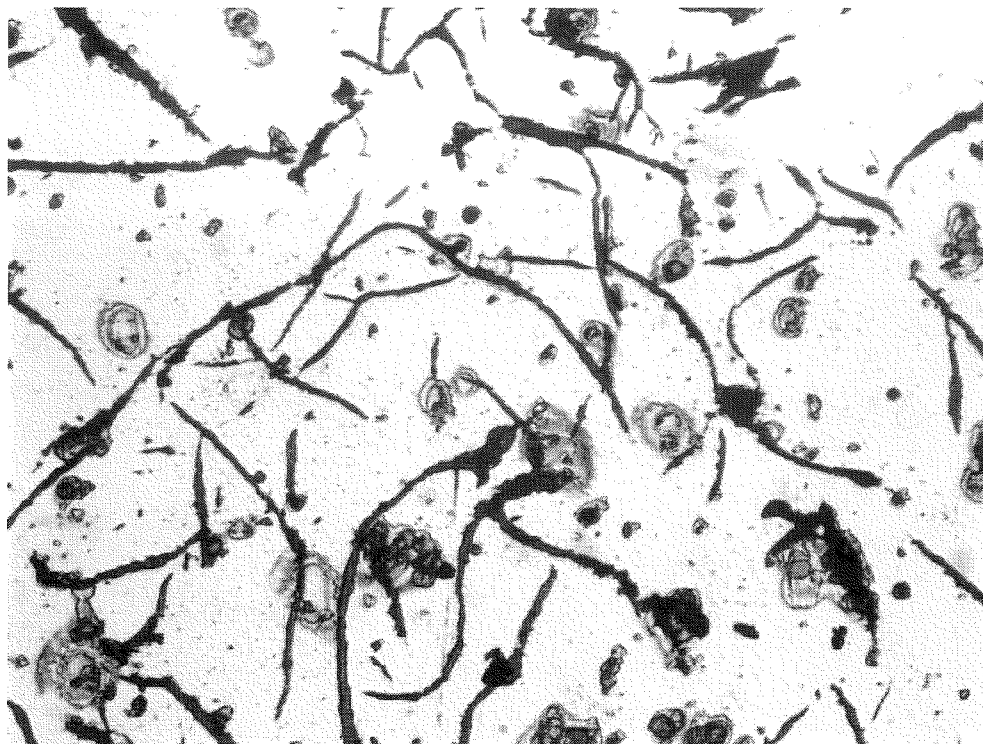
Figure 17 Micrograph of the Core Sample from Ruth Falls #3 Valve Butterfly. 100X

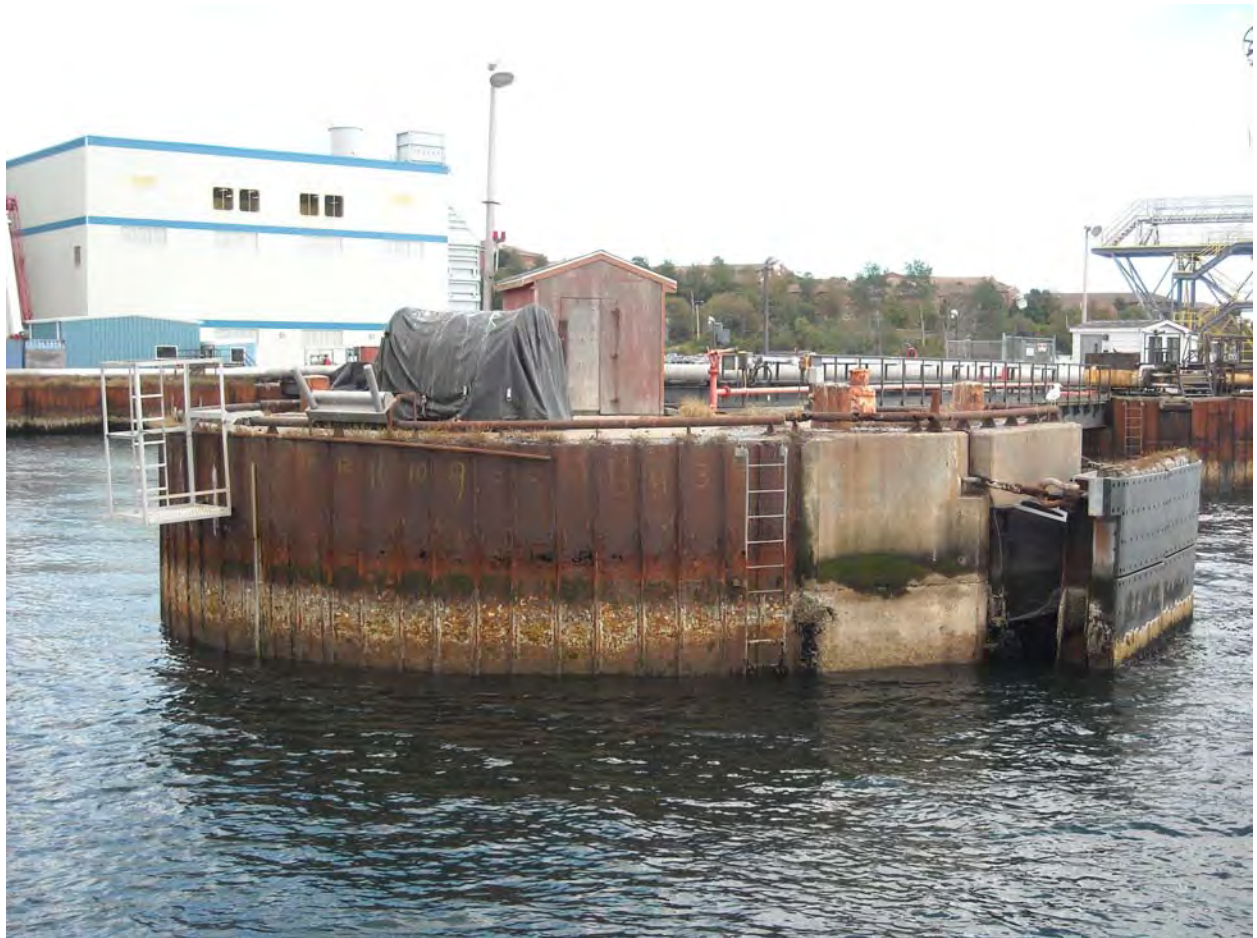
Typical SSP Condition in Tidal Zone
Picture Taken at Low Tide

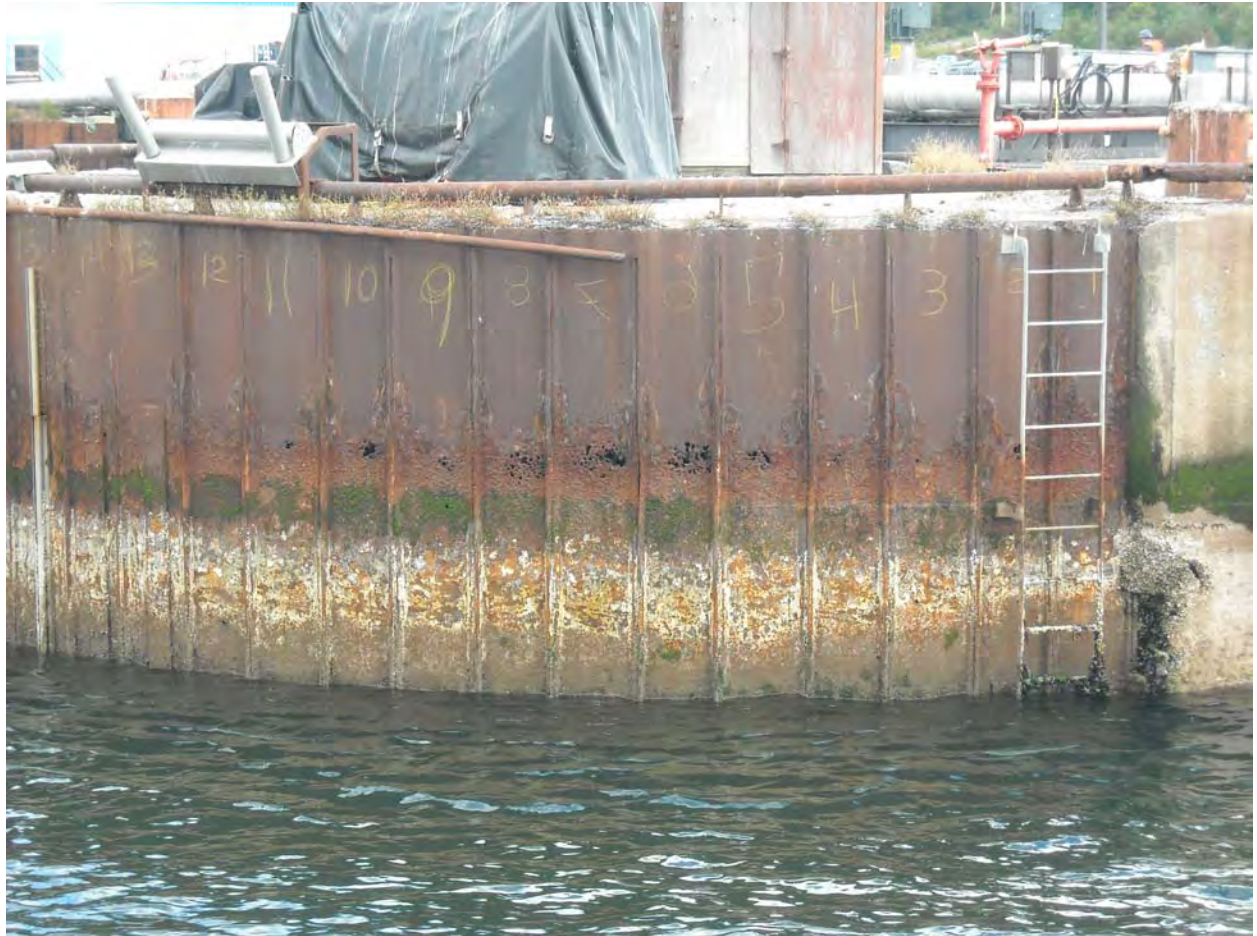
Typical SSP Condition in Tidal Zone
Picture Taken at Low Tide (North Cell)
