IN THE MATTER OF an Application by Nova Scotia Power Inc. for
Approval of the **2013 Annual Capital Expenditure (ACE) Plan**

2013 ACE Plan

2013 Annual Capital Expenditure Plan

Weymouth Surge Tank Inspection

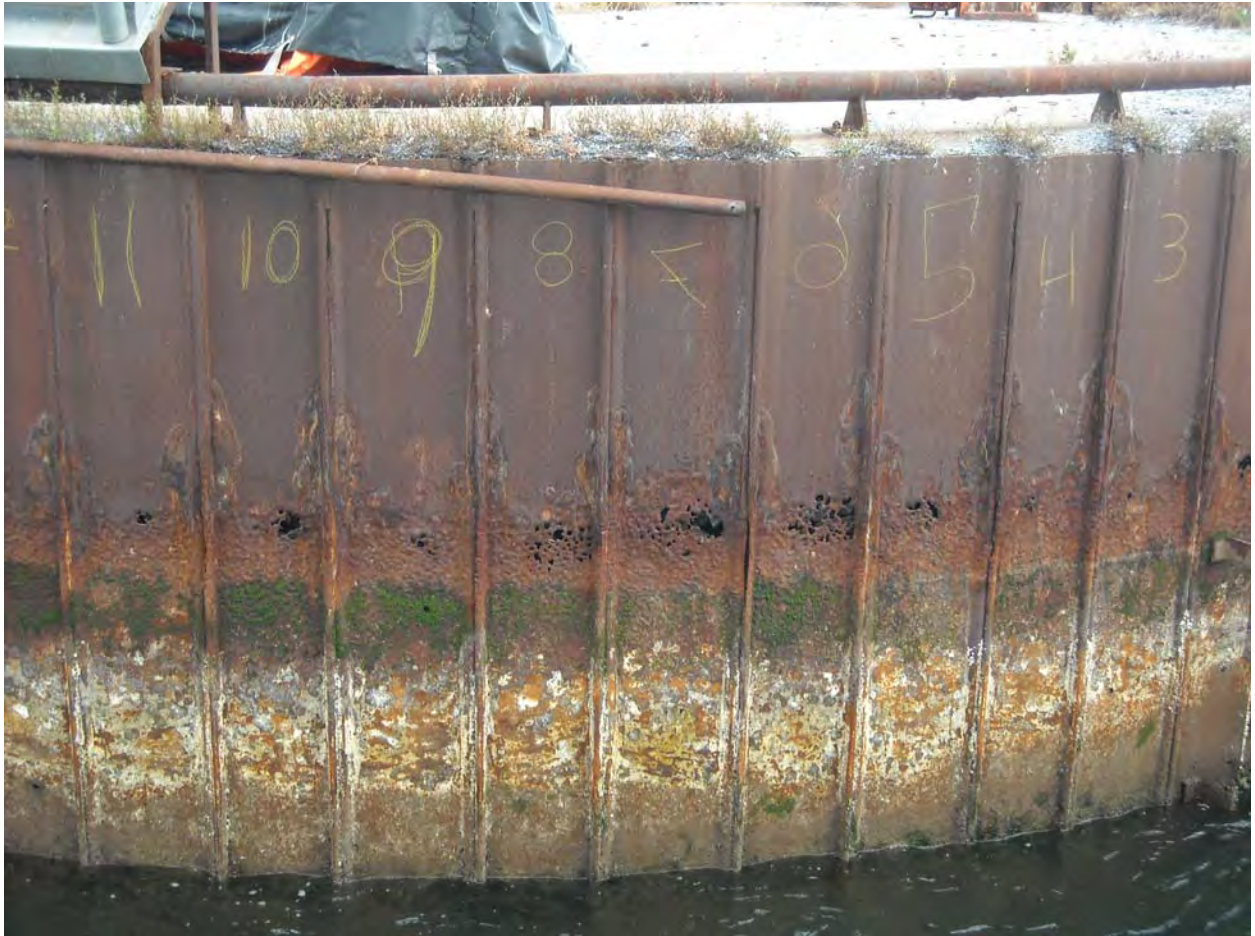
Typical SSP Condition in Tidal Zone
Picture Taken at Low Tide

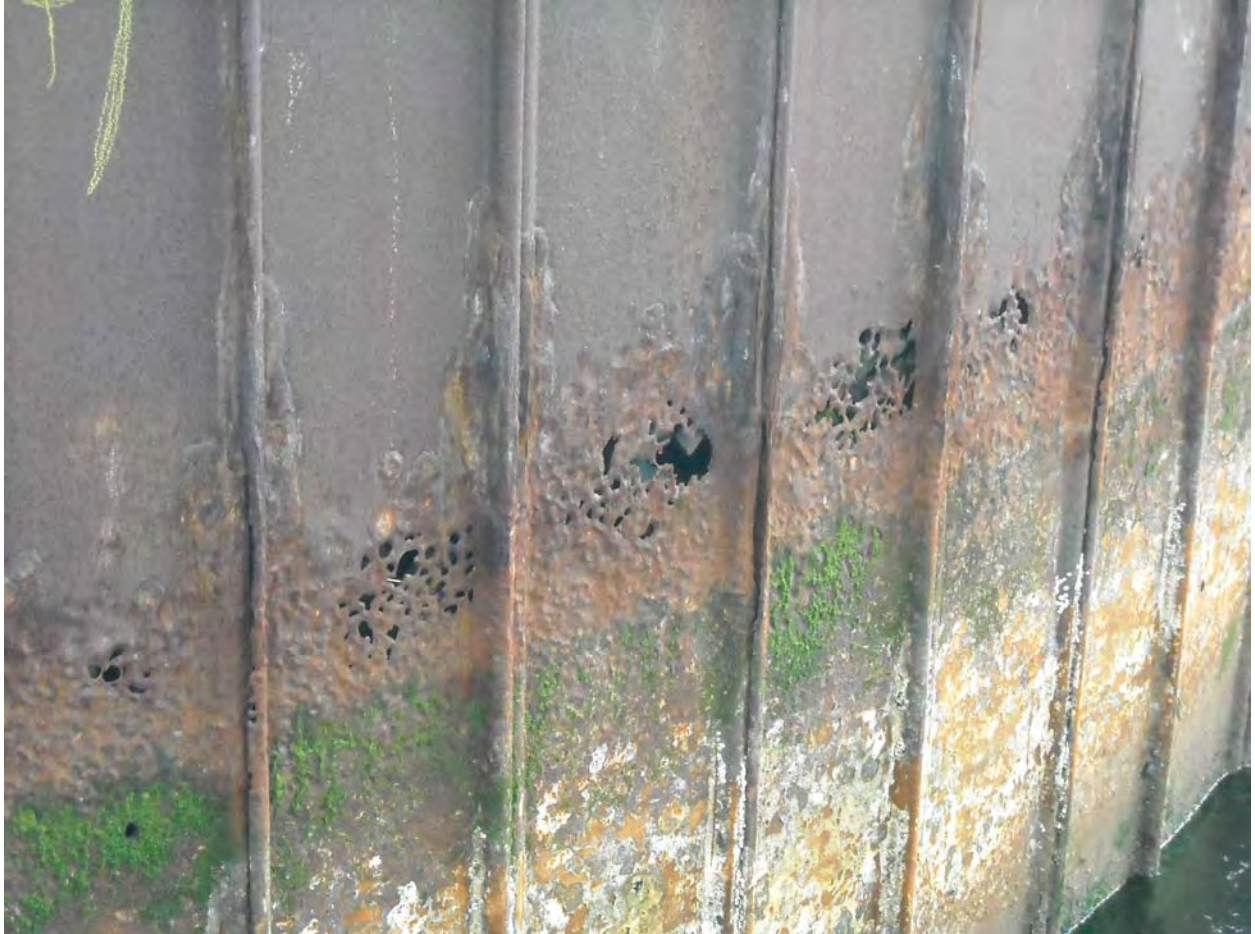
Typical SSP Condition in Tidal Zone
Picture Taken at Low Tide

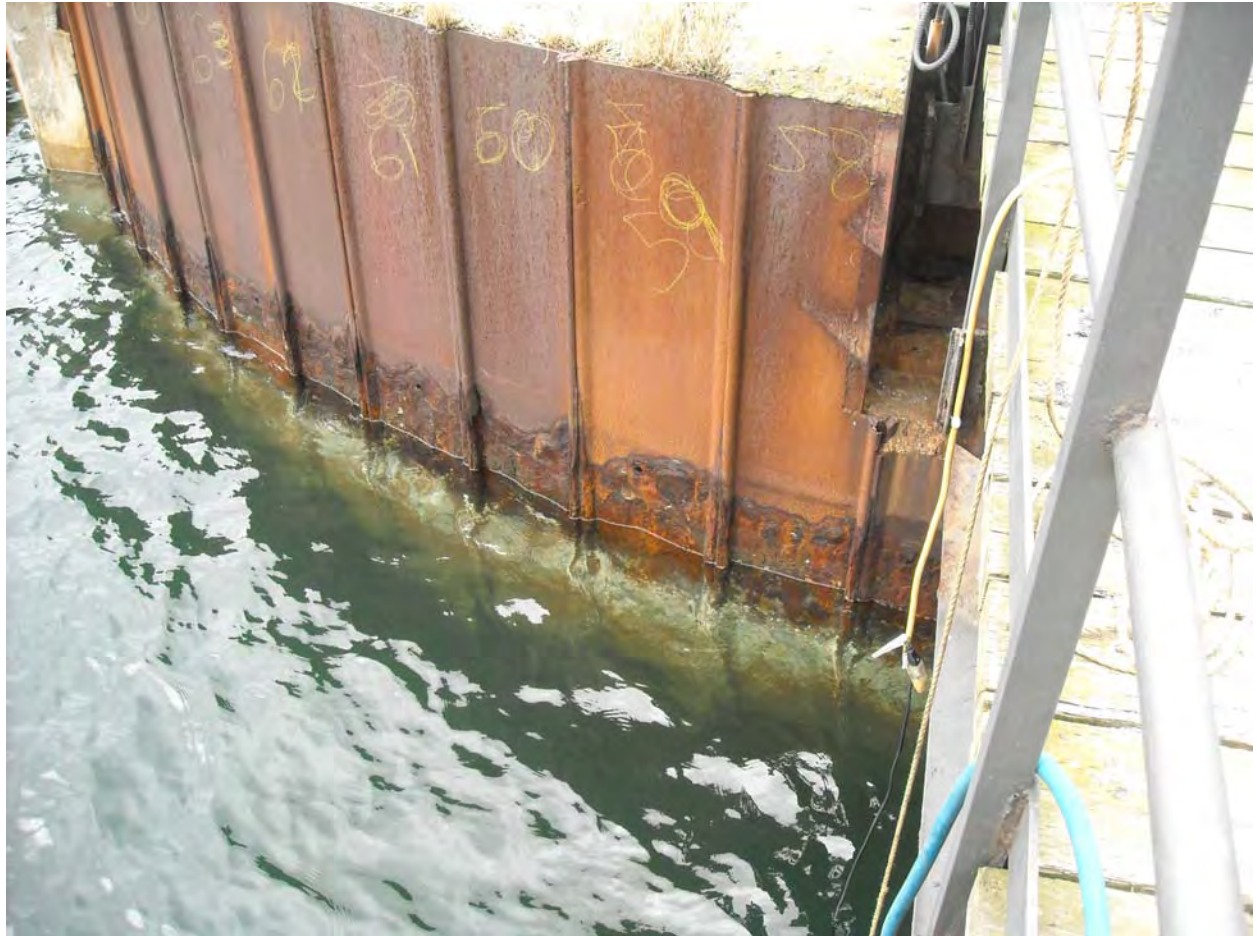
Typical SSP Condition in Tidal Zone
Picture Taken at Low Tide

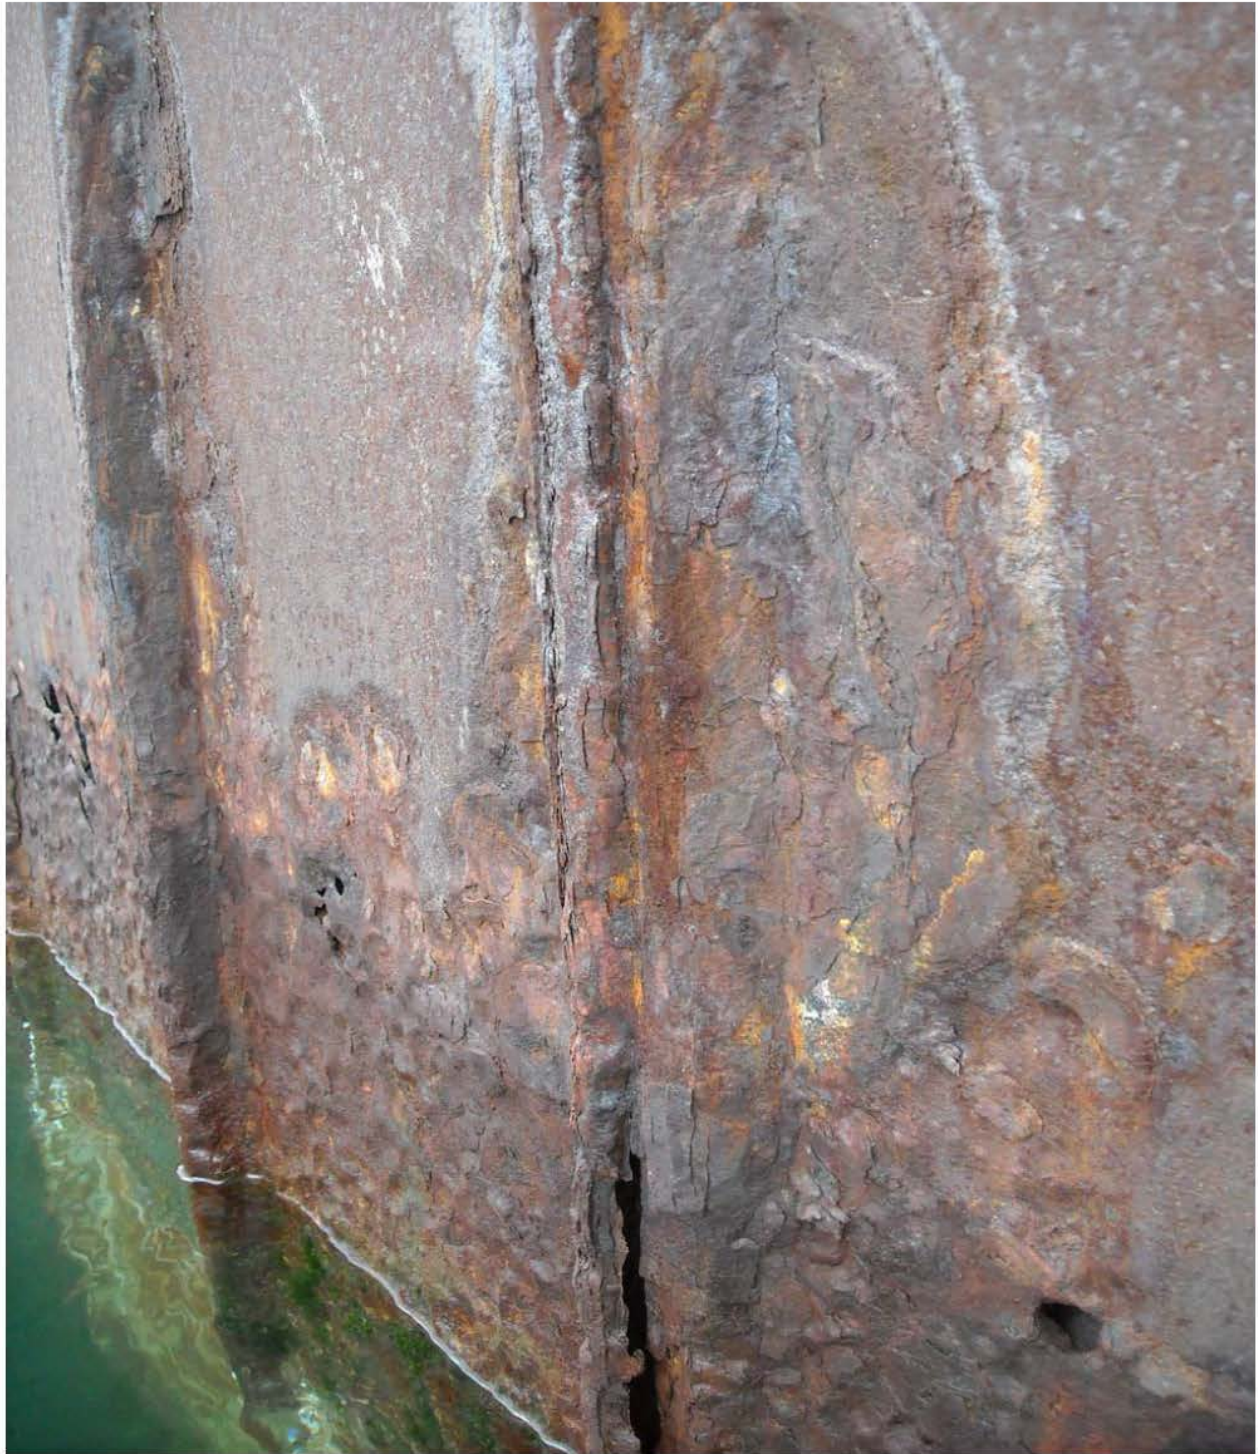
SSP Knuckles in Poor Condition (Open)

Picture Taken at Low Tide

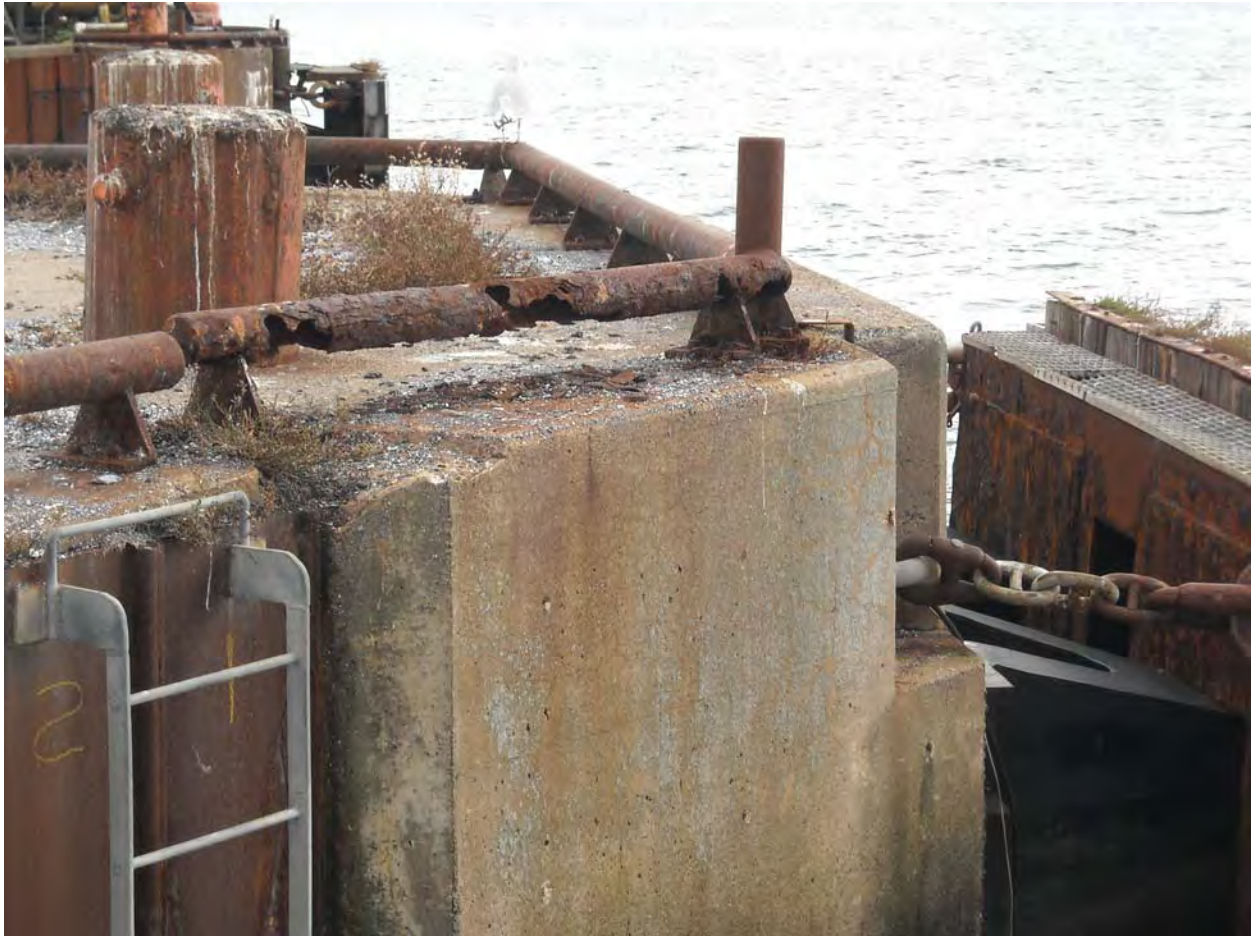
Safety Rail in Poor Condition

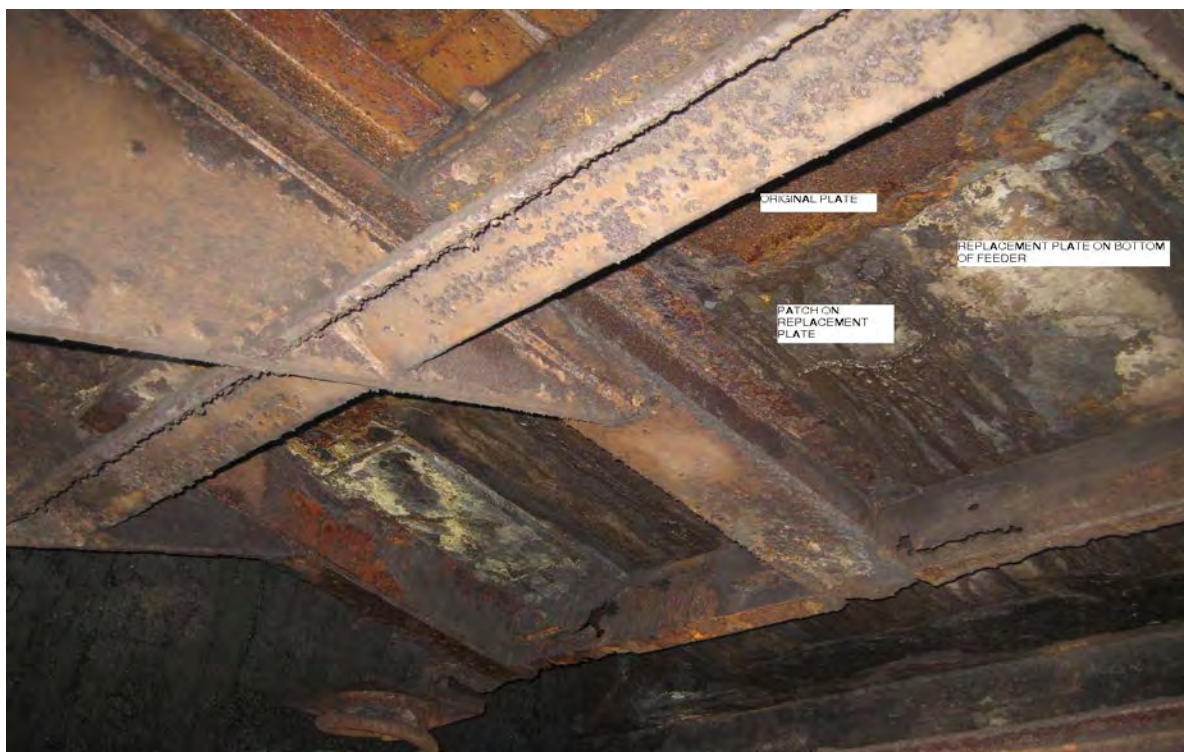
SUBJECT: RECLAIM FEEDER 1A Evaluation:

The vibrating feeder used on the Coal Reclaim 1A was supplied by Stephens-Adamson, and is the oldest feeder, in the coal reclaim system. It has been repaired and replanted numerous times, with patches literally being put on patches. The following pictures illustrate the poor condition.

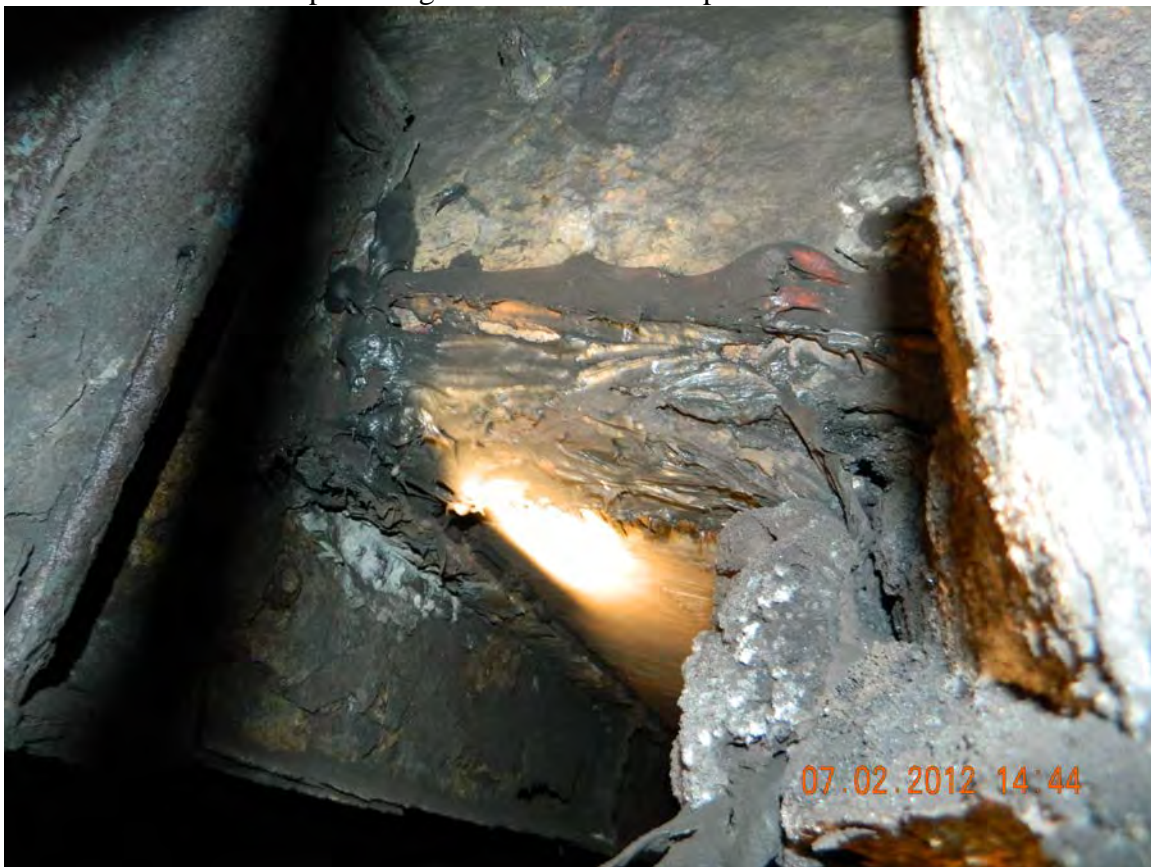
A new crack has developed along the side of the main pan

and has been temporarily sealed with caulking (above photo).

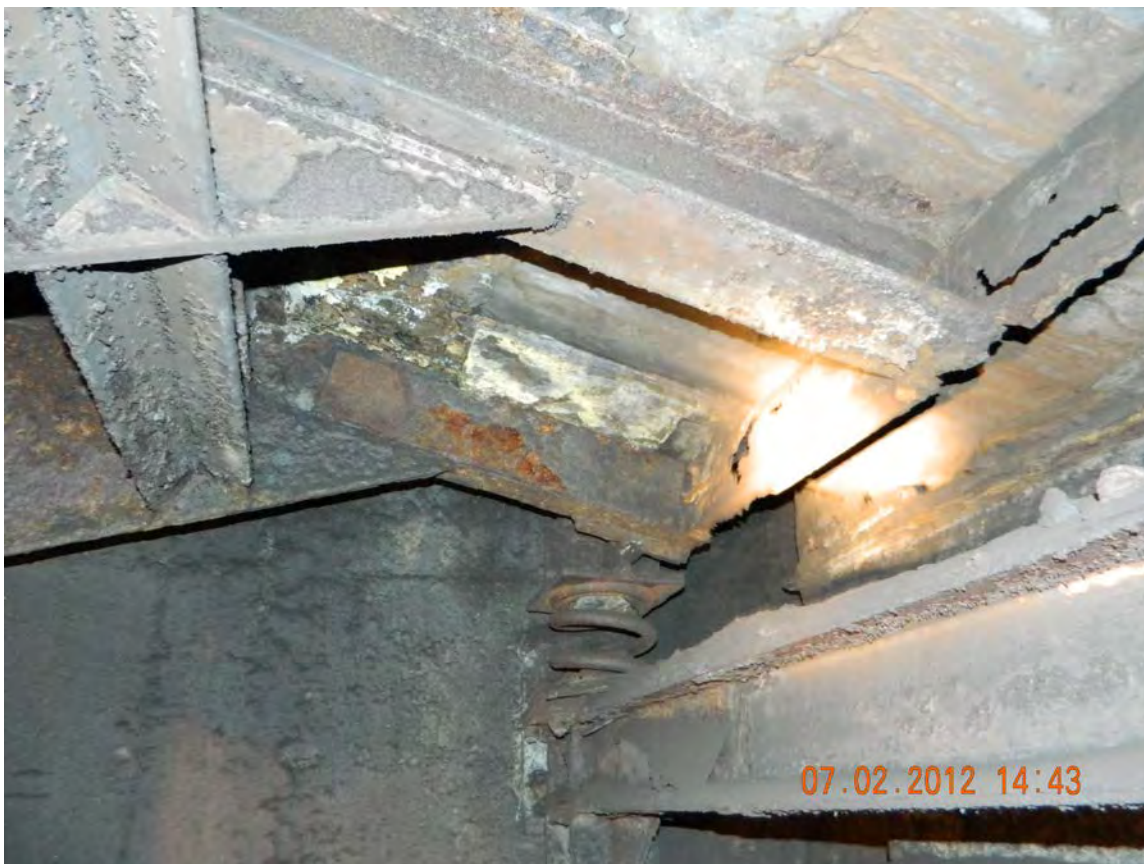
Most of the structural X-bracing and framing has deteriorated, (see below)

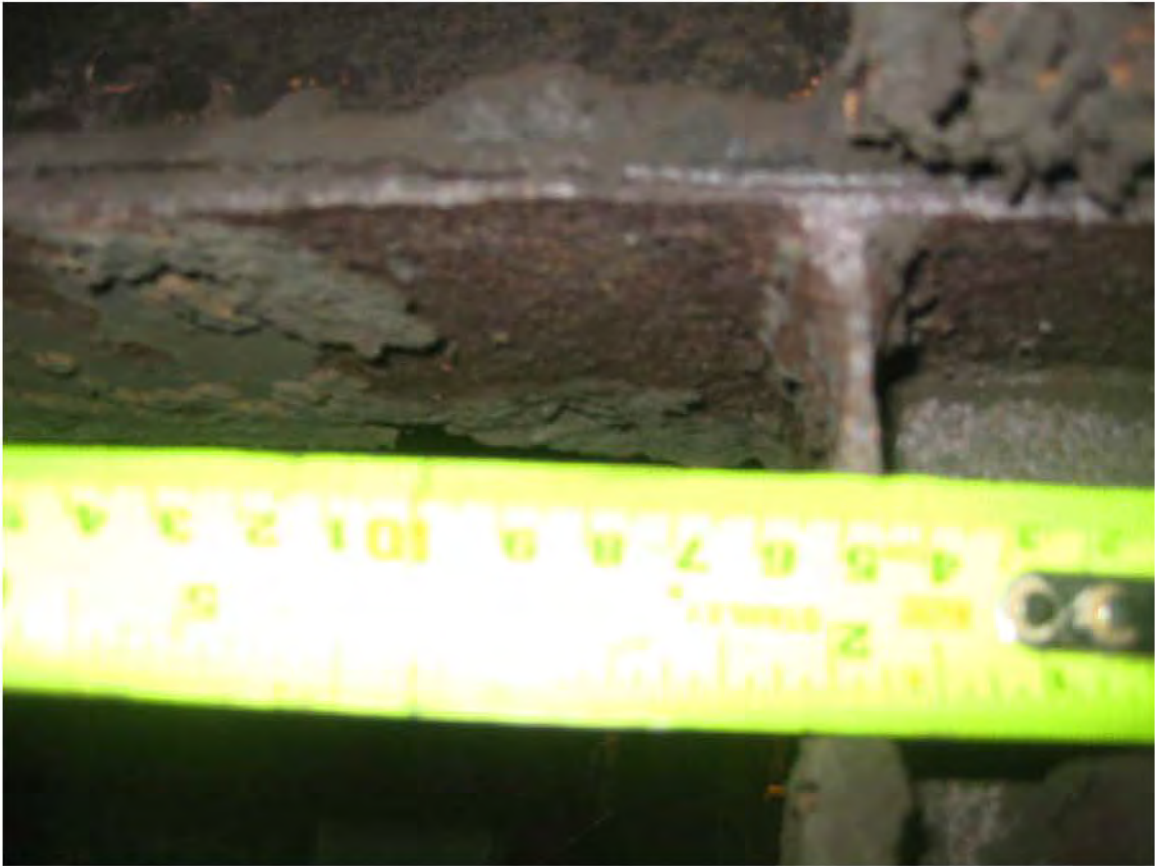
And the underlying support frame has been patched, welded and re-welded.
(see in the following photo the structural support leg has deteriorated from an original thickness of 5 mm to about 2 mm)

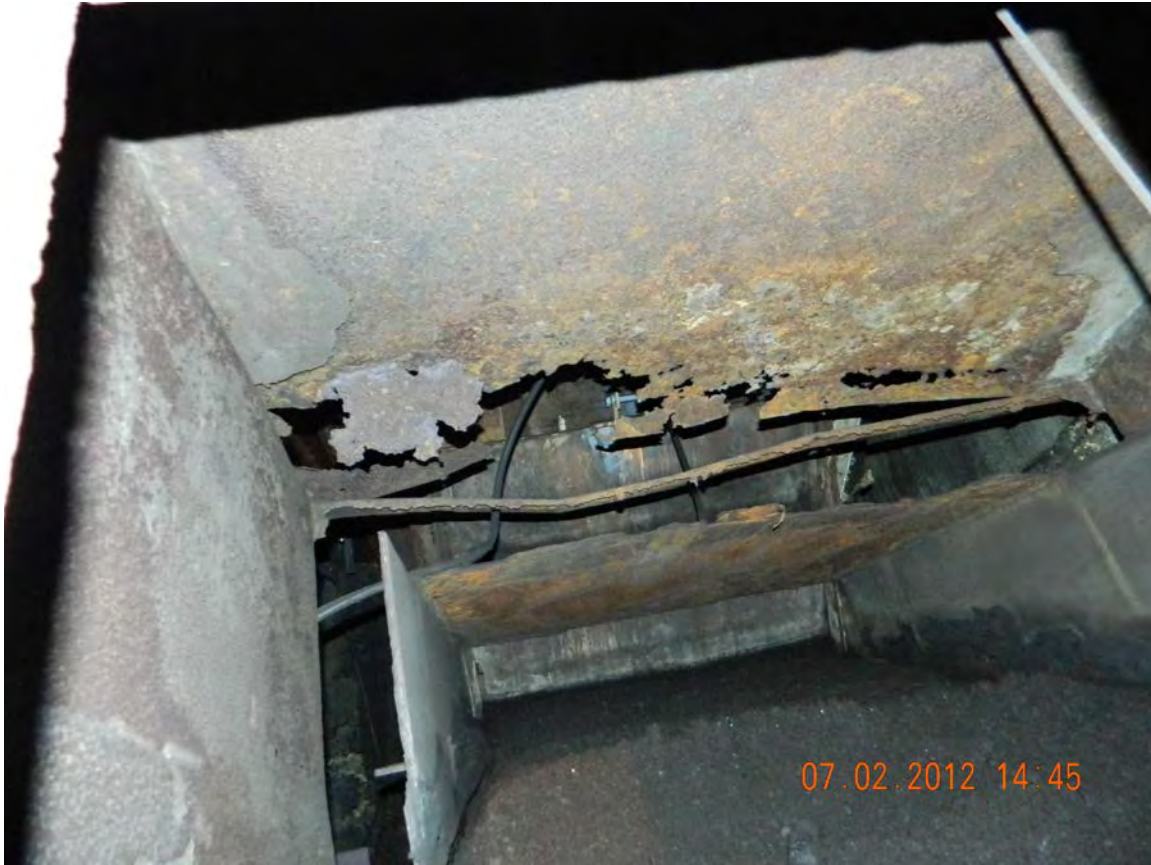
The following shows more metal deterioration.

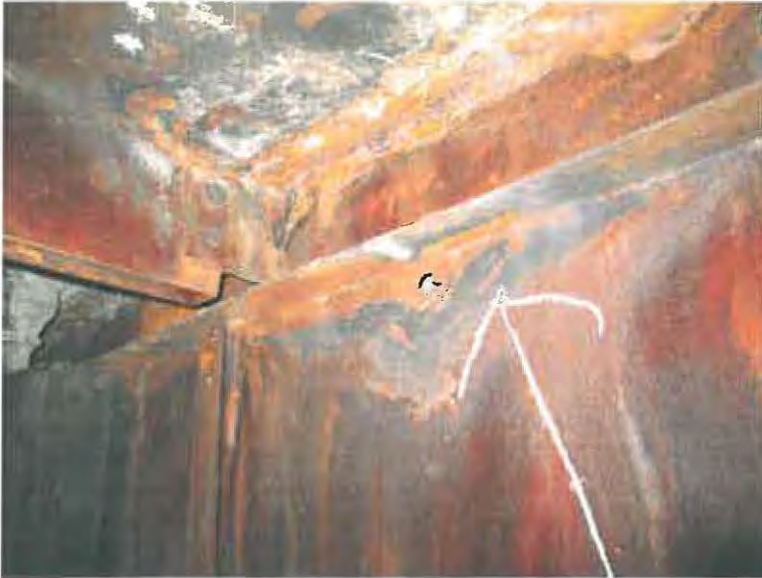
Photo 3

Item 3 Badly worn Corroded area approximately 16ft long
Located below hot roof 2nd field southeast Corner

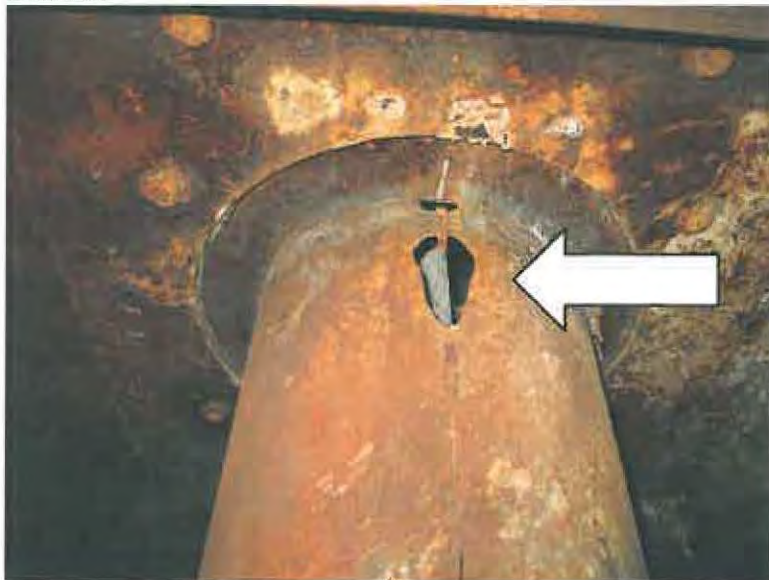
Photo 4

Item 4 (3) Worn corona ring
Located in field 3 east side
Location shown figure 5

2. **Inspect & repair (reinforce) badly worn Lower 3rd field collector plates**
Item 2 on the summary
Estimated resources 3 men 2-3 days
Lodge will advise regarding the parts
3. **Repair (3) Worn corona ring item 4 on the summary**
Estimated resources, 2 men 2days

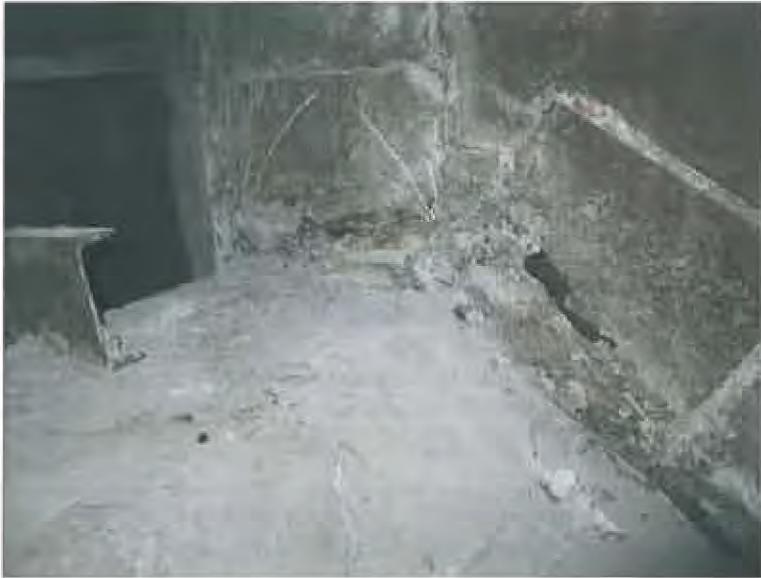
Photo 5

Item 5 Holes in inlet nozzle floor & sidewall total of 6 east side, 3 west sides
Locations shown on figure 6

Several areas of air in leakage and subsequent corrosion were found within the inlet nozzle, outlet side access hatch, between the 2nd & 3rd field upper southwest corner and several minor areas below the roof and penthouse roof and sidewalls, Final repair of the areas between the 2nd & 3rd field is to be deferred until the 2013 outage could possibly require removal of external lagging & cladding. With respect to the inlet, the present condition of the inlet nozzle sloping floor area has been well documented in the past and several repairs completed. Once again several major areas of air ingress were found in both the inlet nozzles As noted in the past the inlet nozzle floor is very thin and in need of major repair and or replacement.

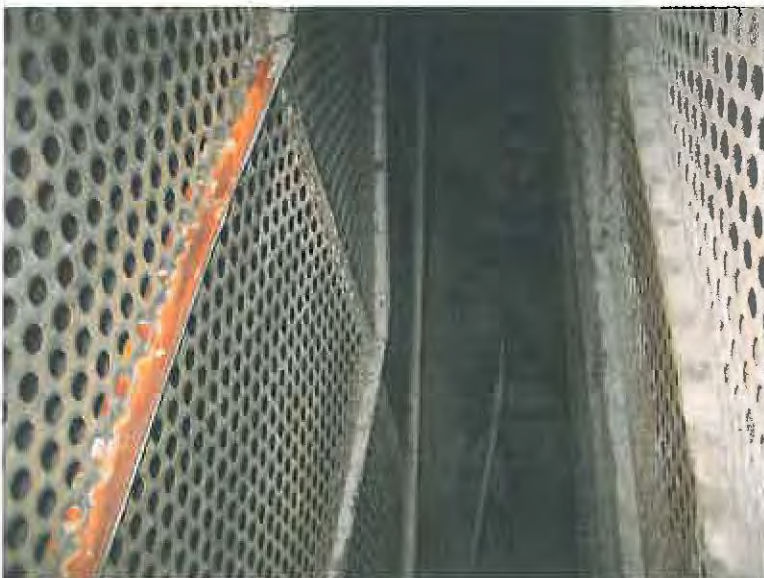
Item 6 Distorted inlet perforated plates
East & West Sides location shown figure 6
Photo 6

In regards to the distorted /missing section perforated gas distribution screen presently these are not a priority item and can be deferred until all of the above item are addressed.

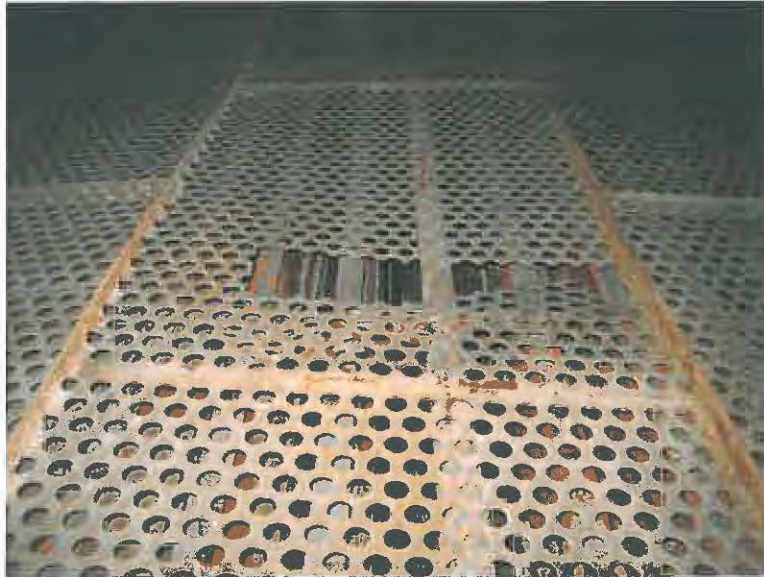
Photo 7

Item 7 Missing section perforated plate east side
Location shown figure 6

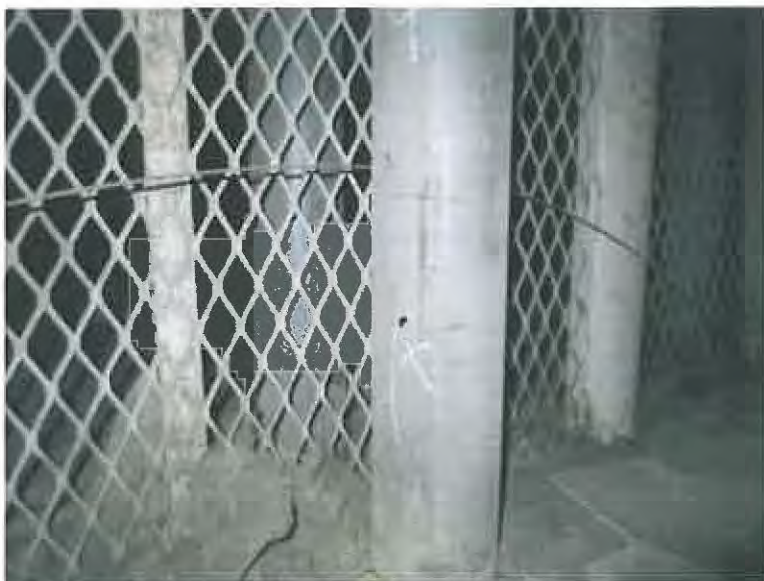
Photo 8

Item 8 Hole /Leaking Collector rapper seal tube
East side 2nd field leading edge

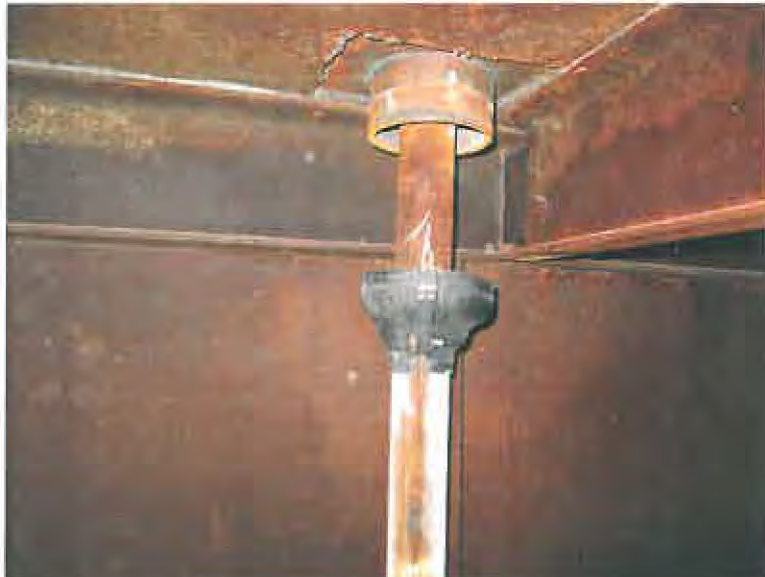
Photo 10

Item 10, 5 each Leaking /torn/missing seal boots
Location shown figure 9

4. **Replace all leaking seal boots**
2 men 1 day
5. **Repair all Air leakage/ penthouse/below hot roof/hatches/inlet nozzle/hatches**
6 men 8 days
6. **Replace missing /damaged insulation 2nd field east side see photo 16 below**
2 men 1day

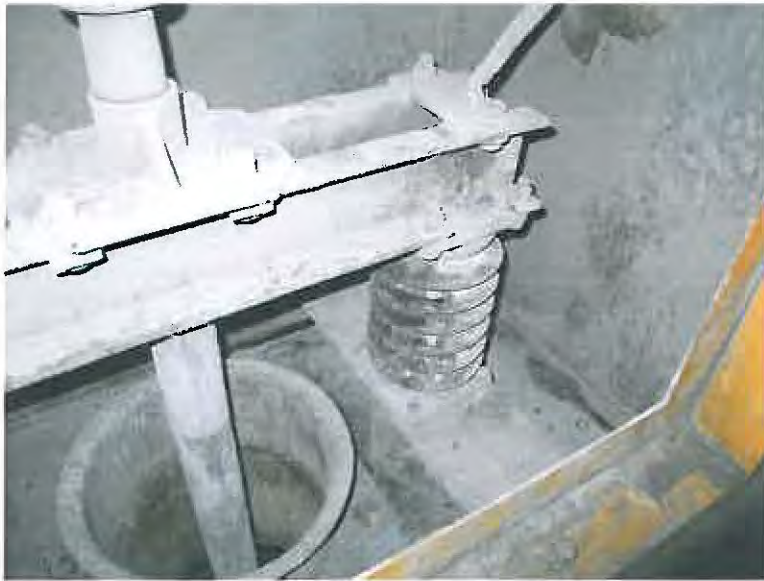
Photo 11

Item 11. Contaminated insulators

All insulator compartments 3rd field insulator compartments should be vacuumed out and insulators cleaned this outage

1. Insulator compartments 3rd field insulator compartments should be vacuumed out and insulators cleaned this outage
2. Repair badly worn collector channel (out of guide)
3rd field east side plate number 21 from side
Access hatch
3. Bad air leak, hole in the precipitator hot roof 2nd field East side
To be repaired this outage
4. Clean out hoppers
4. Verify all rapping is operational.
5. Megger frames to ensure all grounds are cleared.

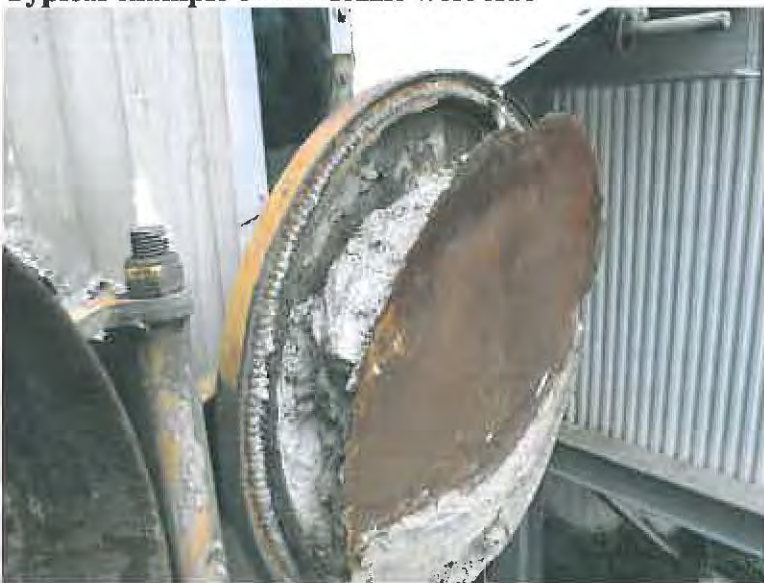
Photo 12

Item 12, (3) each Corroded hatch pans see figure 7

Typical example outlet nozzle west side

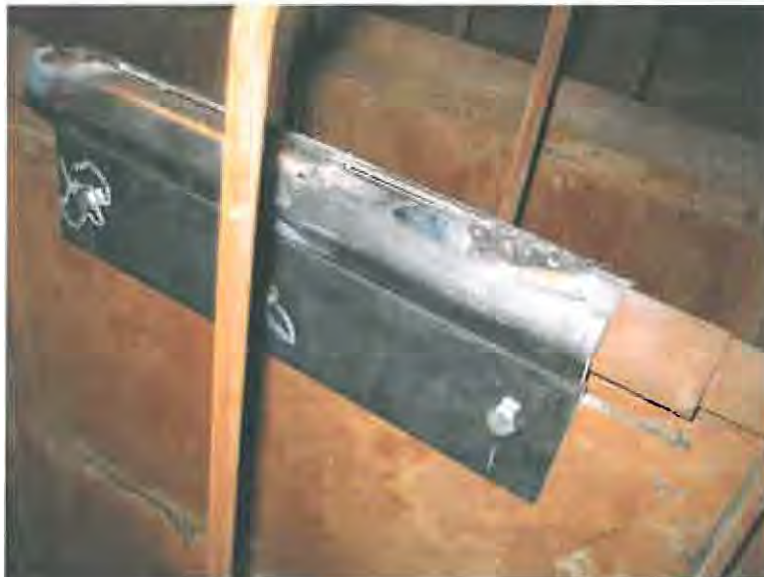
Photo 14

Example of collector repair

The location and nature of items of concern are shown in attached layout sheets . With respect to the precipitator internals, historically the collector plates in fields 1&2 (old UOP) are badly distorted and consequently greater focus was given to these fields. It was noted that several electrical clearances are reduced slightly by approximately $\frac{1}{2}$ to $\frac{3}{4}$ inch when compared to previously issued layout maps dated 2007 quantifying the distortion. This would indicate the collector plates have distorted somewhat from 2009 and is probably associated with item 1 badly damaged collector support shown in photo 1 a total of 110 was found. This item has been documented in the past and trial parts had been installed shown below photo 14. Note the quantity of repairs required has significantly increased since 2009. The failure is predominately found at the leading edge of the 1st field however the failure is now increasing at all location, as can be seen in figures 1-4.Lodge Cottrell strongly recommends all collector plates should be repaired in 2013.

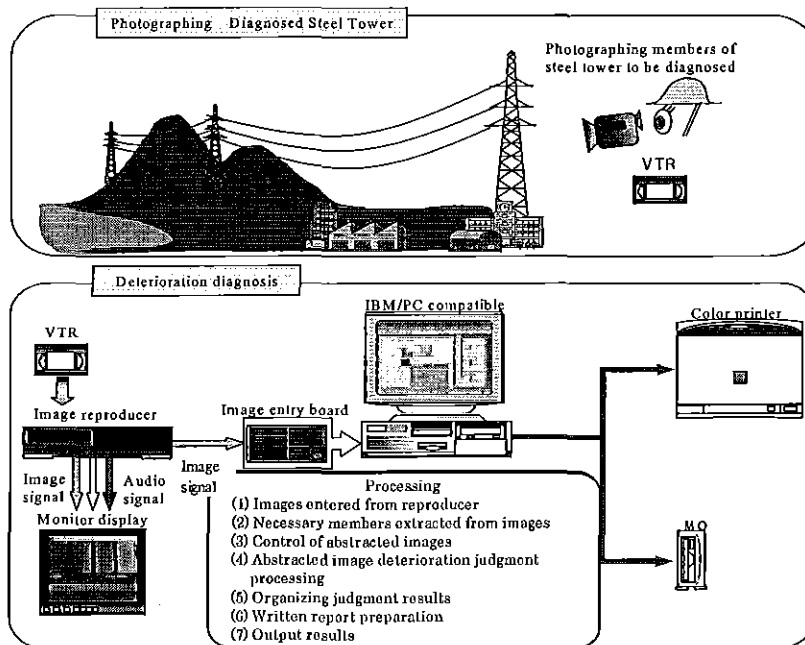
FIGURE 2 Outline of Image Diagnosis

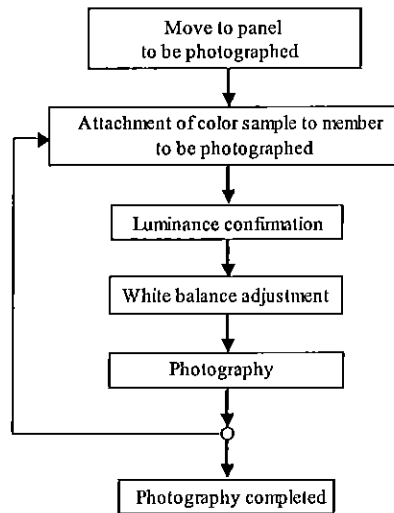
FIGURE 4
Field Photography Procedure and State of Photography

The photography is done by the following procedure. Fig. 4 shows the field photography method and the photography flow chart.

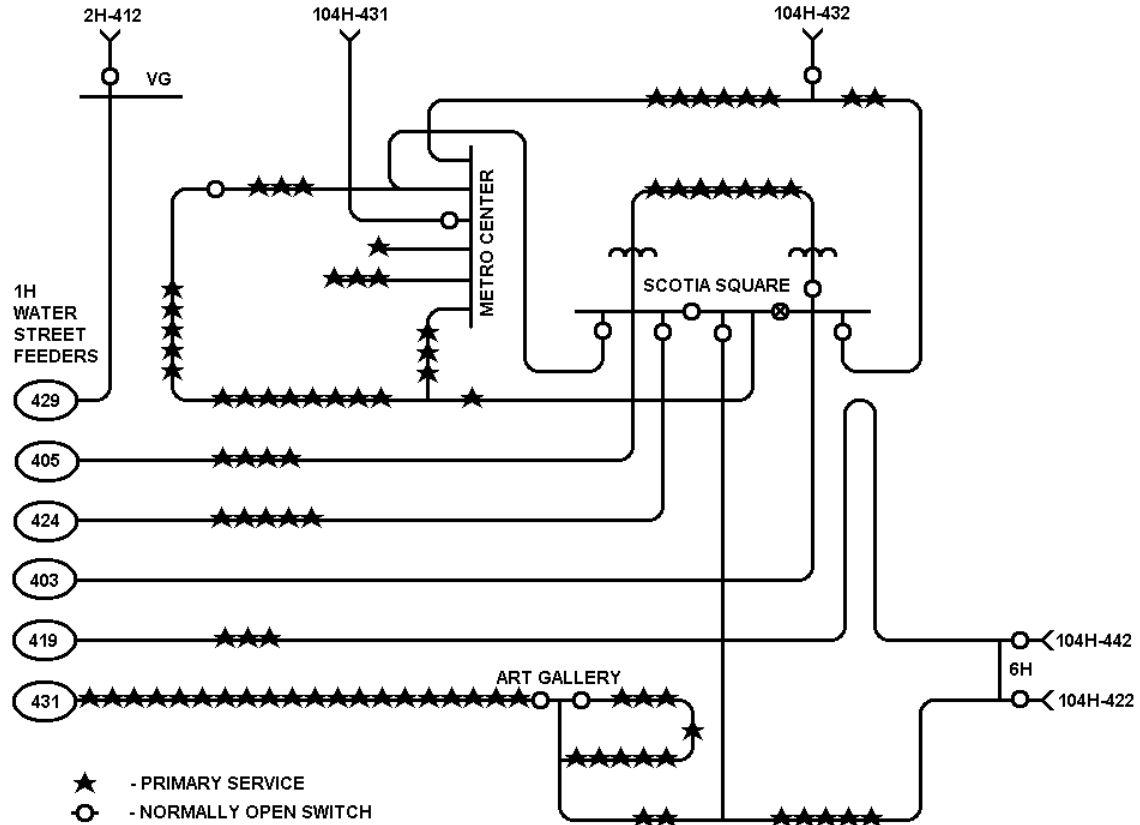
Fig. 2.1 Simplified Feeder Diagram

The diagram on Fig. 2.1 is a simplified combination of an electrical single line diagram and a geographical layout of the Halifax UD system. For simplicity, only open points are shown (except for the one at Scotia Square).

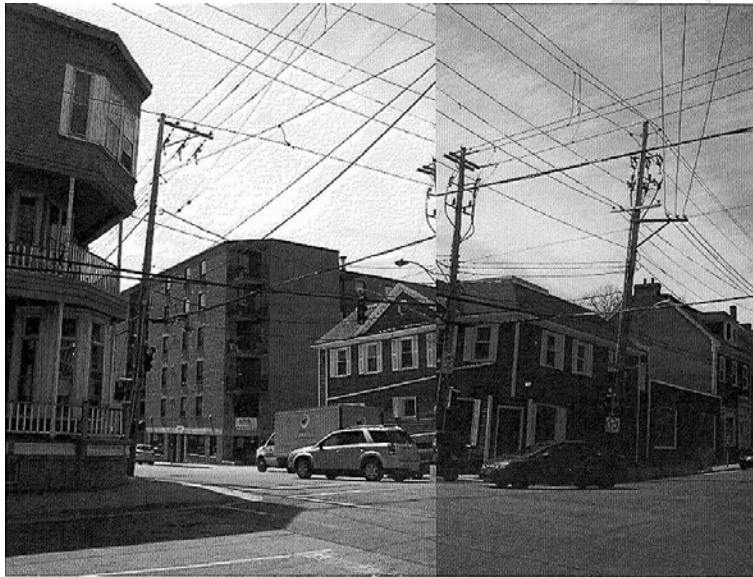
Converting the o/h portion of the feeder 1H-431 would benefit the reliability of the Halifax underground system. There are six riser poles around the intersection of Hollis and Morris Streets that are exposed to traffic and weather. Also, there is a number of flying taps (two sets), quick sleeves, inline switches, communication loops and 4 kV lines sharing the same poles. The top circuits on each of the three poles on Fig. 4.10 are the feeder 1H-431.

Fig. 4.10 Intersection of Hollis and Morris St.

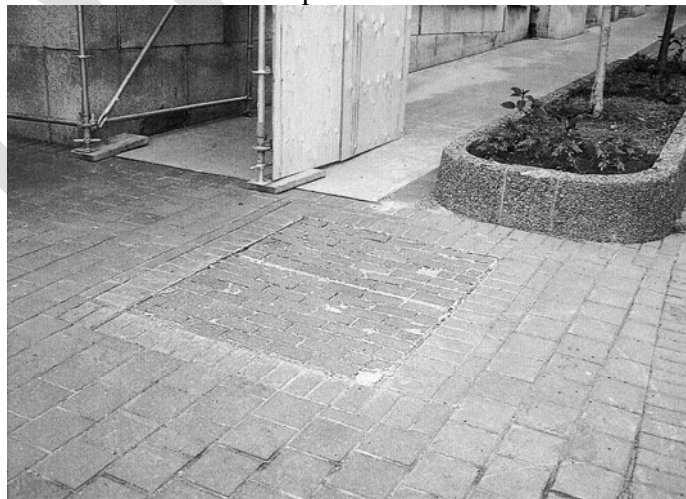
Fig. 4.4 Manhole MH56

The electrical connections in the vault will have to be modified to allow for a new switch. One of the options would be to install a new two-way 200 A VacPac switch and relocate the CS431-272 primary service from the existing four-way VacPac switch to the new switch. The source side of the new switch will be piggybacked at L431-209. See Fig. 4.5 and 4.6 for details. This will free up one of the 600 A switches on the existing VacPac which will be used to tie-in the feeder 1H-424.

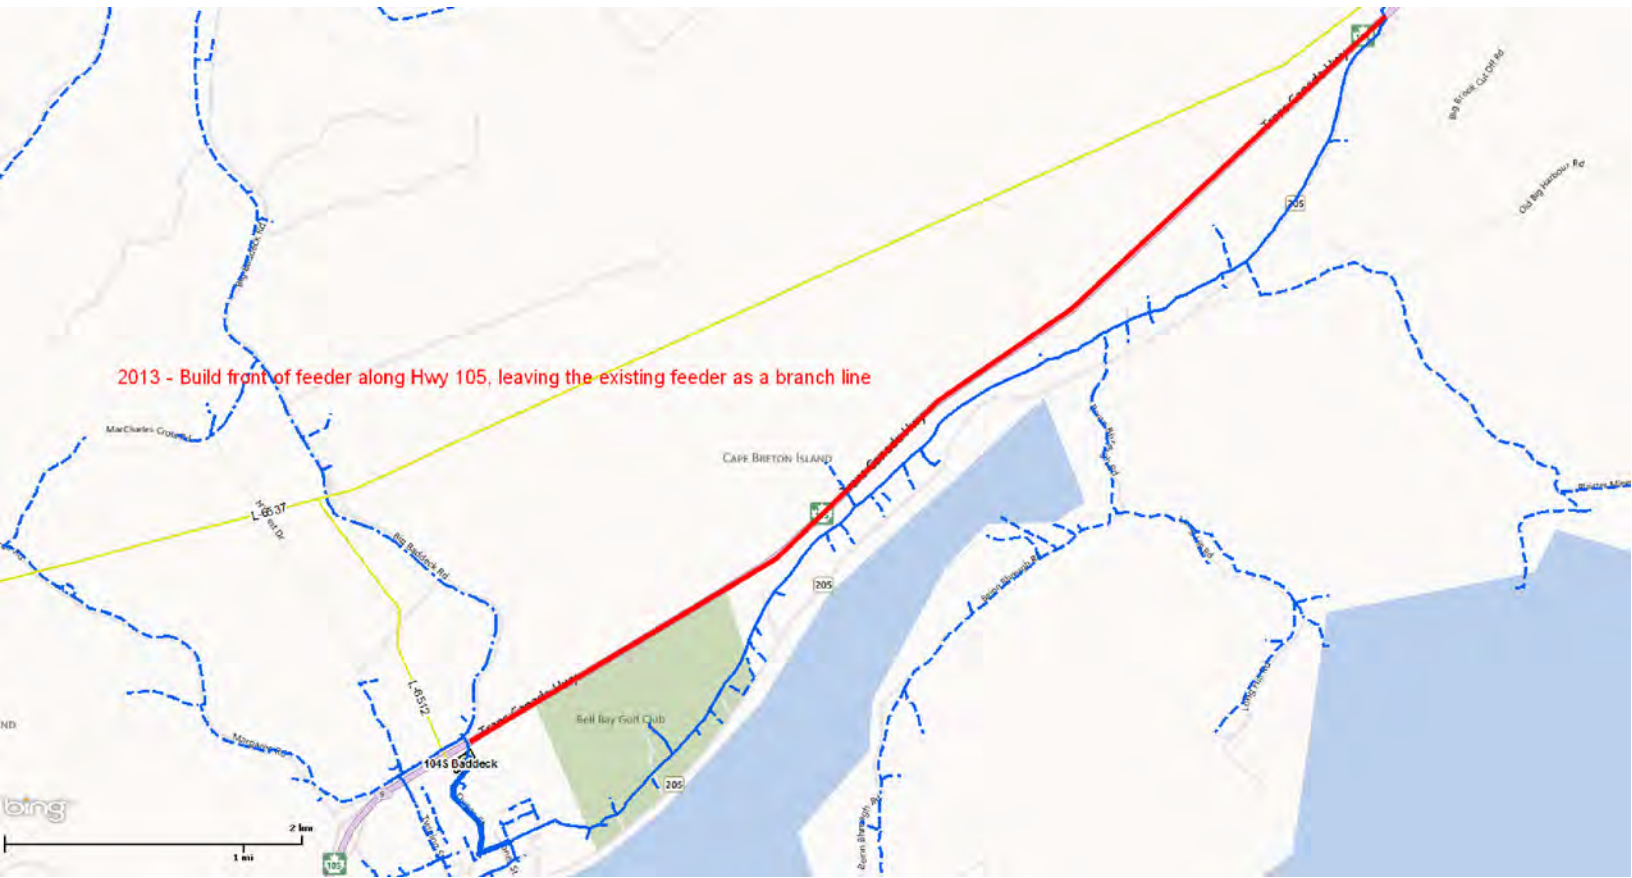
2013 104S-313 Baddeck Rebuild

Map from a NSPI GIS

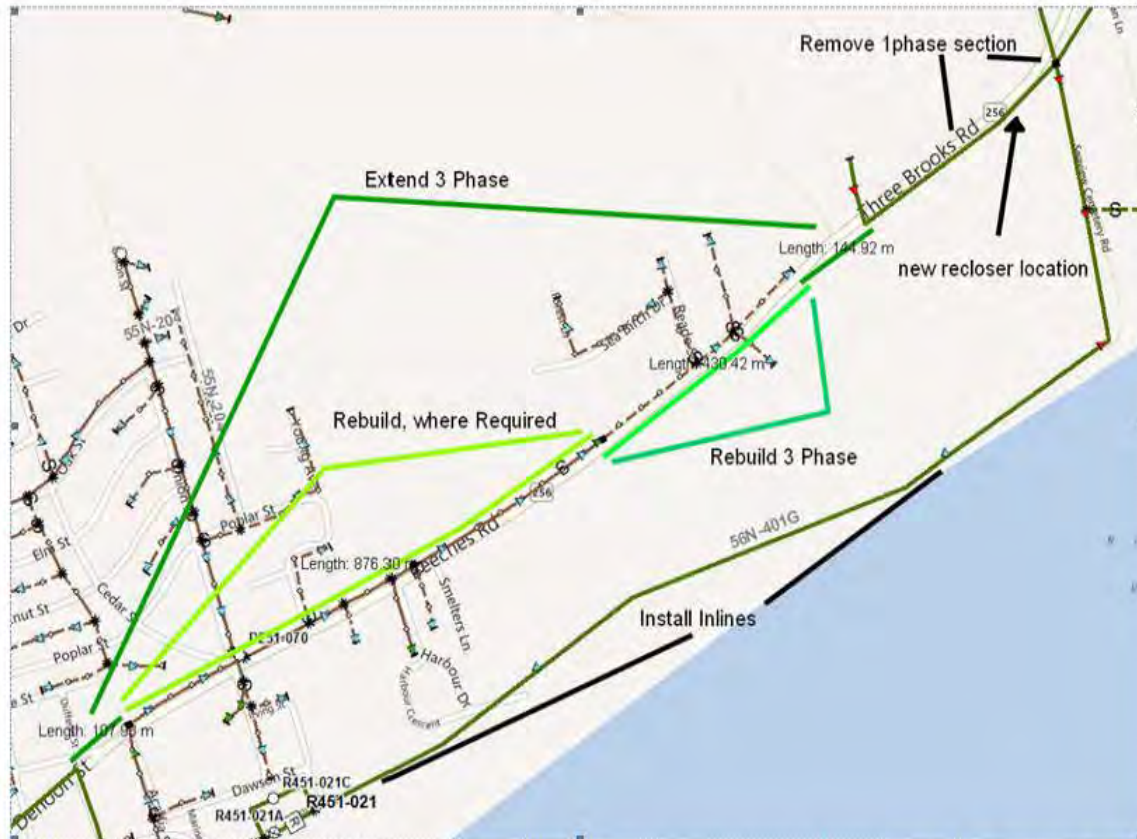
2013 56N-401 Pictou Rebuild

In this project the 25kV line will be extended along Denoon Street through to where it ends on Three Brooks Rd, via Beeches Road.

There will be two sections where new construction will occur for approximately 250m.
