IN THE MATTER OF an Application by Nova Scotia Power Inc. for
Approval of the **2013 Annual Capital Expenditure (ACE) Plan**

2013 ACE Plan

2013 Annual Capital Expenditure Plan

Weymouth Surge Tank Inspection

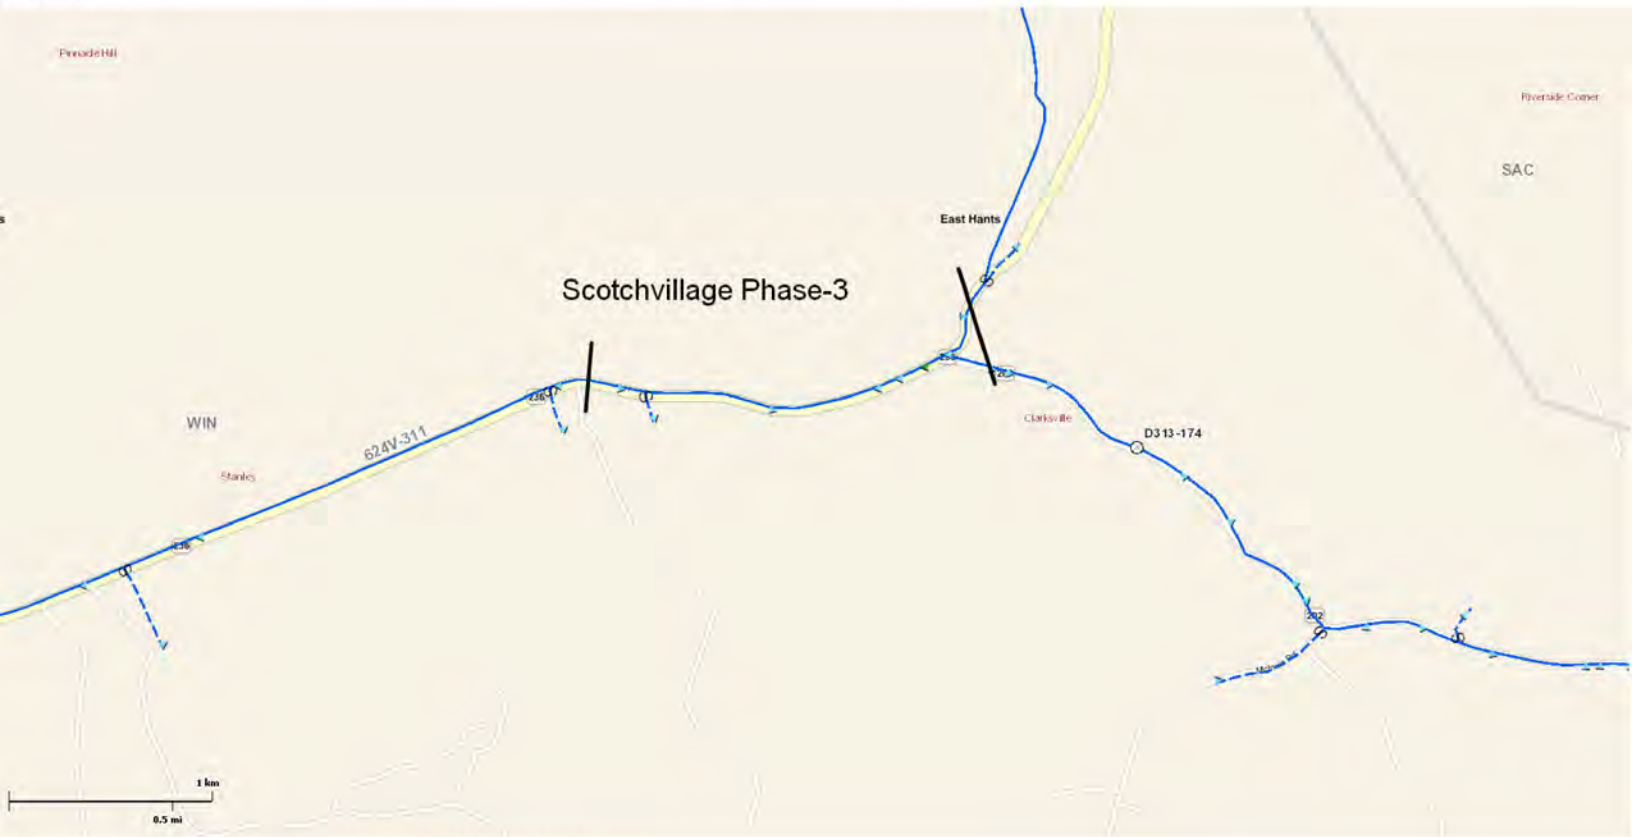
624V-311 Scotchvillage Reconductor

Feeder Section: 624V-311
